Re: Waller County Assessments
Hempstead, Texas
JQ Project No. 3210155

JQ Engineering (JQ) performed a limited, structural review of three buildings for Waller County, the historic 1955 Courthouse, the 1954 Jail building, and the County Hospital on June 16 and 17, 2021. The purpose of the review was to assess the structural condition of the buildings for the purpose of providing recommendations for repair.

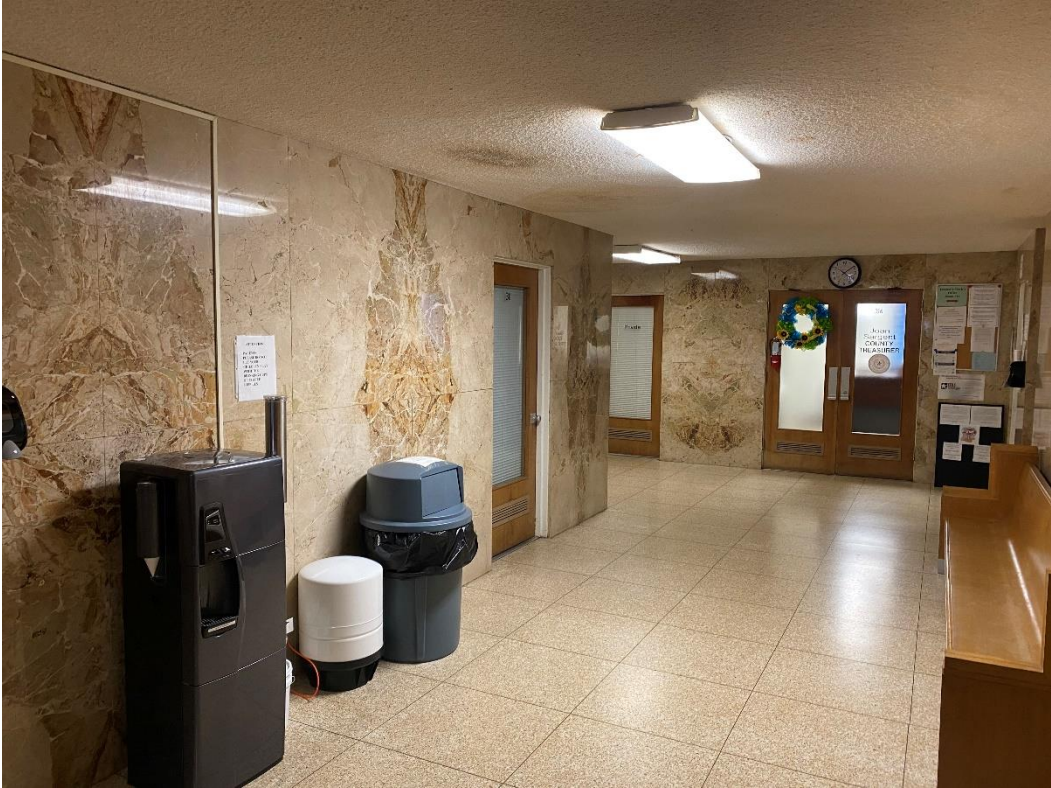
- The upper levels of the structure, level 2 and above, were almost entirely covered with finishes and were not observable during the site observation; see photographs 1 and 2.

Photograph 1 – Interior corridor.

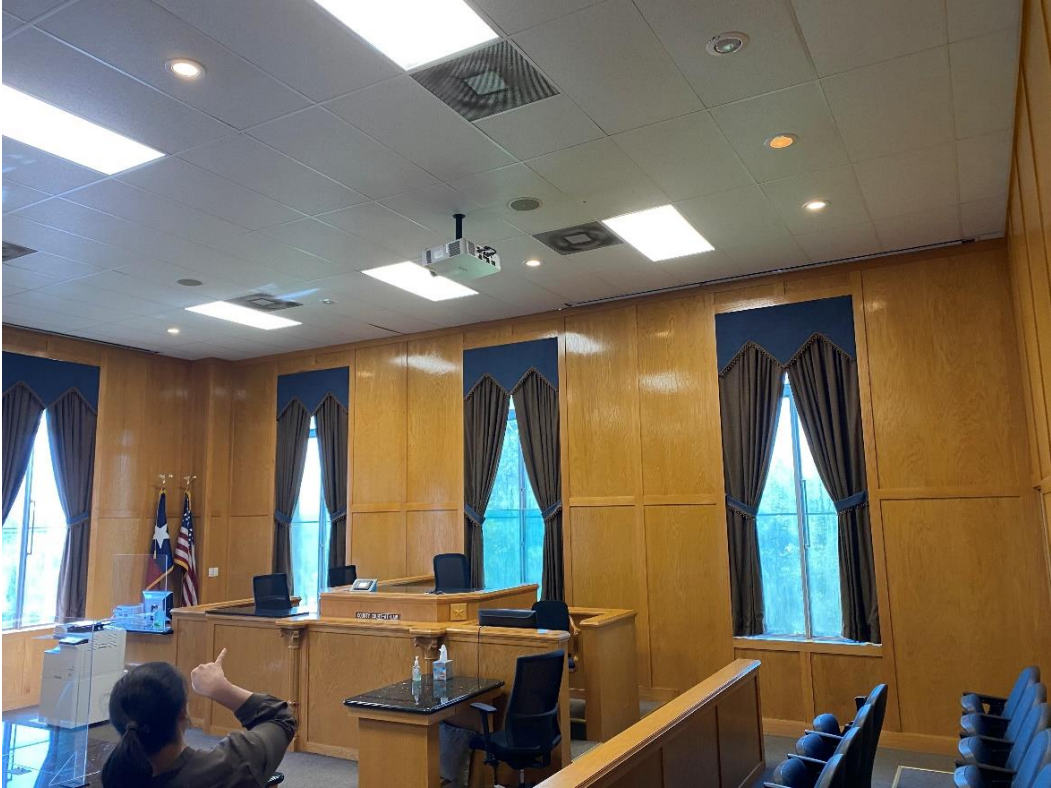
Photograph 2 – Interior of the courtroom.

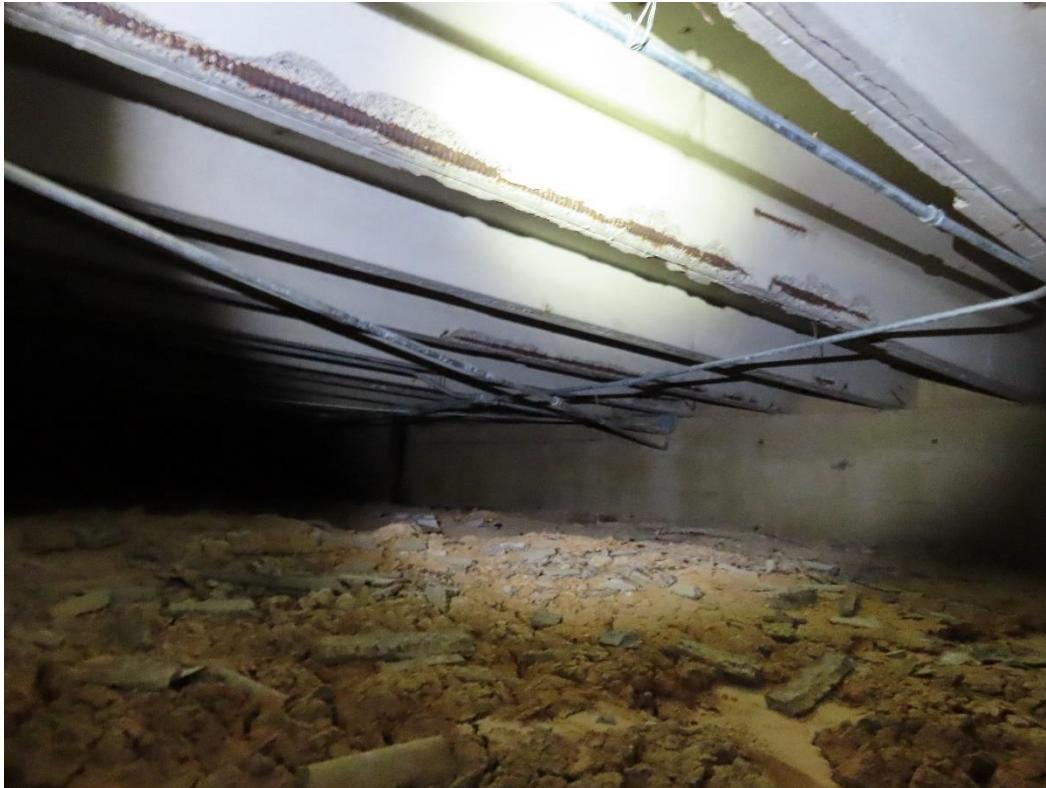
- The crawlspace was accessible in three locations. The observed framing has experienced significant corrosion of the reinforcing steel in each compartment of the crawlspace; see photographs 3, 4, and 5. The estimated number of precast channels experiencing visible spalling and corrosion is 25%, 50% and 90% in the three compartments observed.

The crawlspace is experiencing extensive corrosion of the precast channels, while the cast-in-place concrete grade beams did not show signs of deterioration. In general, hardened concrete has a pH between 11 and 13.5 which provides corrosion protection of the embedded steel reinforcing. Over time the concrete pH can be lowered due to environmental exposure to carbon dioxide or salts which causes carbonation of the concrete. The test results determined a reduction of the pH of the concrete within the

precast concrete channels, which indicates the natural corrosion protection provided by the concrete is no longer present.

Photograph 3 – Reinforcing steel corrosion in the crawlspace.

1. Replace the precast concrete channels, including the floor slab in the crawlspace, with new structural framing that is supported on the existing cast-in-place concrete grade beams. In order to perform this work, the entire first-floor slab and all finishes supported by the slab will need to be replaced. Due to the invasive nature of this solution, it is likely to be cost-prohibitive to the overall project to be a viable option.

2. As an alternative to the above replacement, the precast channels could be repaired, and a penetrating corrosion inhibitor applied to the surfaces of the concrete. Application of the inhibitor to all concrete surfaces would be difficult due to limited construction access in the crawlspace. Due to the constructability challenges with applying the penetrating corrosion inhibitor, future concrete repairs should be expected and budgeted for by the County. These future repairs are difficult to predict when and where they may occur and may impact future building operations. The owner should carefully consider the impact on future operations before determining the viability of this option.

3. Add mechanical crawlspace ventilation to meet the current building code requirements.
4. Repair the parapet brick veneer at the building corners.
5. Cut in vertical control joints in the existing brick veneer within four feet of the building corners and at 30 feet on center.

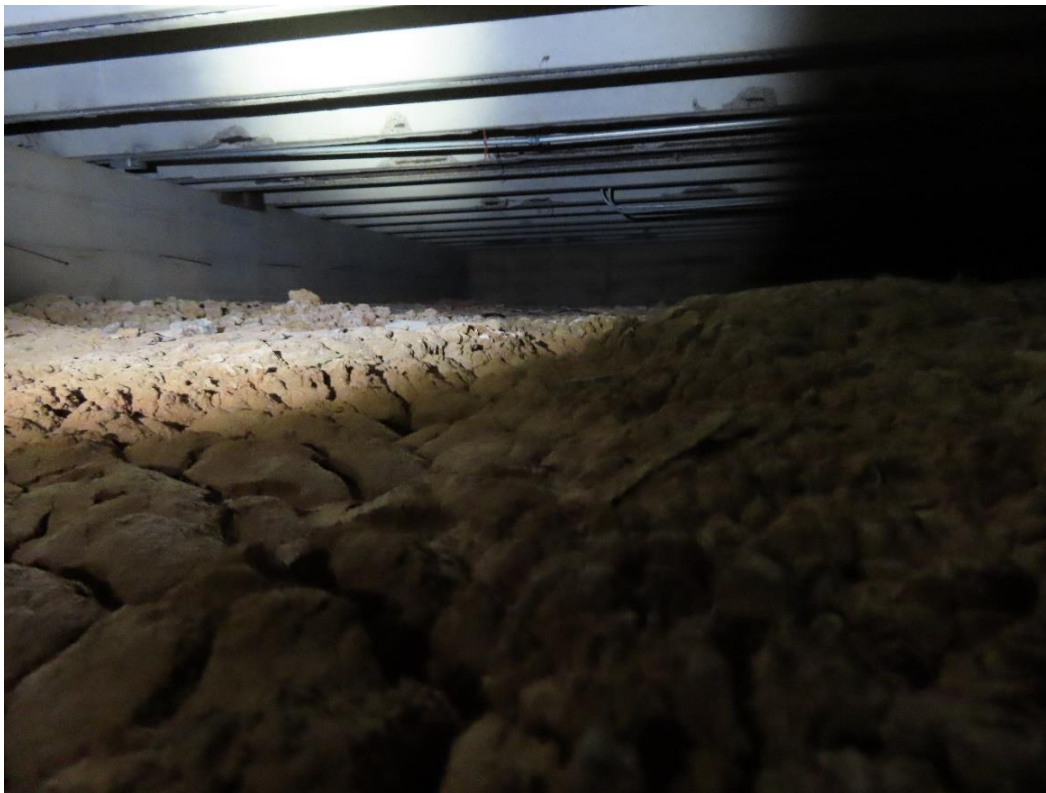
Photograph 4 – Reinforcing steel corrosion in the crawlspace.

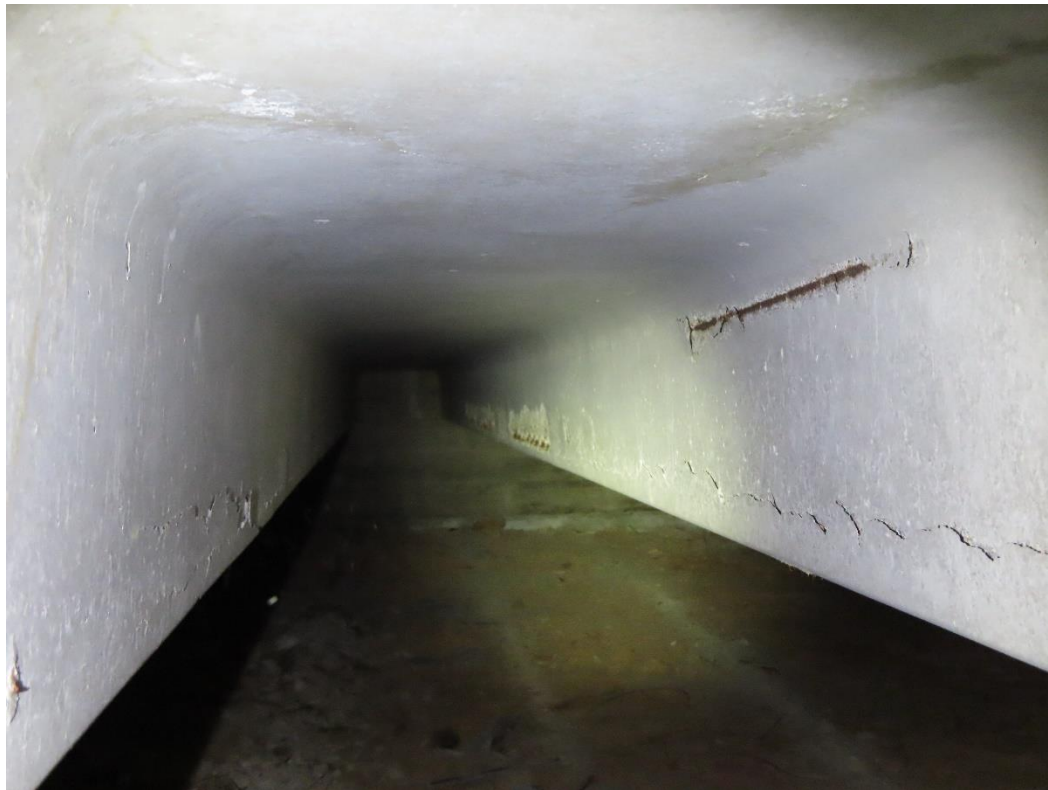
Photograph 5 – Reinforcing steel corrosion in the crawlspace.

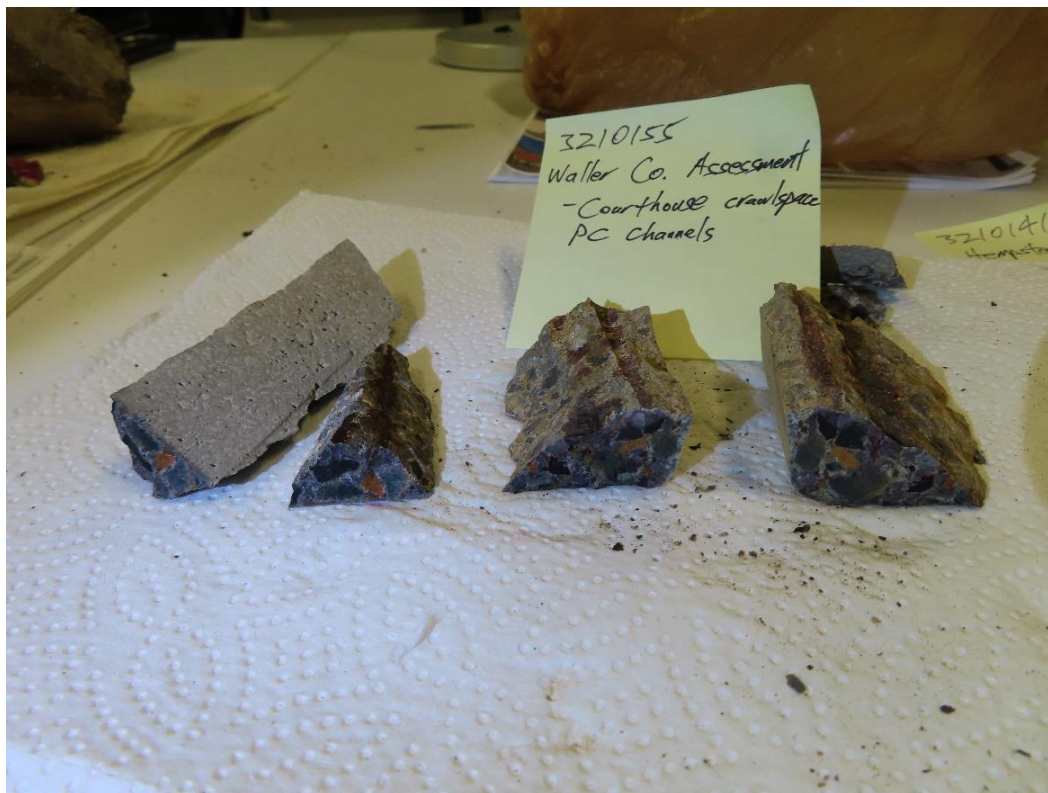
- A sample of the precast channel concrete was obtained for pH testing of the concrete with phenolphthalein to determine the depth of carbonation. The concrete was none reactive, indicating a pH less than 8.5; see photograph 6. See the discussion section of this report for further comment.

Photograph 6 – pH test results showing a pH less than 8.5.

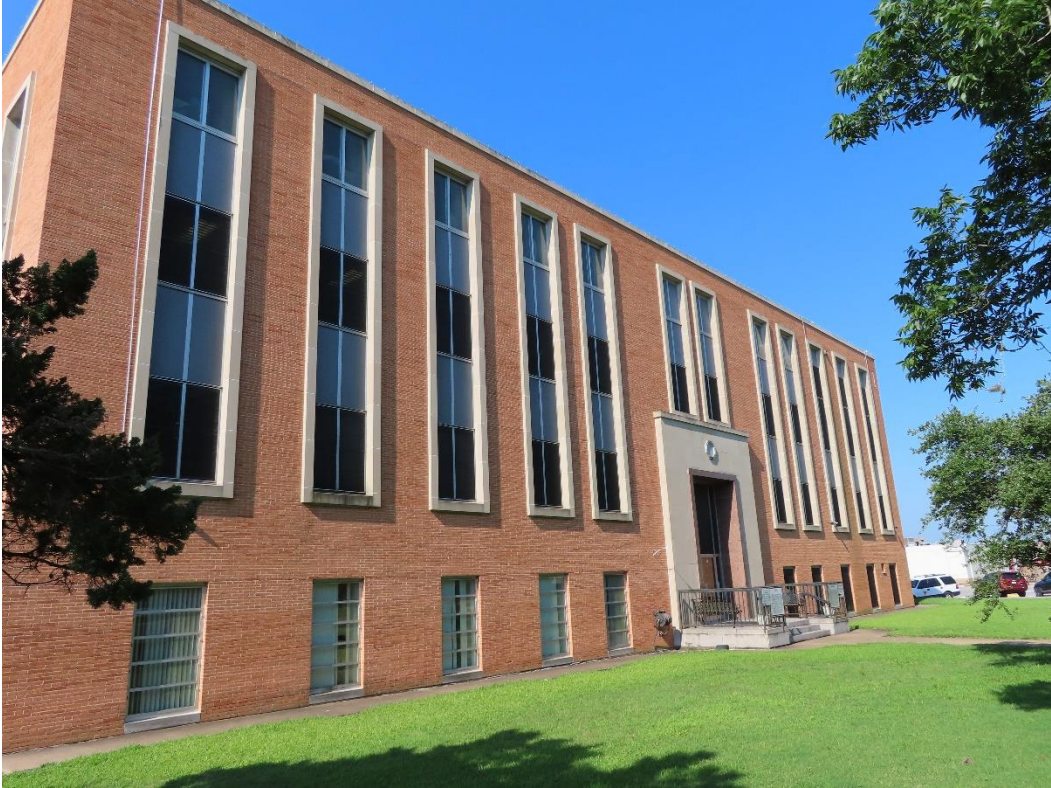
- The exterior brick veneer does not have any control joints installed; see photograph 7.
- The parapets of the brick veneer have been pushed out at the building corners due to volumetric change of the brick veneer over time; see photographs 8 and 9.
- The site retaining walls show signs of lateral displacement; see photographs 10 and 11.
- Joint sealants in the exterior retaining walls have failed in multiple locations; see photograph 12.
- Crack in the brick veneer at the southeast retaining wall corner; see photograph 13.

Photograph 7 – North façade elevation.

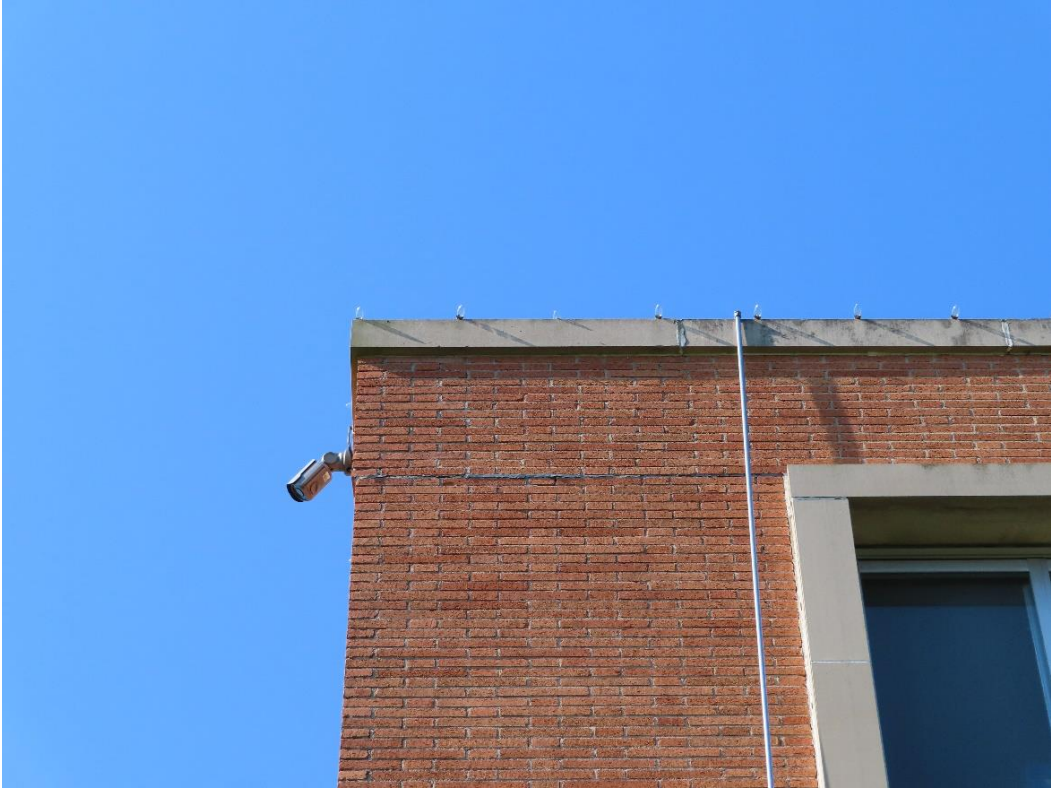
Photograph 8 – Parapet displacement in the brick veneer.

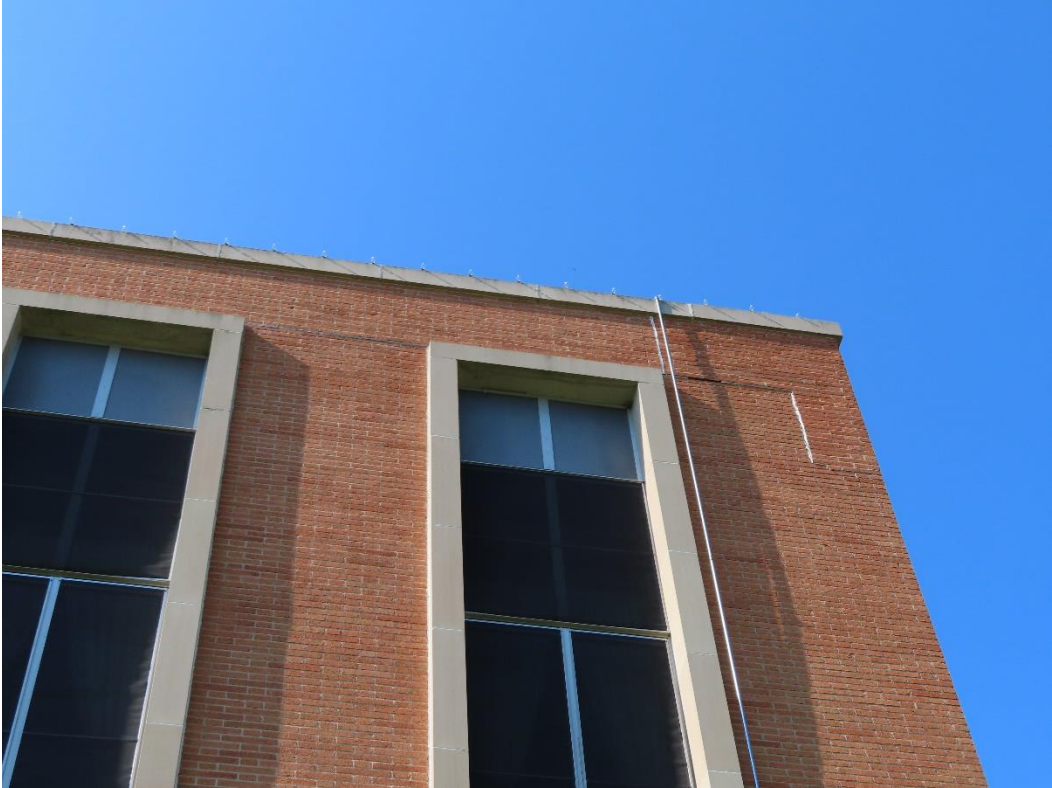
Photograph 9 – Parapet displacement in the brick veneer.

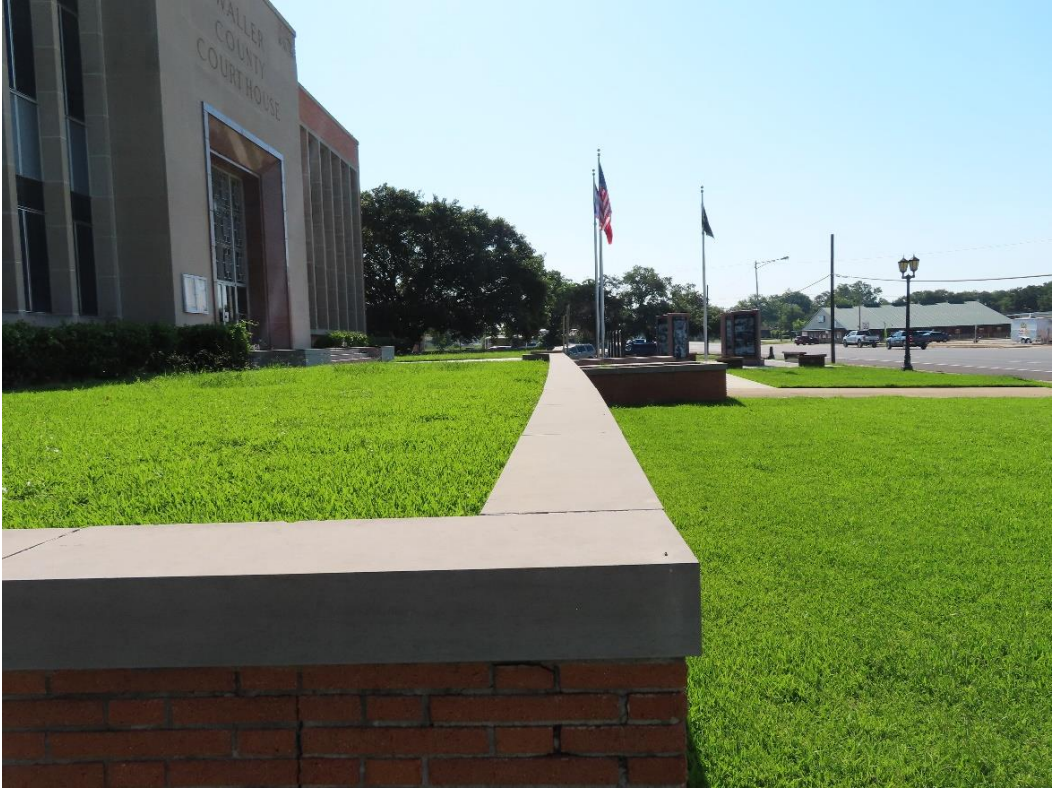
Photograph 10 – Retaining wall displacement on the south site wall.

6. Replace joint sealants in cast stone caps in the retaining walls and at the building parapets.
7. Repair the brick veneer at the southeast retaining wall corner and cut in a new control joint.

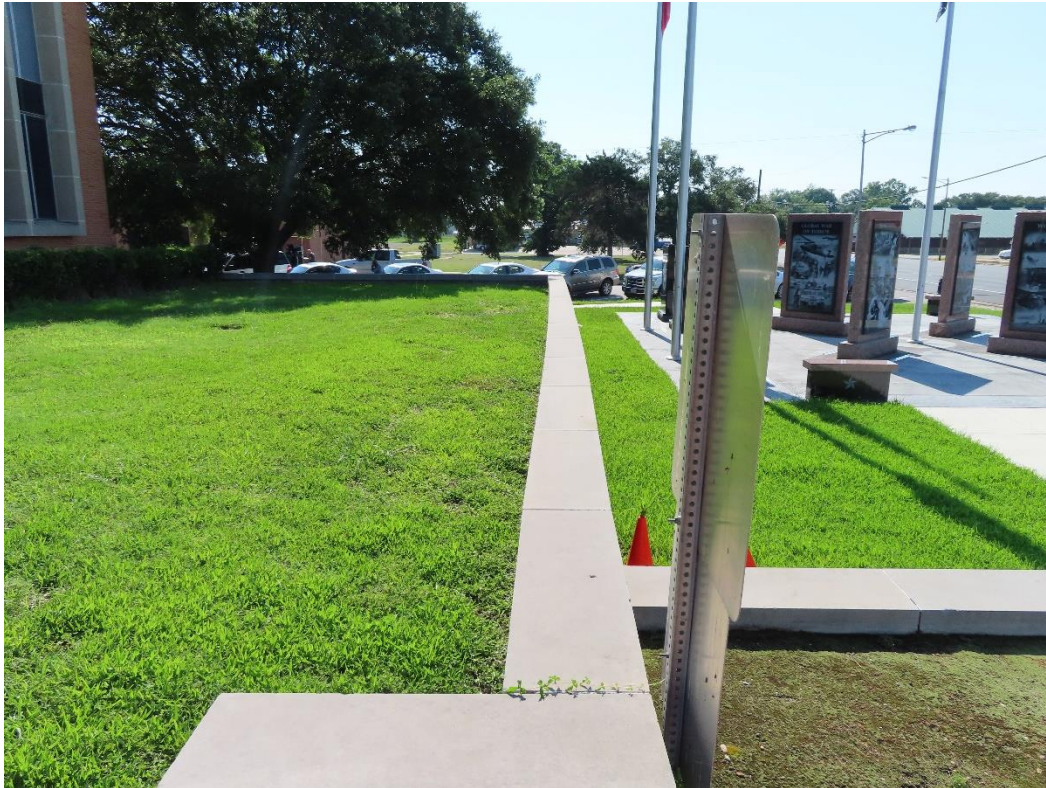
Photograph 11 – Retaining wall displacement at the south site wall.

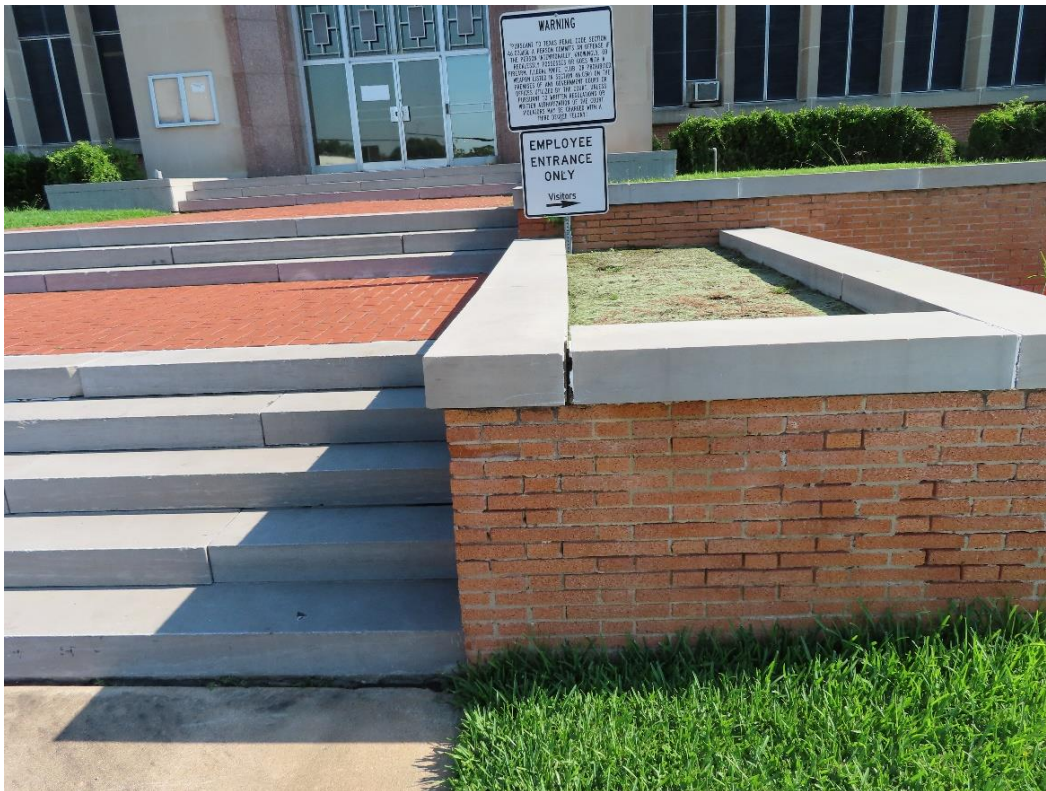
Photograph 12 – Retaining wall displacement on the south site wall.

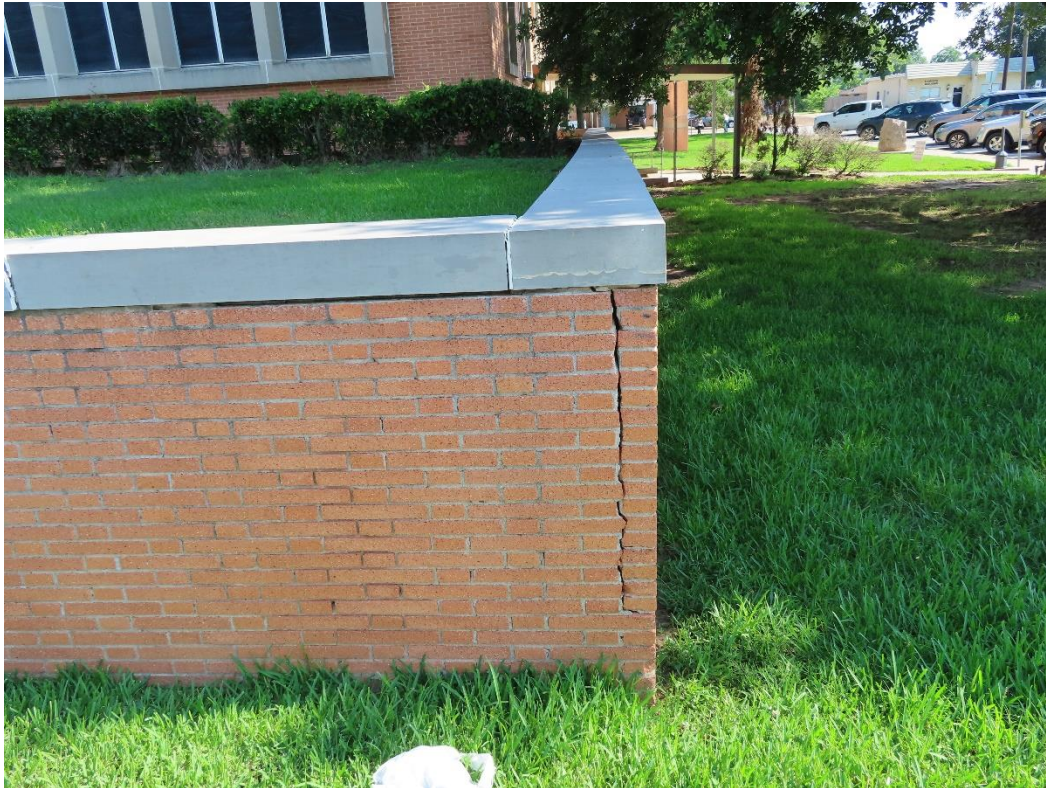
Photograph 13 – Damage retaining wall brick veneer southeast site wall corner.

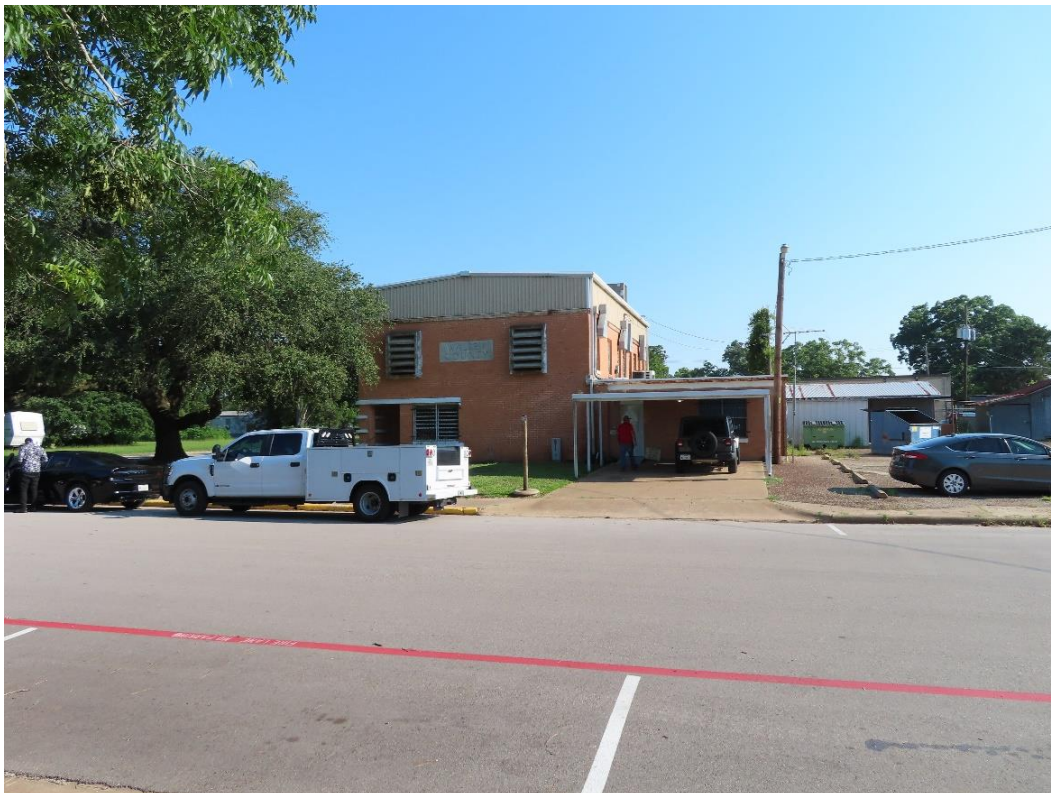
The jail consists of a two-story cast-in-place concrete structure. The framing system of the second floor and roof consist of cast-in-place concrete one-way slab and beam system. The ground level is concrete slab-on-grade. The foundation consists of drilled and under-reamed concrete piers bearing 8'-6" below the finish floor. See photograph 14.

Photograph 14 – Jail building overall photo.

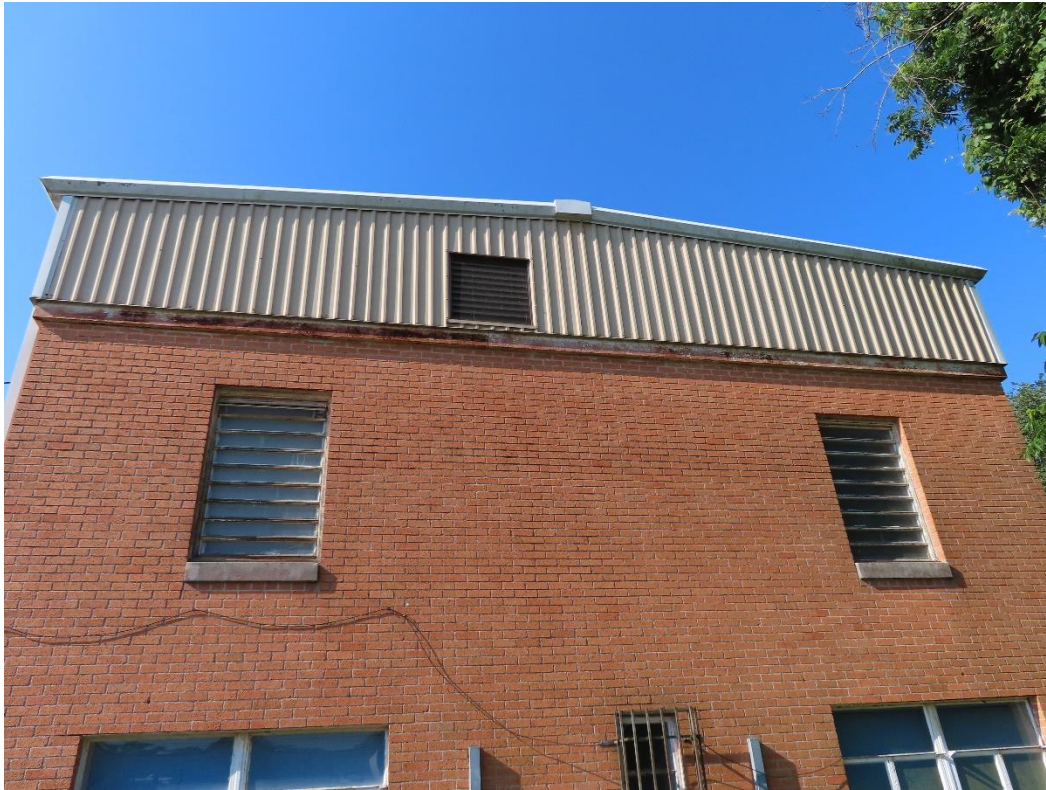
- The exterior brick veneer façade does not have any control joints; see photograph 15.
- The exposed concrete structure is in generally good condition; see photograph 16.

Photograph 15 – North façade of the Jail Building.

1. Cut in new vertical control joints in the existing brick veneer within four feet of corners and at 30 feet on center.

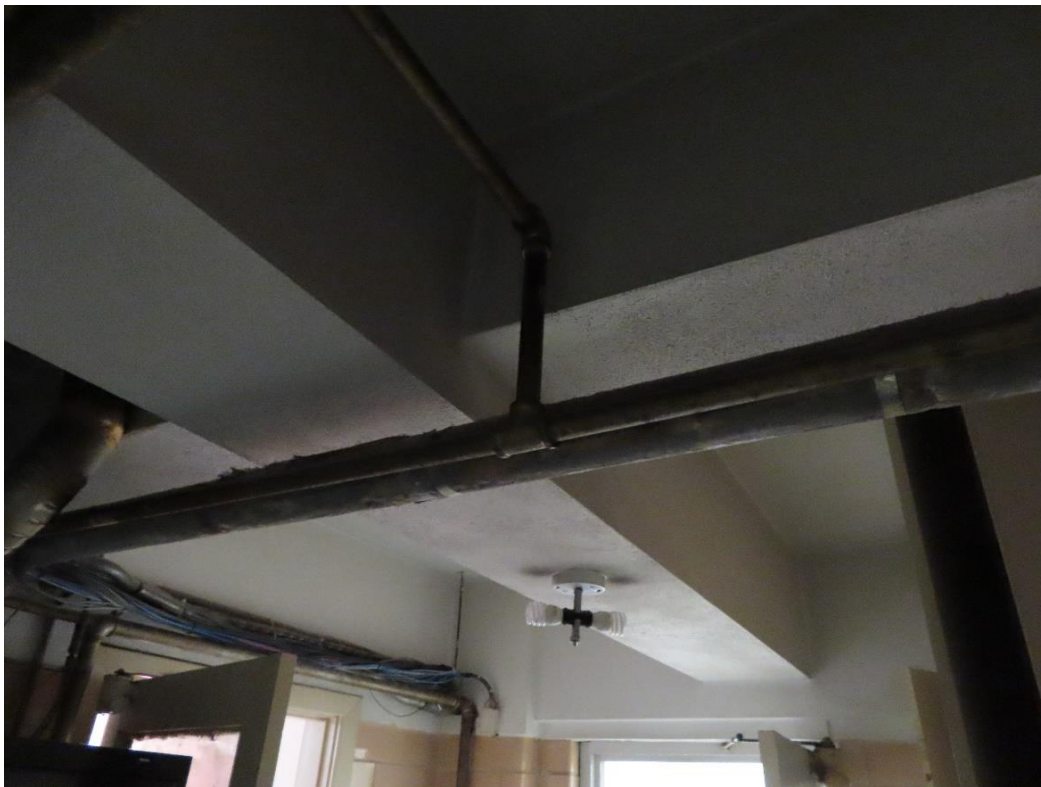
Photograph 16 – Exposed concrete structure.

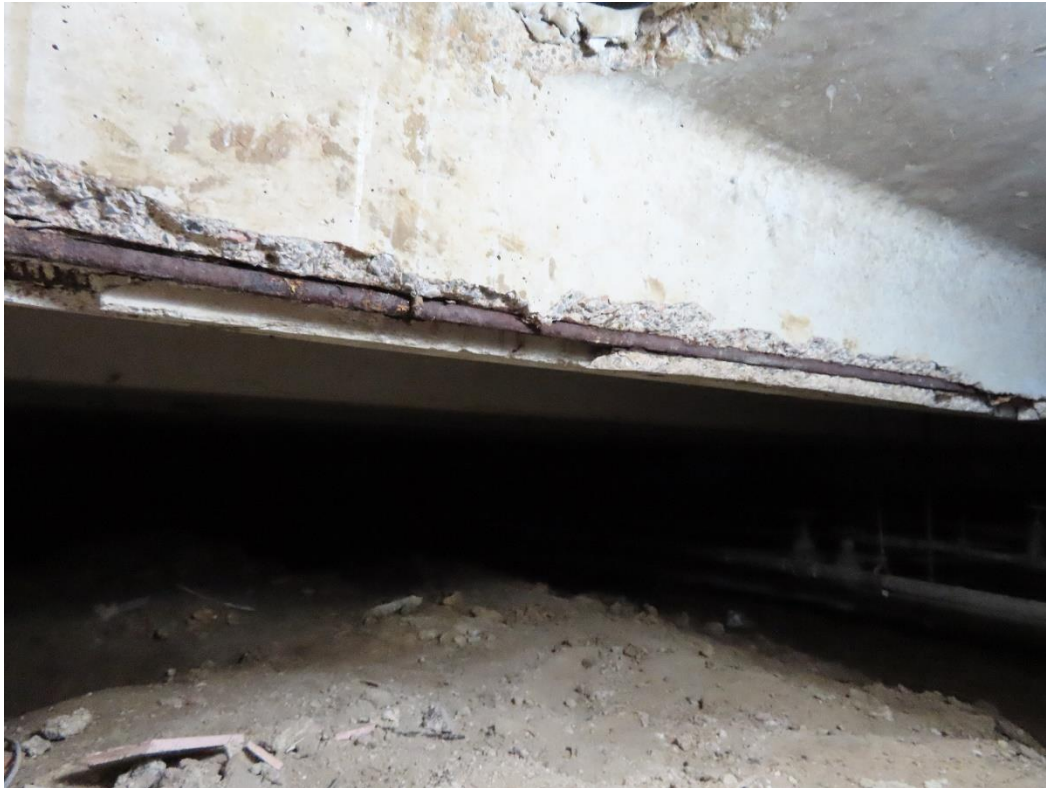
- The crawlspace has limited access, and observations were limited to the area immediately adjacent to the access hatch.
- Reinforcing steel corrosion in the precast concrete channels and the cast-in-place concrete grade beams in the crawlspace was extensive; see photographs 17, 18, 19 and 20.

The precast concrete in the hospital building is experiencing extensive corrosion of the precast channels to an even greater extent than discussed in the Courthouse. Similar to the Courthouse, the testing of the precast concrete channels indicated a reduction of the pH in the concrete. The corrosion attack discussed above in the Courthouse section of this report is much more extensive than found in the Courthouse, and the repair of this floor is no longer a feasible option in the hospital crawlspace.

Photograph 17 – Reinforcing steel corrosion in the crawlspace.

Due to the extensive structural repairs required to rehabilitate the building structure that would require the removal and replacement of all finishes and the structural elements, it will be cost-prohibitive to rehabilitate the structure. Therefore, we recommend that the hospital structure be replaced with a new structure.

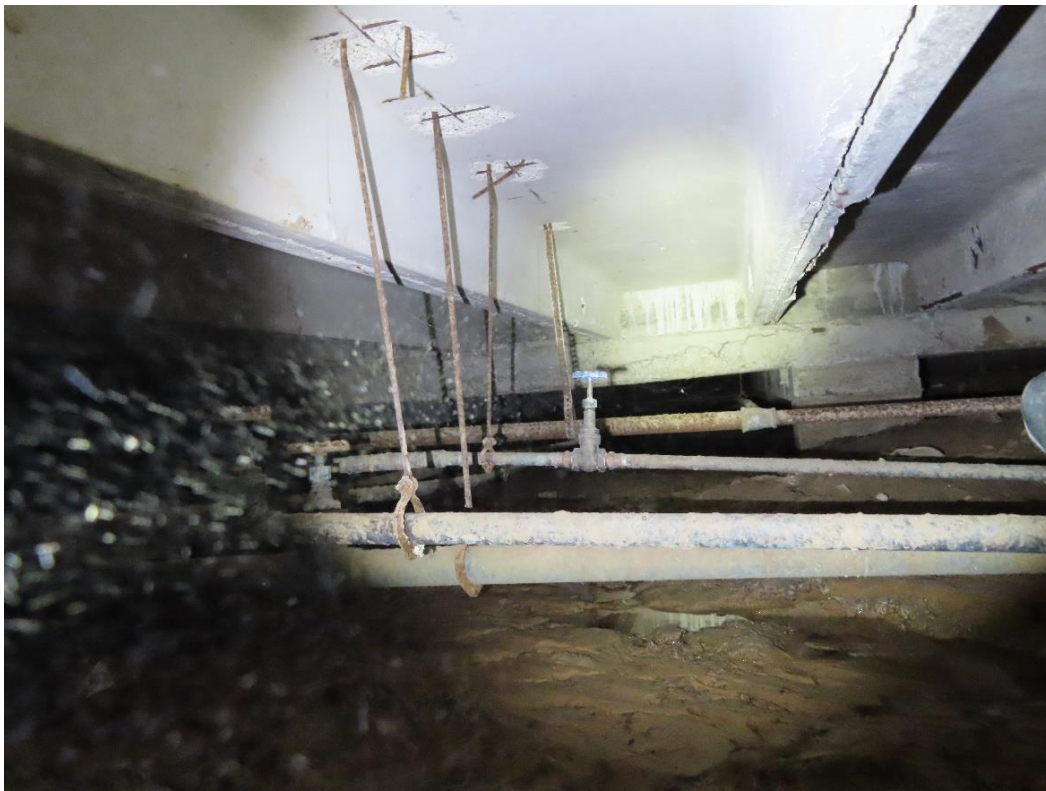
Photograph 18 – Deteriorated concrete and reinforcing steel corrosion in the crawlspace.

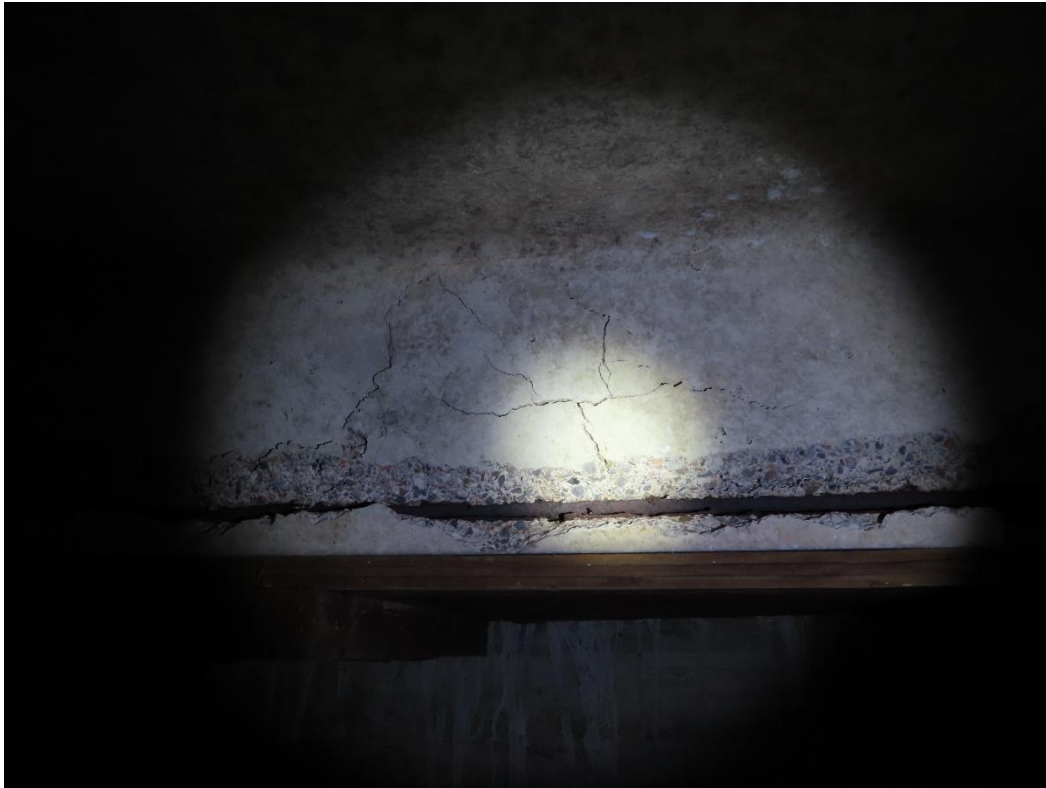
Photograph 19 – Deteriorated concrete and reinforcing steel corrosion in the crawlspace.

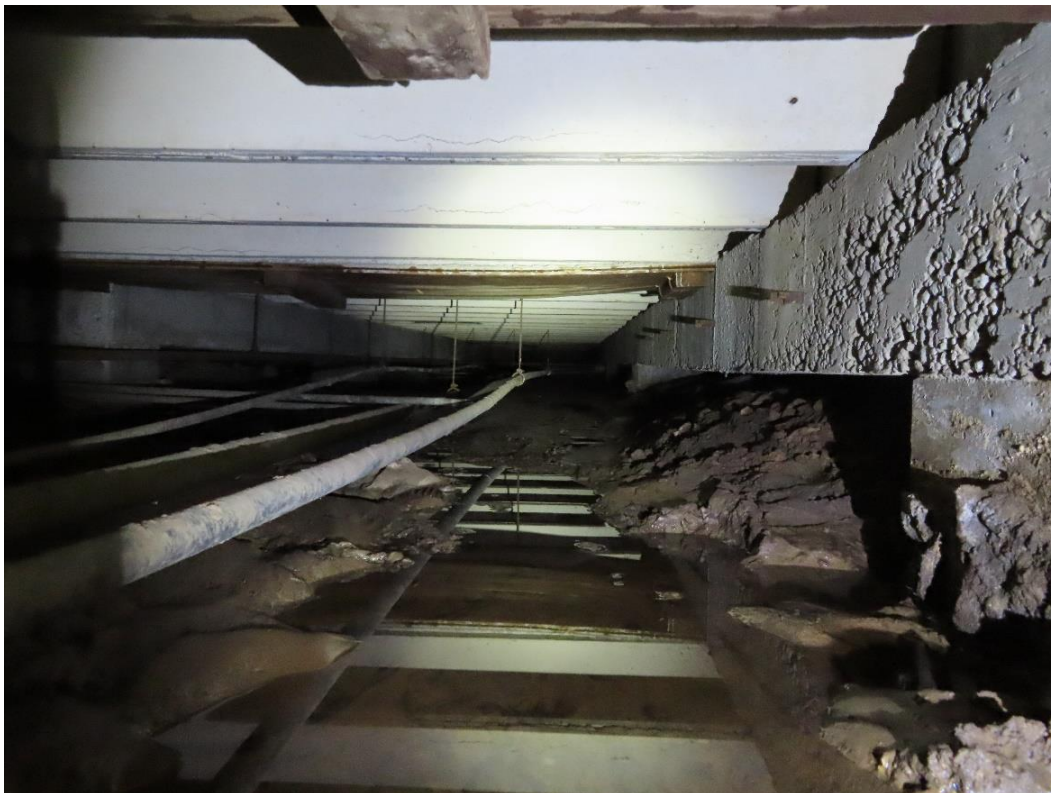
- Standing water was present in the crawlspace; see photograph 20.
- Passive crawlspace ventilation was provided with small vents in the grade beam walls.

Photograph 20 – Deteriorated concrete and reinforcing steel corrosion in the crawlspace.

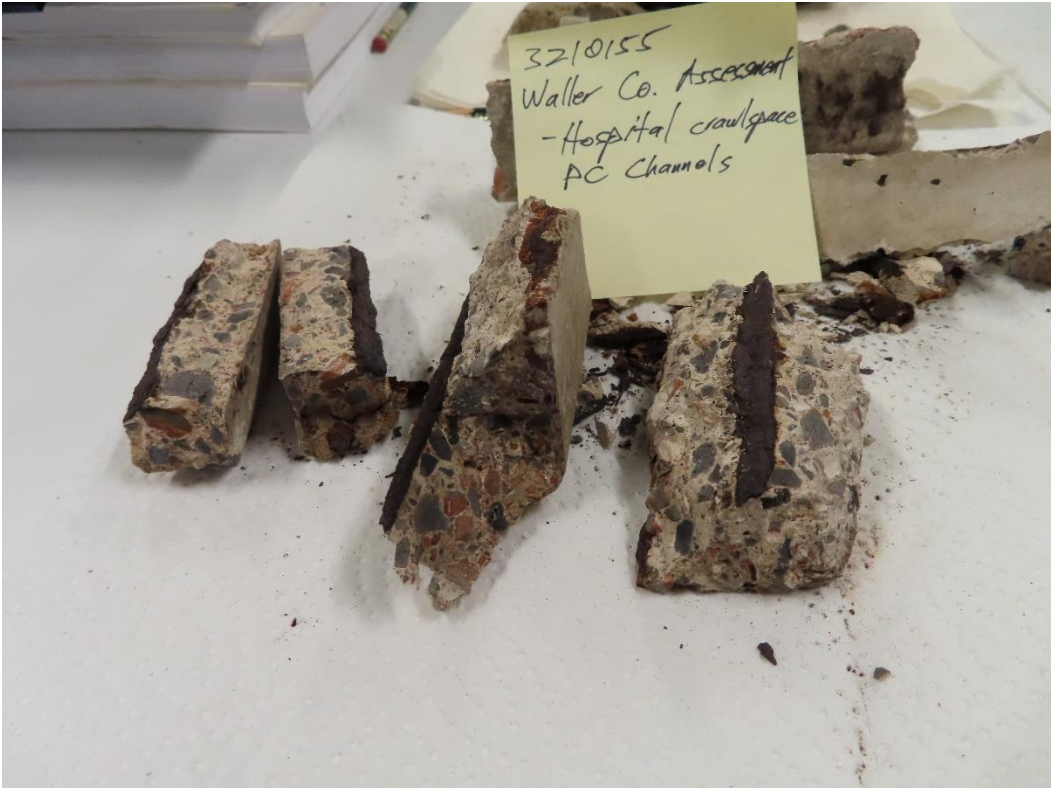
- A sample of the precast channel concrete was obtained for pH testing of the concrete with phenolphthalein to determine the depth of carbonation. The concrete was none reactive, indicating a pH less than 8.5; see photograph 21. See the discussion section of this report for further comment.

Photograph 21 – pH test results showing a pH less than 8.5.

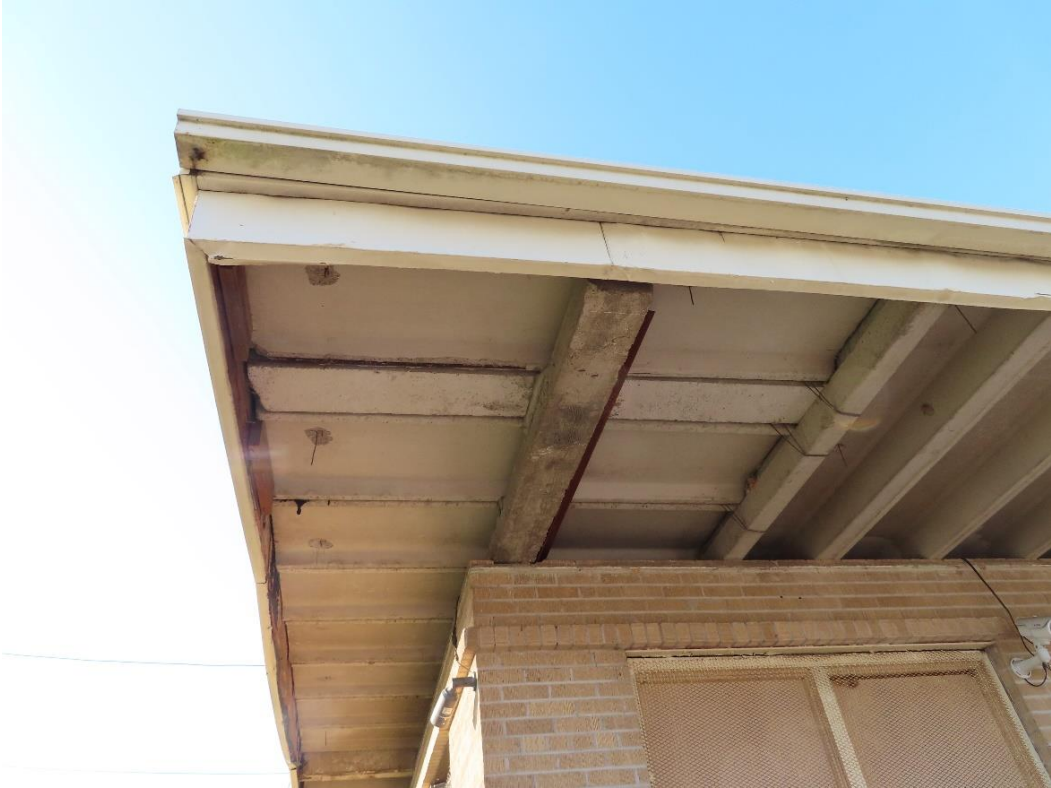
- The plaster soffit at the roof overhang has been removed, exposing the precast channel roof structure; see photograph 22. We understand the County demolished the plaster soffit as sections had fallen and the remaining soffit was considered a safety hazard.

- The precast channel roof structure has corrosion of the reinforcing steel on the soffit; see photographs 22, 23, and 24.
- A metal canopy was added and is supported by the brick veneer; see photograph 25.

Photograph 22 – Exposed roof overhang structure and corroded reinforcing steel.

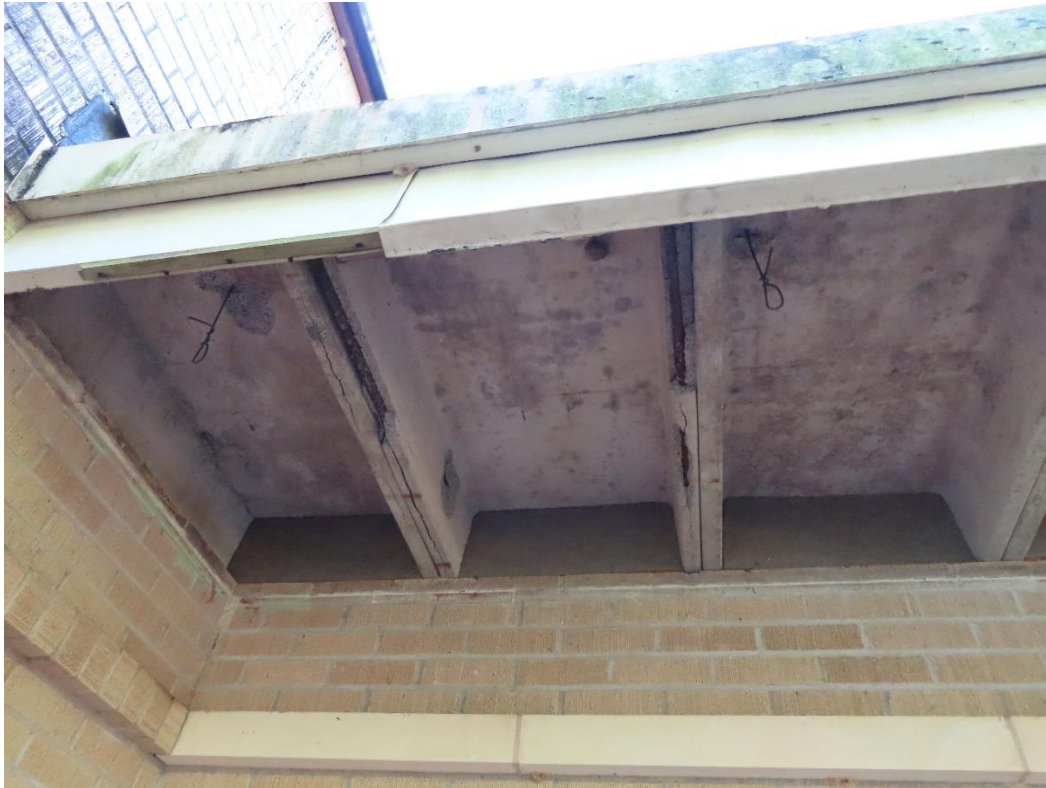
Photograph 23 – Reinforcing steel corrosion in the soffit.

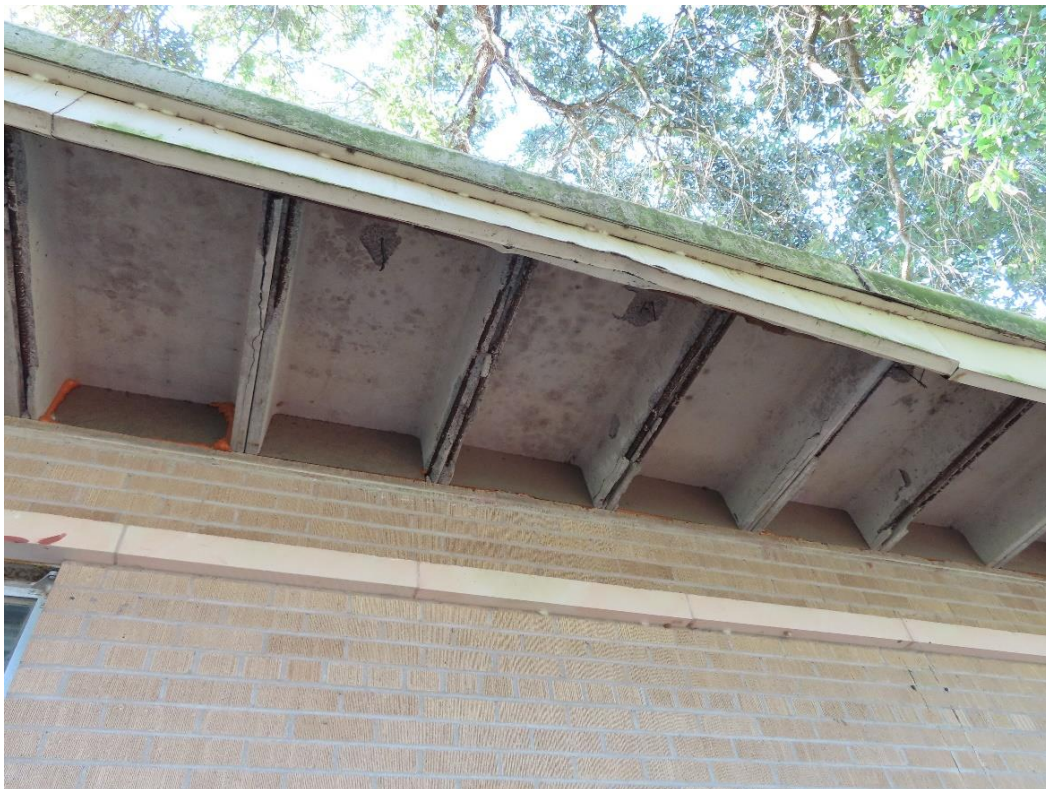
Photograph 24 – Exposed roof overhang structure and corroded reinforcing steel.

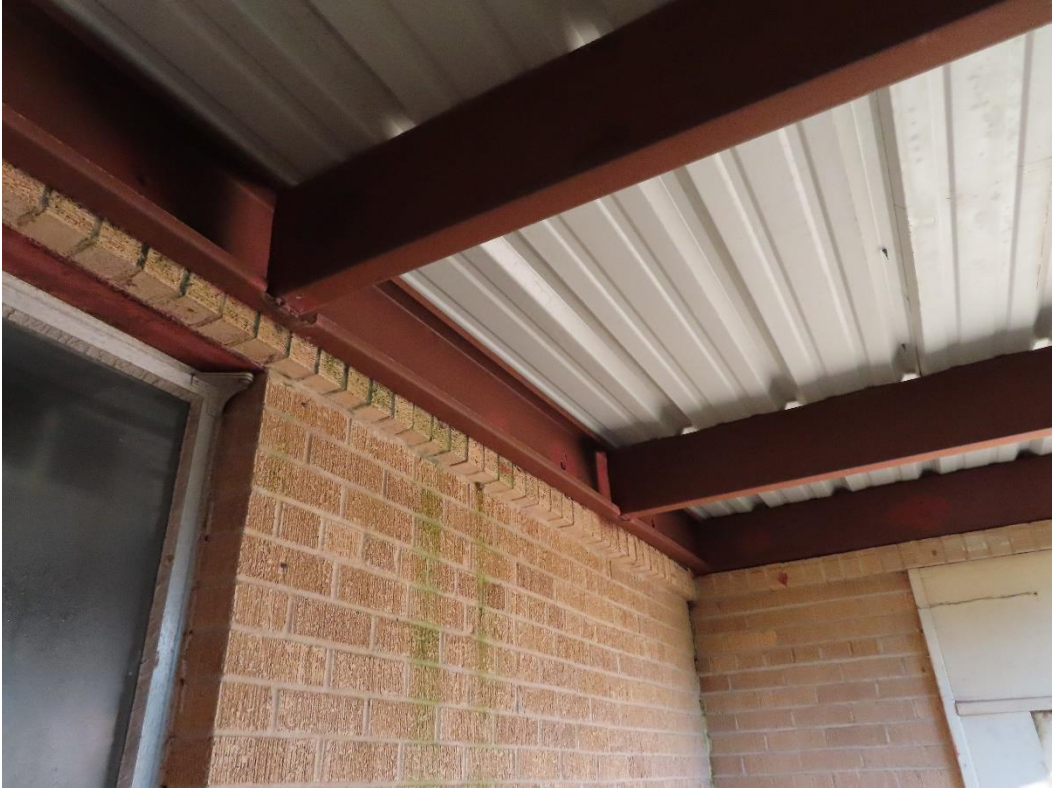
Photograph 25 – Metal canopy supported by the brick veneer.
