Re: Waller County Assessments
Hempstead, Texas
JQ Project No. 3210155

JQ Engineering (JQ) performed a limited, structural review of three buildings for Waller County, the historic 1955 Courthouse, the 1954 Jail building, and the County Hospital on June 16 and 17, 2021. The purpose of the review was to assess the structural condition of the buildings for the purpose of providing recommendations for repair.

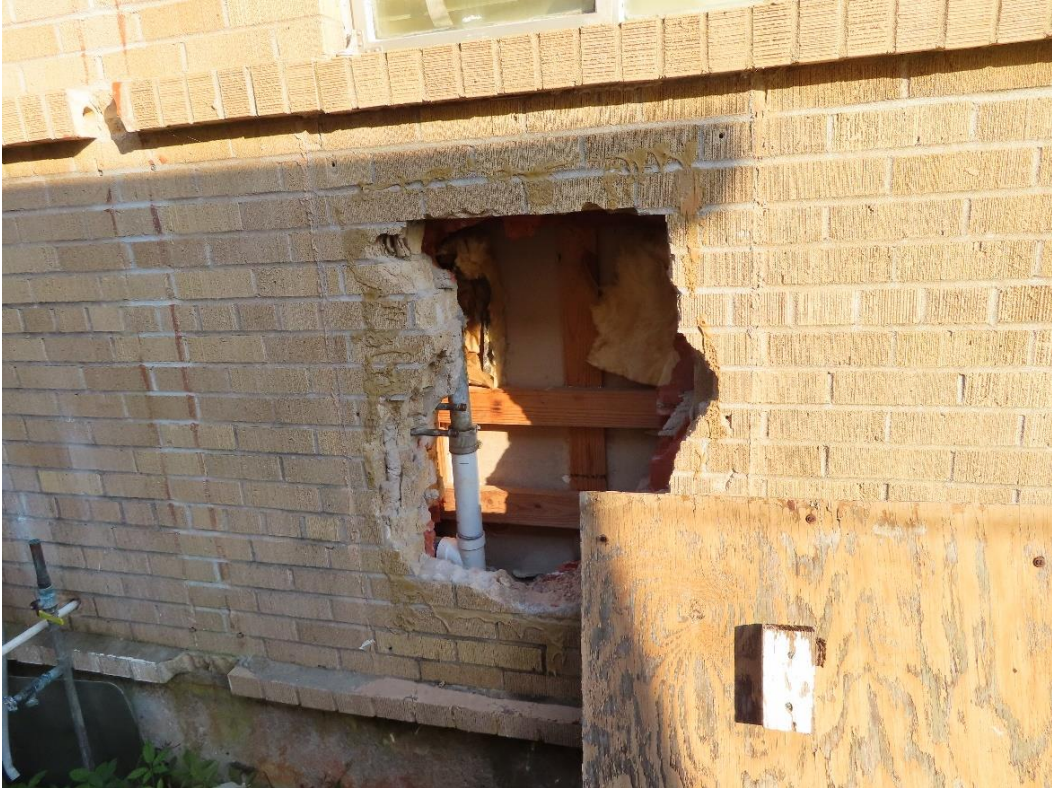
- A hole in the exterior load-bearing wall appears to have been caused by impact; see photograph 26.

Photograph 26 – Impact damage in the exterior load-bearing wall.
