The Waller County Commissioners Court is evaluating the viability of renovations and adding on to the existing Waller County Courthouse in Hempstead, possibly relocating to the former hospital or outlet mall in Hempstead or demolishing and replacing the courthouse.

The purpose of this report is to document the existing conditions of the mechanical, electrical, and plumbing systems and to identify deficiencies to determine the order of magnitude to design and install a functioning and energy efficient MEP systems.

### **WALLER COUNTY COURTHOUSE MEP SYSTEM DESCRIPTION**

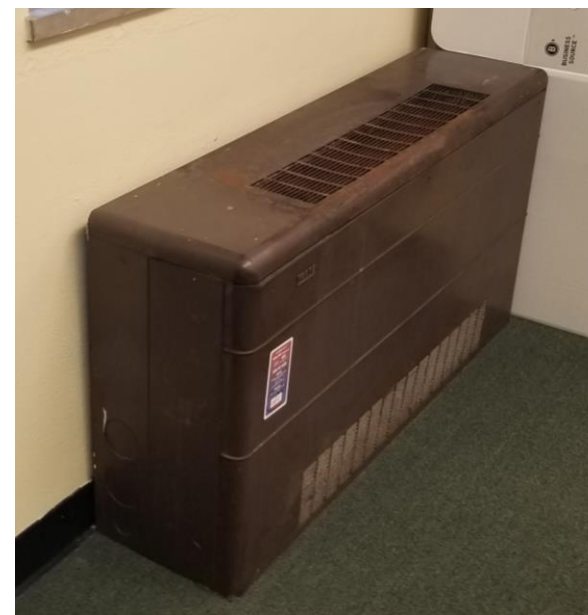
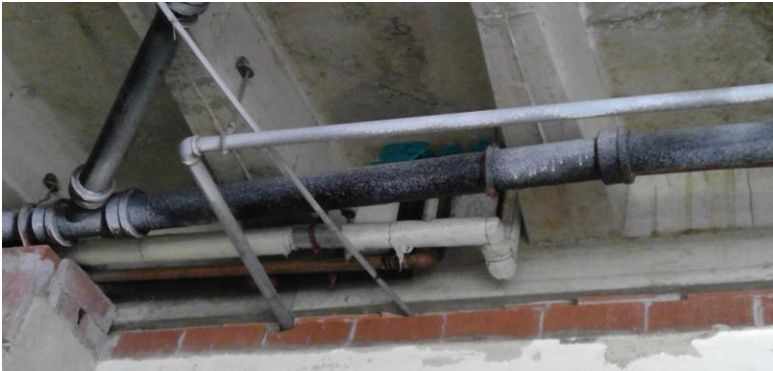
The original chilled water system was a water cooled centrifugal chiller with a cooling tower located on the roof. The hydronic boiler is located in the same equipment room, which is a boiler code violation. The centrifugal chiller was decommissioned, but is still in the equipment room on the 4<sup>th</sup> floor. To replace the air cooled chiller was installed in 2008/2009 (based on the manufacturer's serial number. The hydronic boiler was replaced in 2021. The air handling equipment which consists of a fan, motor, and coil appear to be the original equipment from the 1950's.

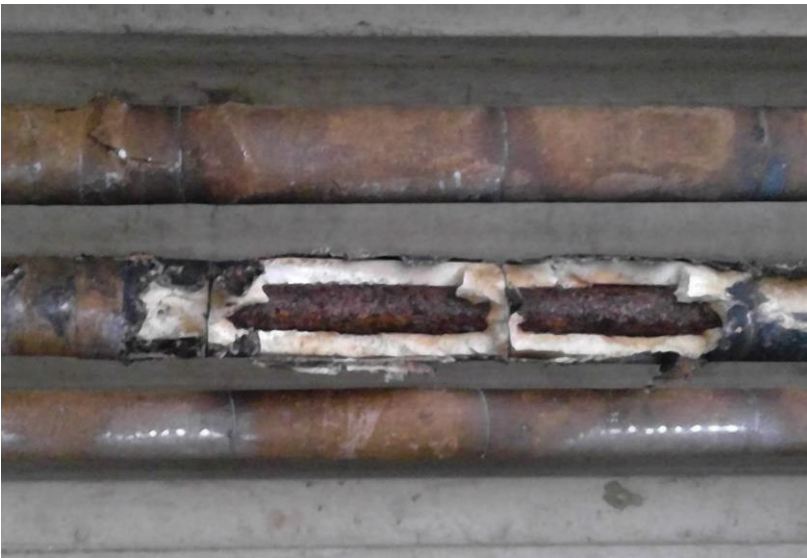
The two pipe system shares a common supply and return pipe for chilled water or heating. The system is in either heating or cooling and must be switched between modes often with a delay in switching between heating and cooling because the water temperate had to cool down or warm up. This design was popular during the era the courthouse was designed, especially in climates where buildings often go the entire year in one mode of operation. This system reduced the amount of piping compared to a four pipe system saving initial cost and installation time.

The hydronic piping system is in bad shape from age and several other factors like open insulation which allows pipes to condense on the outside, interruptions in chemical treatment to preserve the interior of the pipe and valves that no longer seal the system to allow for repairs. Given the integrity of the pipe or lack of integrity it is difficult to know where to stop the replacement of new piping creating a difficult costing issue.

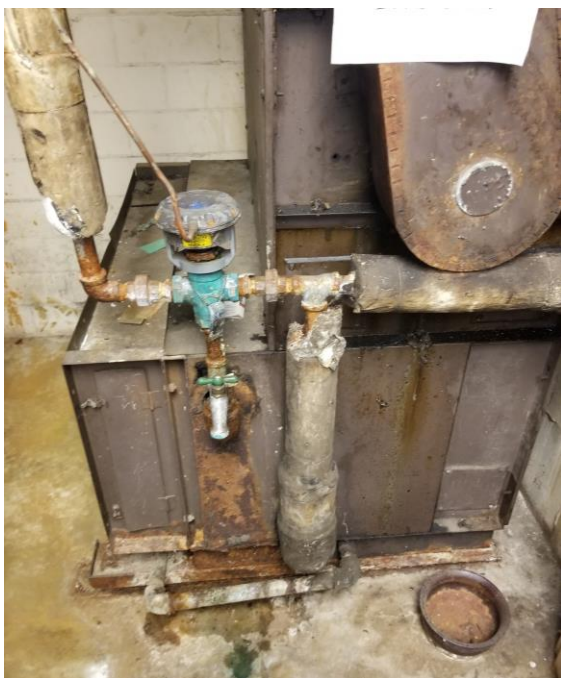
The control system needs to be upgraded from a pneumatic system to a direct digital control system to allow for better control of the HVAC system and allow Waller County to schedule the HVAC systems at the courthouse.

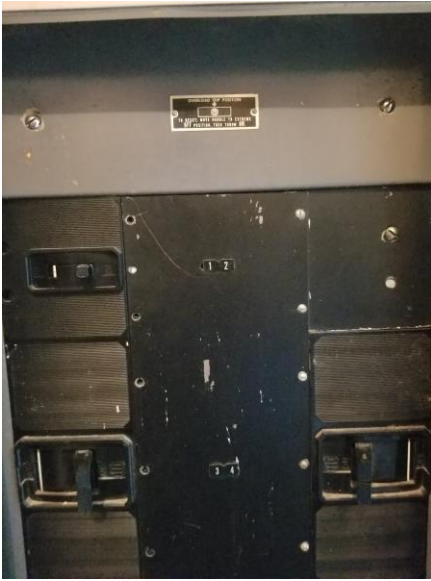
The electrical service to the building is pole mounted which is vulnerable to storm damage. The natural gas generator and exterior automatic transfer switch which were added later, provide emergency backup power during an outage. It appears that the normal power and emergency power are all located at the pole, which means if the pole was damaged the courthouse would be without power.

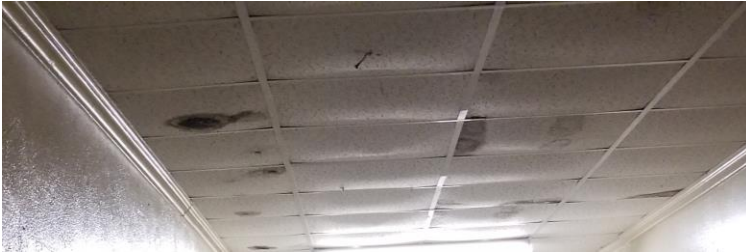
The existing Waller County Hospital was designed in the mid 1950's and is still used for County functions including Environmental and Maintenance. The building shows evidence of moisture in the building observed by the cupping of the tiles. This could be from several factors including envelope issues allowing warm humid air into the space, the HVAC system being off while the building was unoccupied, or the HVAC system not adequately conditioning the space due to age, improper functioning or inadequate sizing.

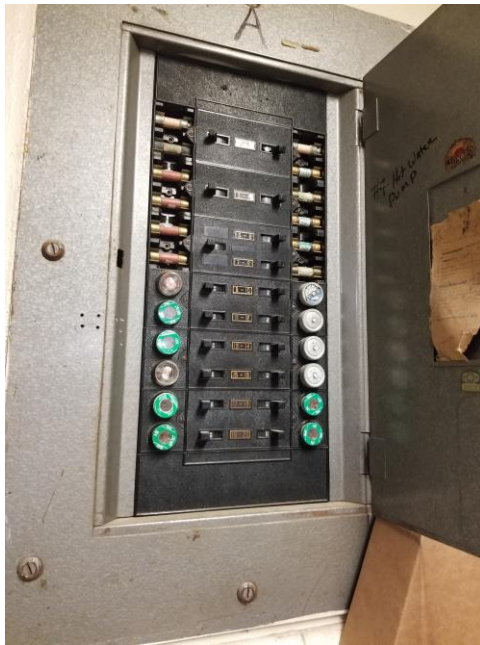
The building is served by three, overhead services at 120/240 volts, 1 phase, 3 wire. The electrical system, in most cases, consists of original panelboards, wiring and receptacles. Several panels utilize Edison base fuses and disconnect switches.
