# EXISTING CONDITION ASSESSMENT

**WALLER COUNTY COURTHOUSE**  
Hempstead, Texas

**836 Austin Street**  
Hempstead, Texas 77445

October 27, 2021

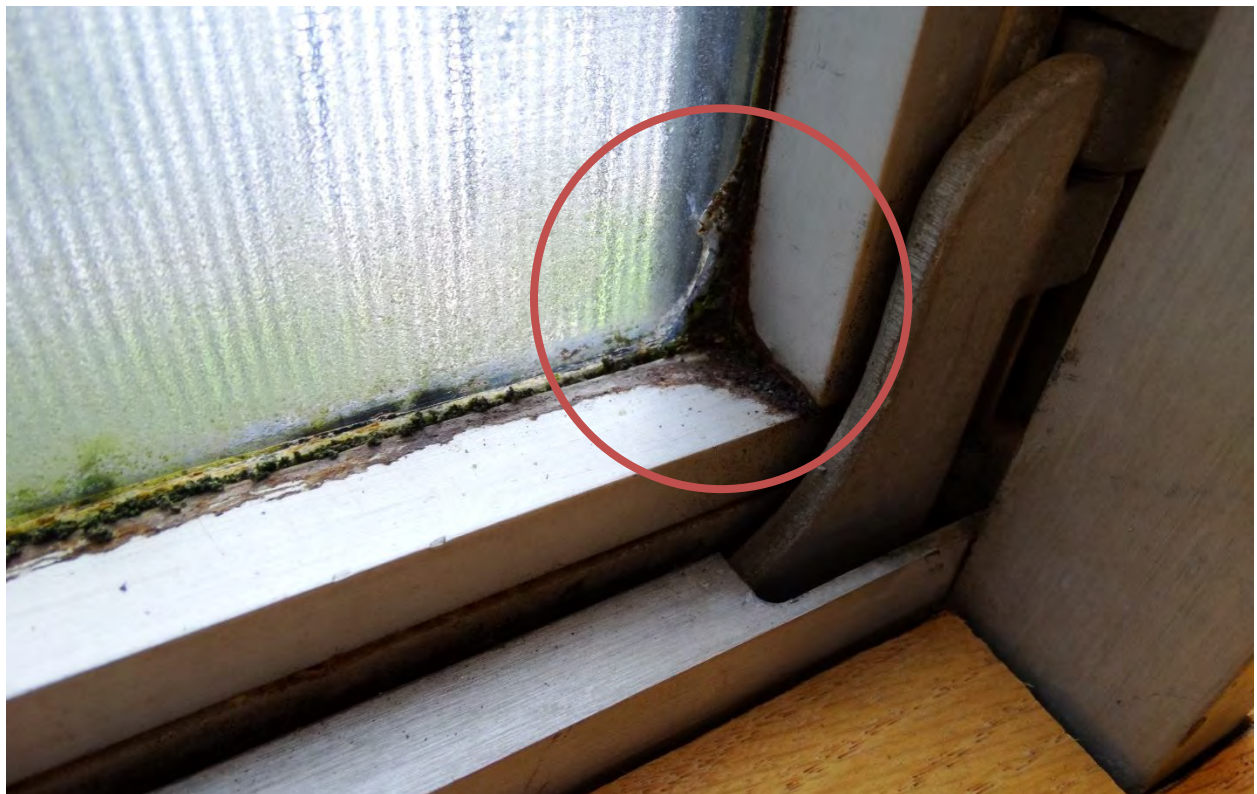
The windows are in moderate condition. It was observed from the interior, that large amounts of condensation builds up on the exterior face of the plate glass. Which is likely causing the visible biological growth to occur on the lower sash railing throughout the building. This is also the place where most of weathering of the windows appear. The hardware all appears to be original and in moderate condition. The modifications that occurred on the interior were mostly window treatments/blinds/curtains and additive wood stools, which was observed in a few offices. Most of the stools were still stone or tile as delineated in the original drawings.

*Figure 31. Biological growth occurring at window lower sash, typical.*

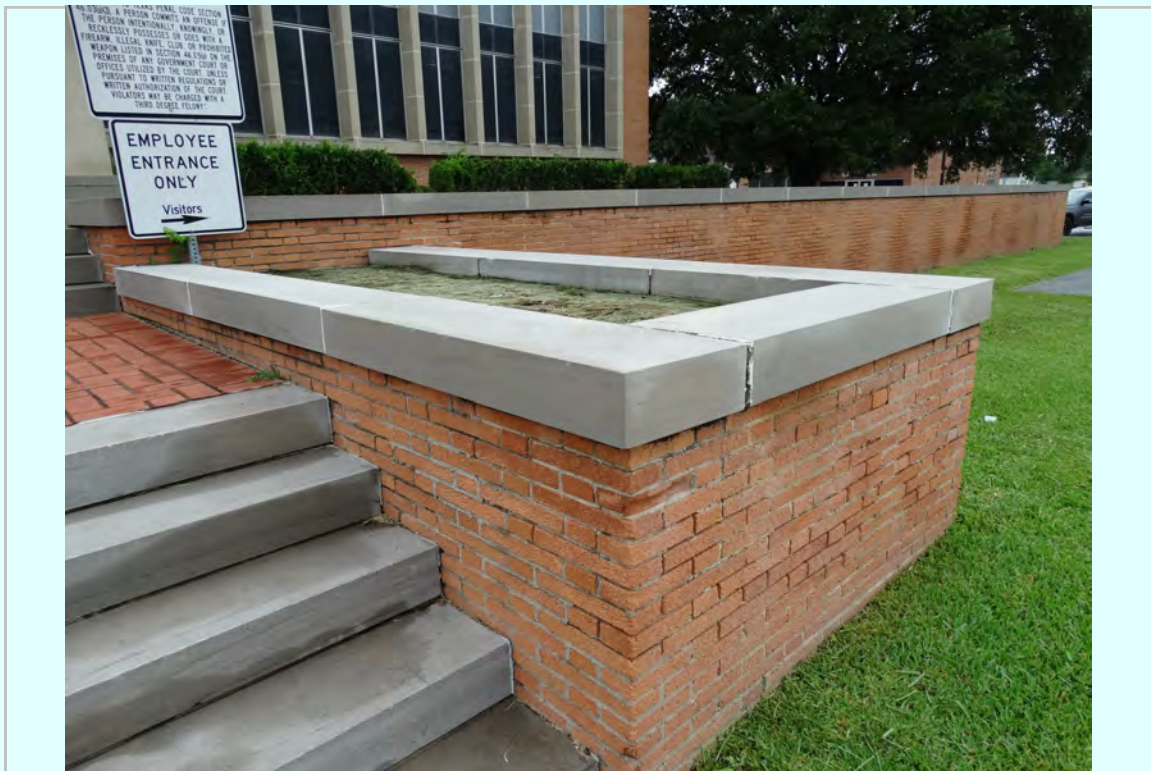
Photo: South entry retaining wall planters, coping joints failing and mortar deterioration

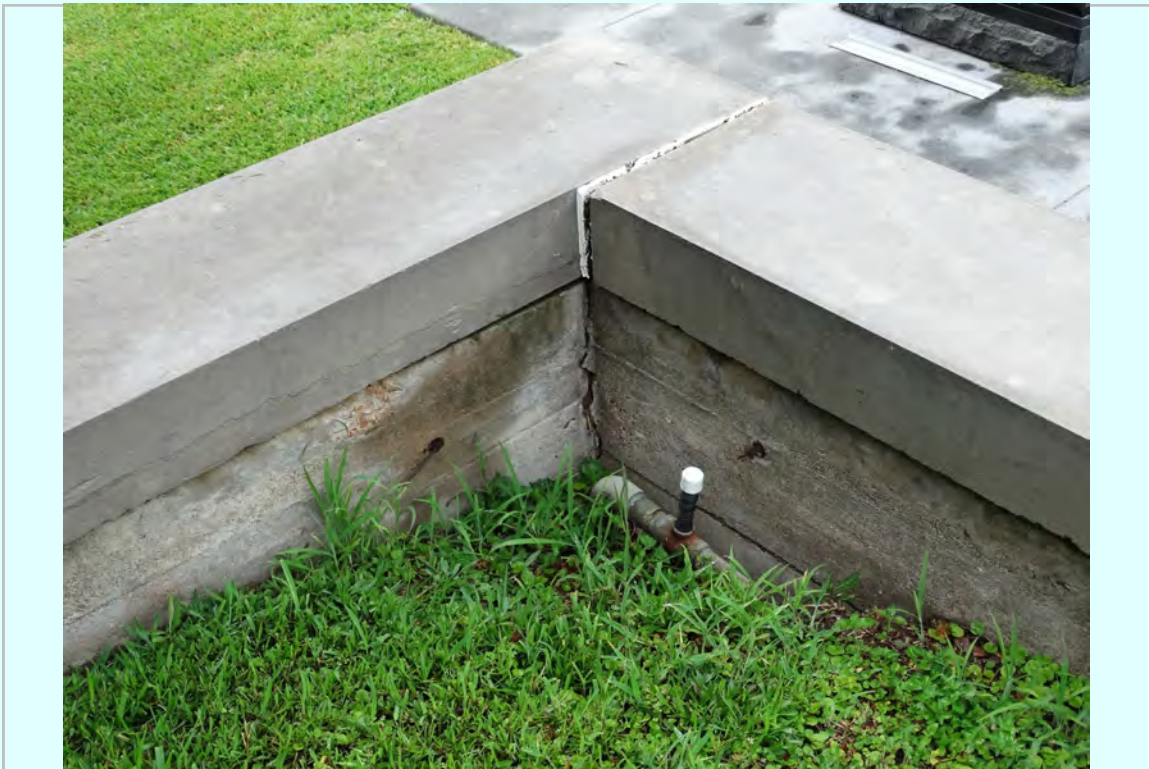
The outside retaining walls are in moderate/poor condition as the outside corner of the retaining walls are beginning to fail and buckle slightly. The mortar joints are failing and on the high side of the wall in the inside corners the ground is settling creating unsafe holes in the soils. There are also sink holes at the base of the foundation wall in which the County has had to place caution cones to prevent any injuries to pedestrians. There is also a high degree of biological growth on the masonry mortar joints. There is evidence of a recent intervention at the failing joints of the coping stones that show a white sealant along the entire perimeter of the wall.

Photo: South entry retaining wall cracking and coping joint failing

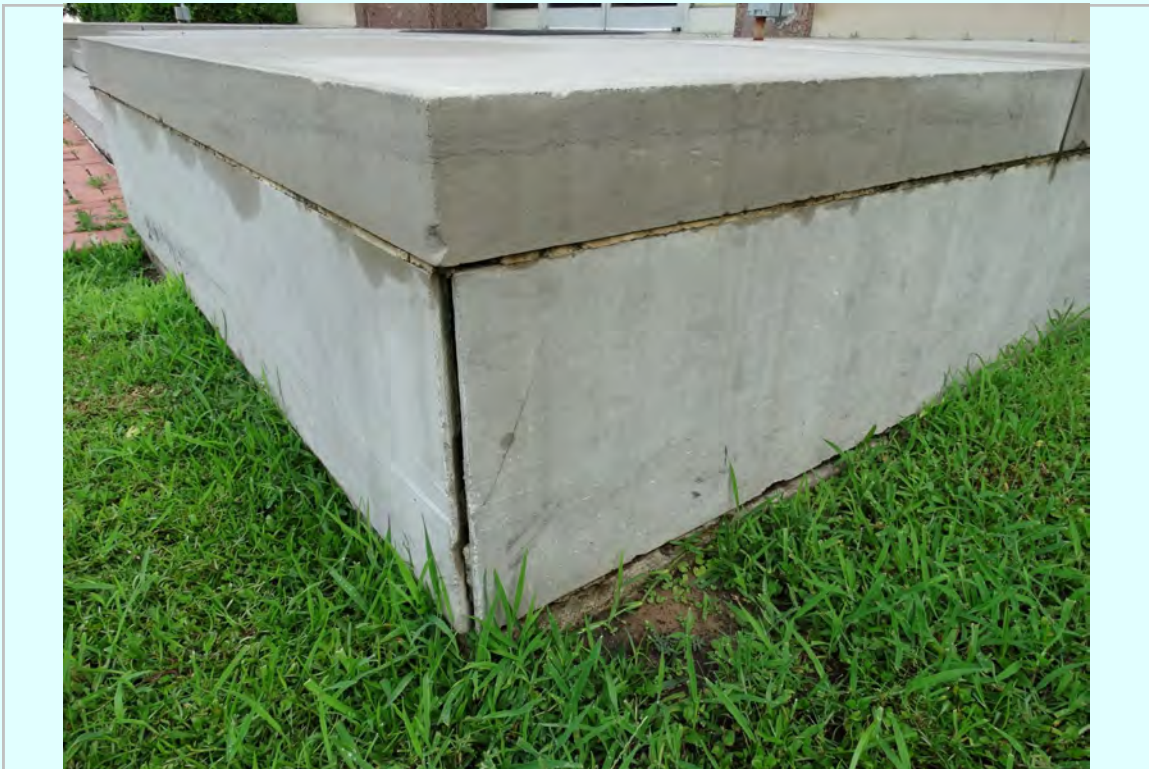
Photo: South entry patio stone joints failing and moisture staining

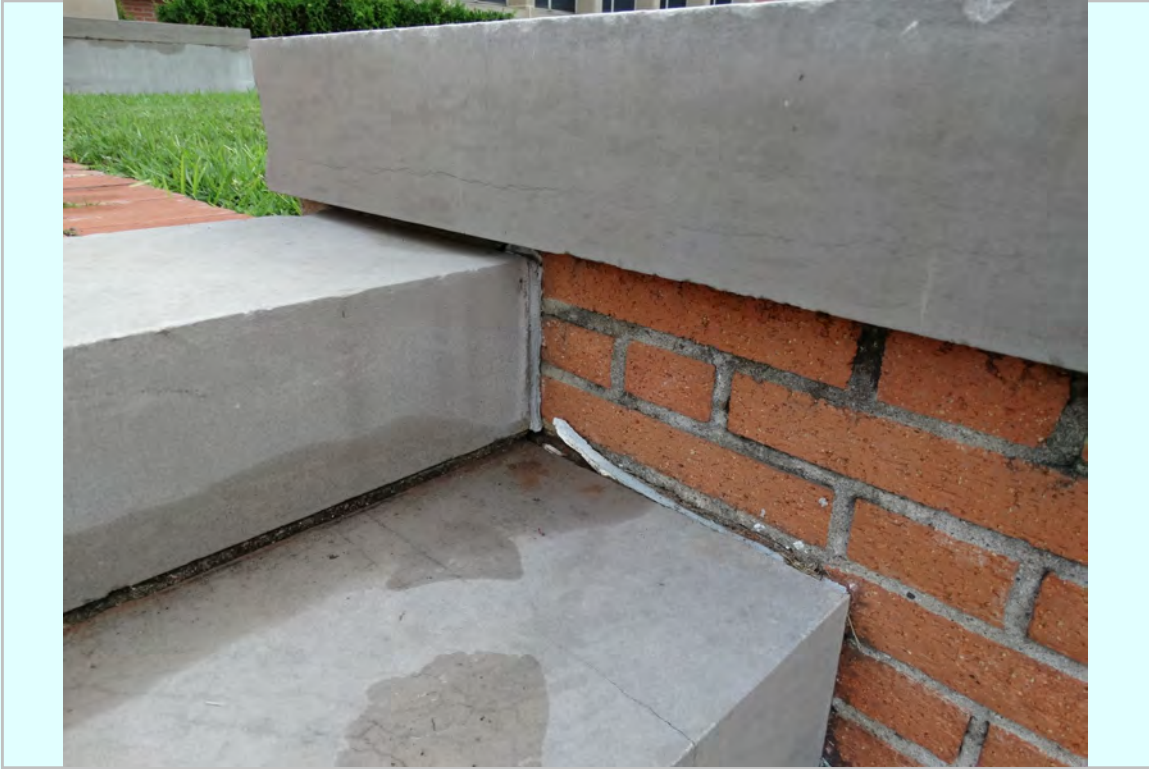
Photo: South entry retaining walls at stair juncture failing

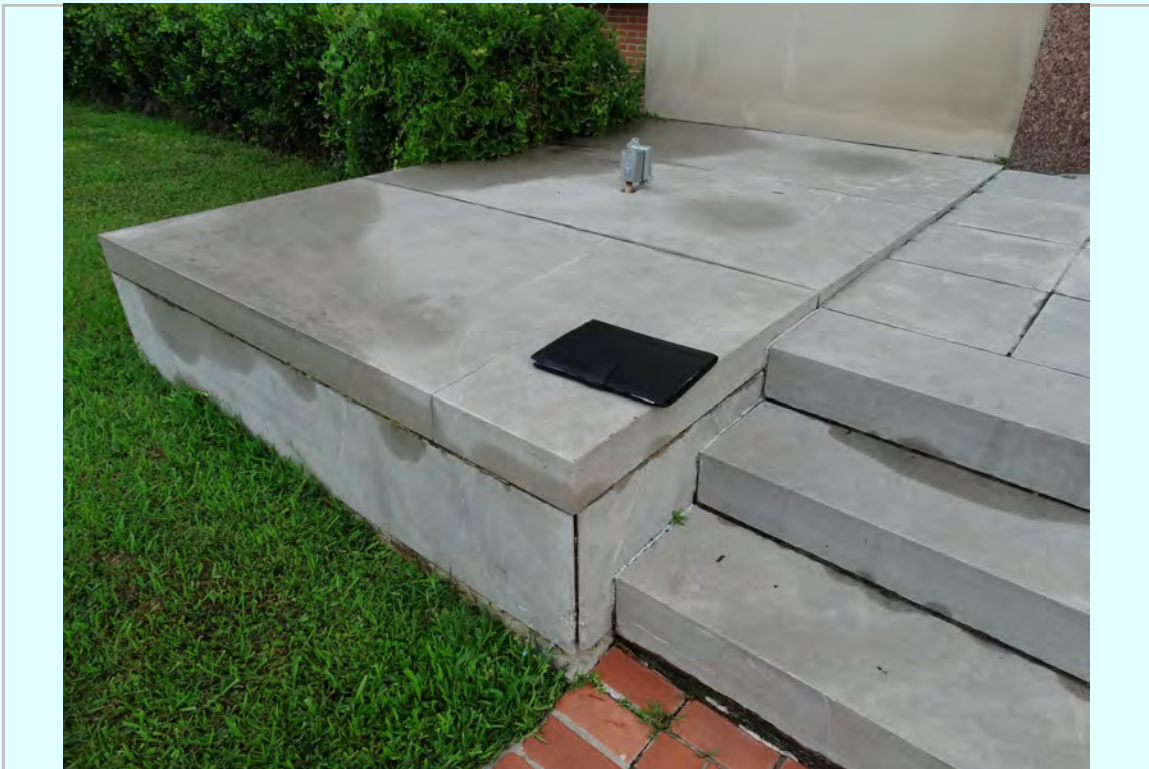
Photo: South entry patio stone joints failing and moisture staining and cracking

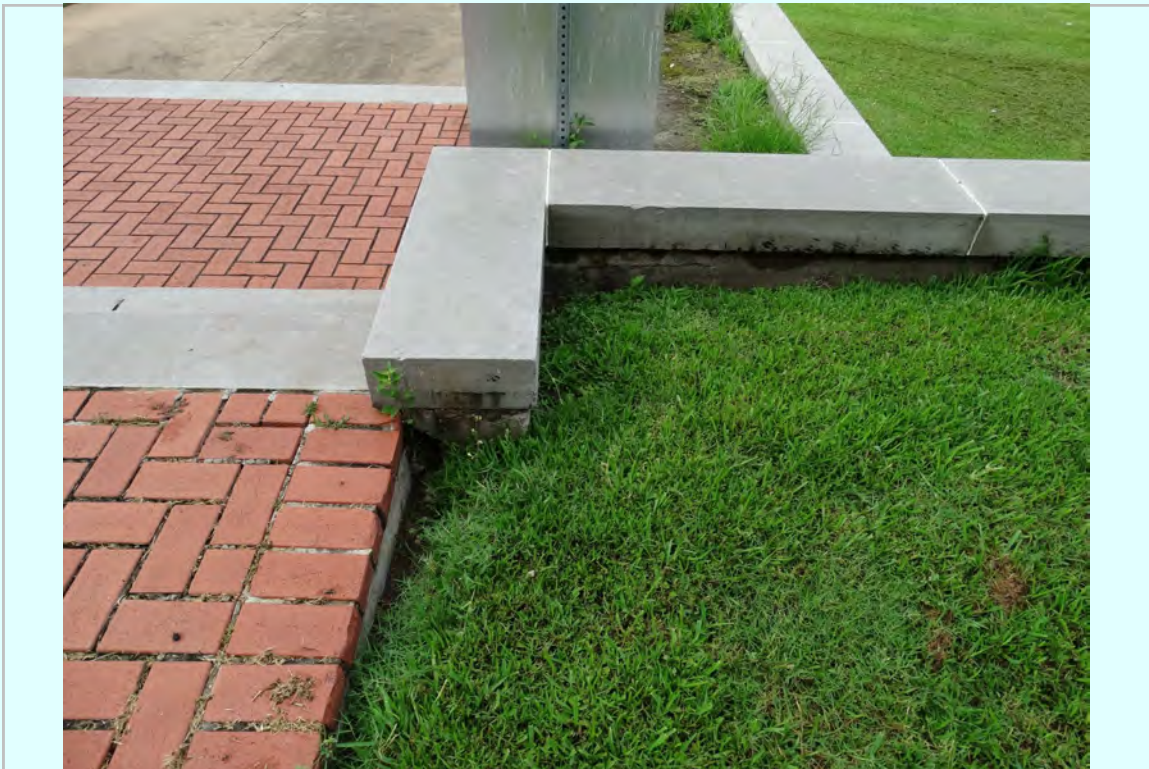
Photo: South entry retaining wall and erosion

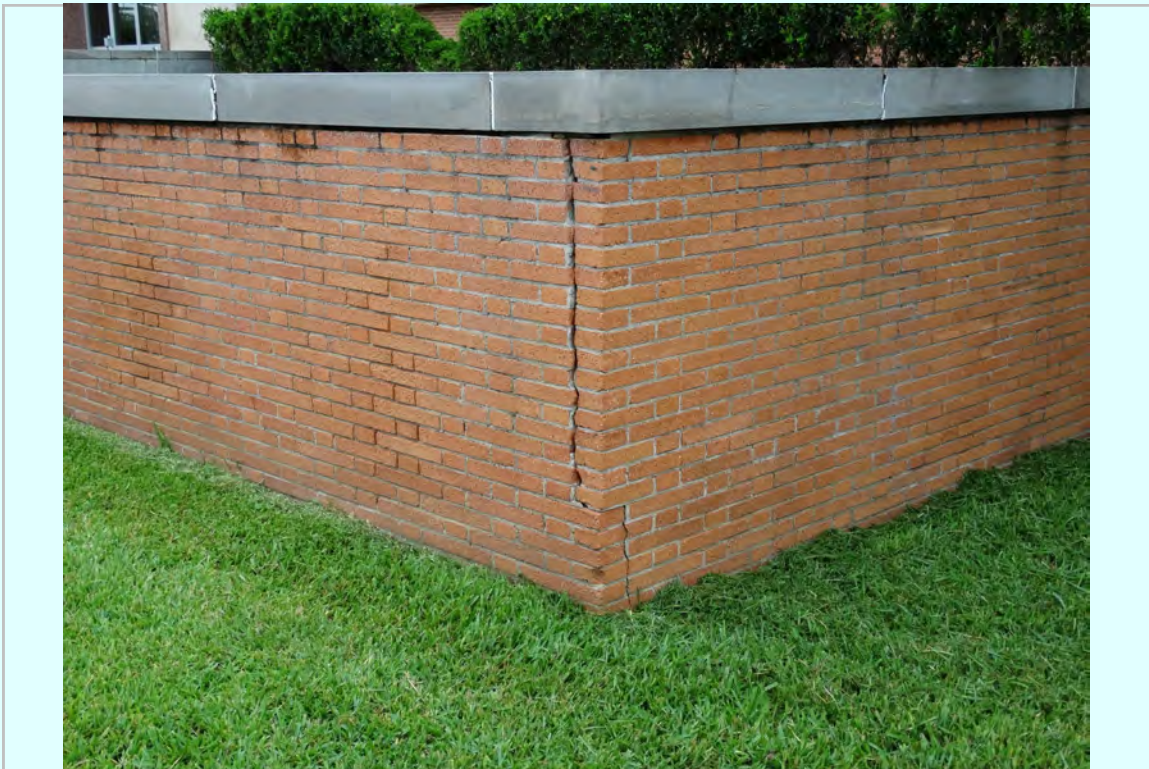
Photo: South entry East retaining wall outside corner, failing

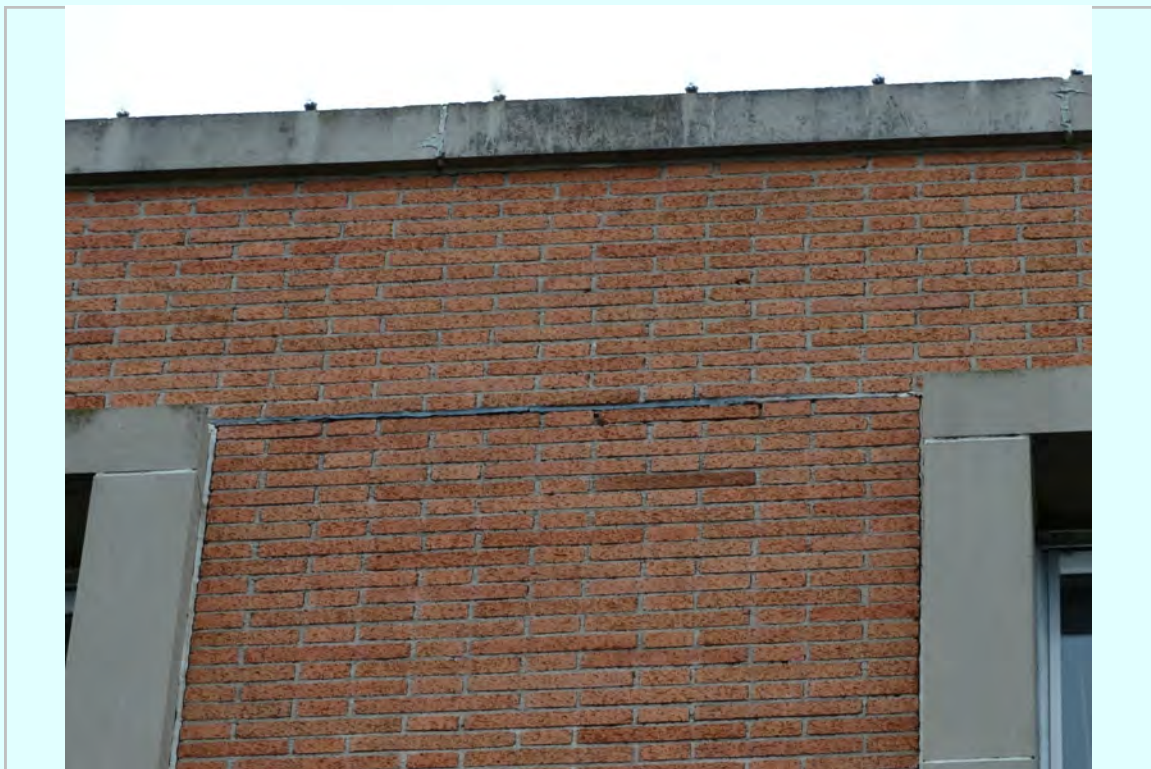
**Photo:** Deterioration, masonry joint and coping staining

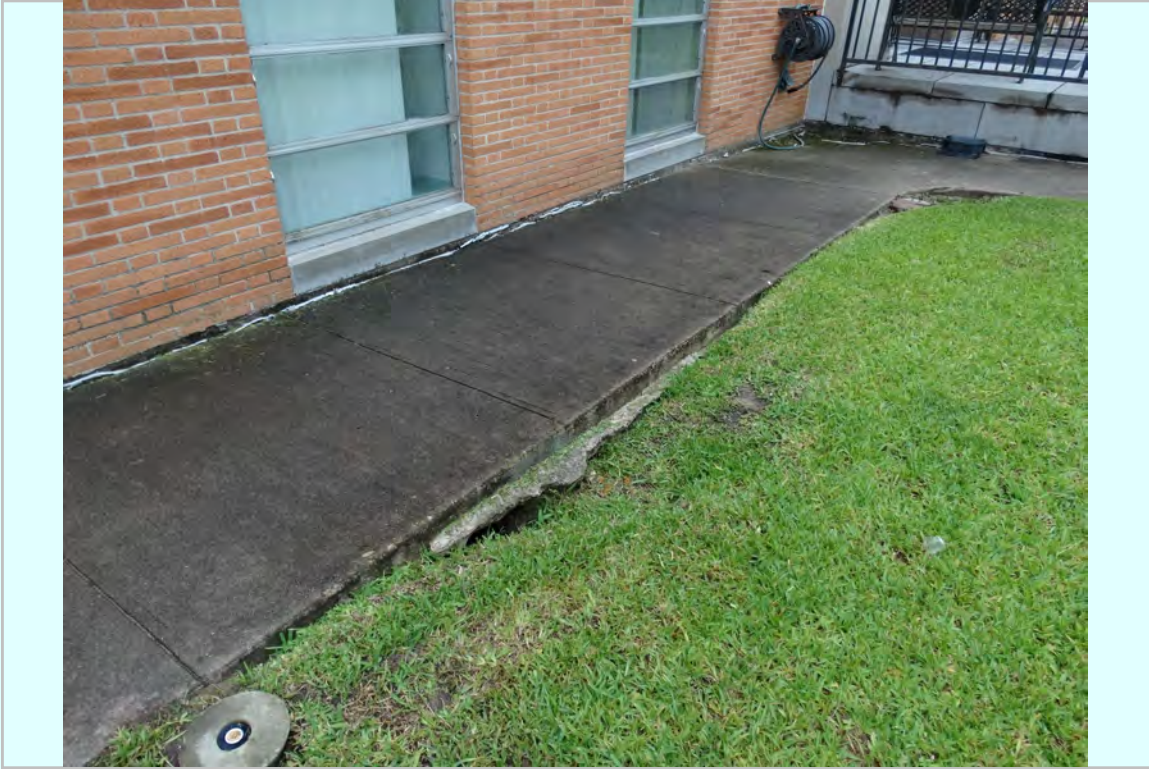
Photo: North Elevation ground floor windows and site erosion

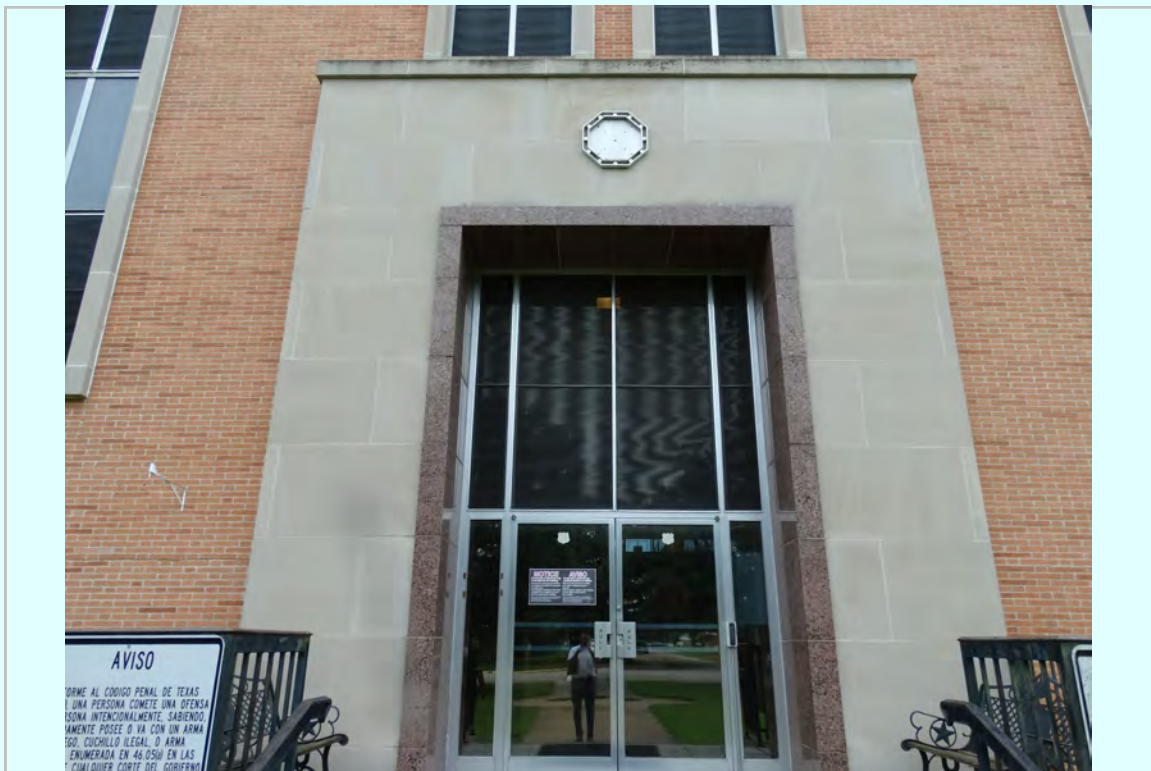
Photo: North Entry , missing clock, masonry staining

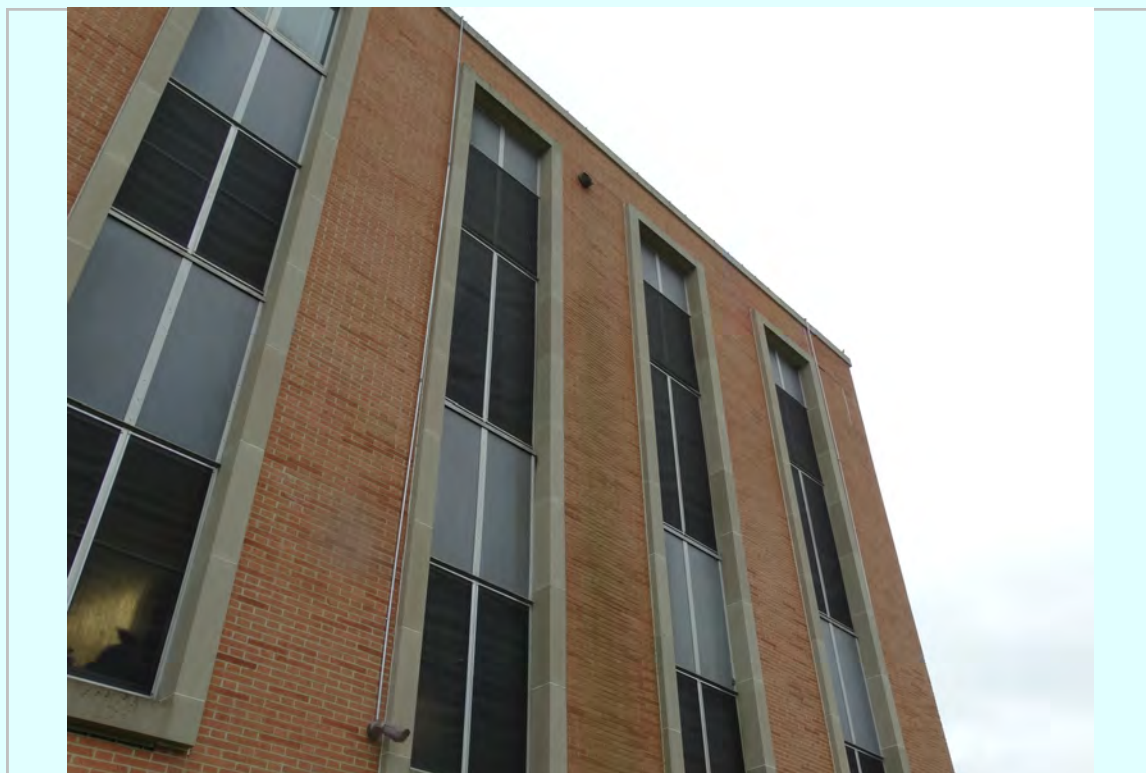
Photo: North Entry , moisture staining at masonry and biological growth, exposed conduit

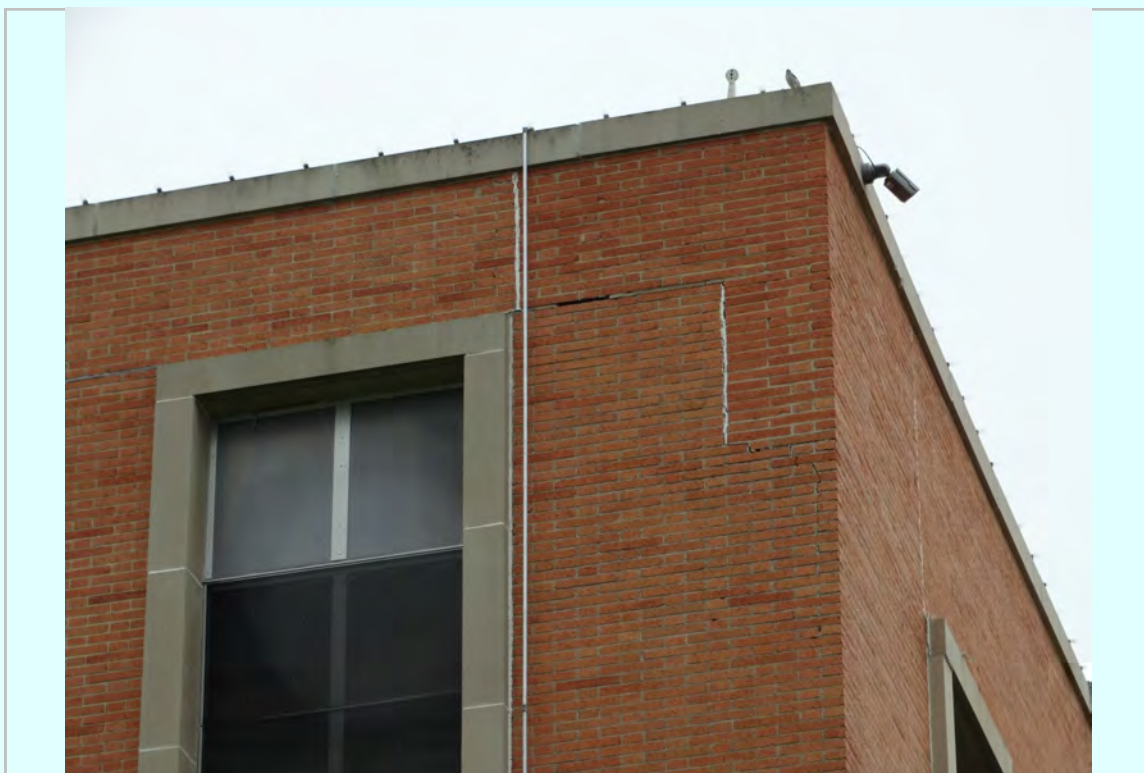
Photo: North Elevation, masonry cracking, mortar joints failing

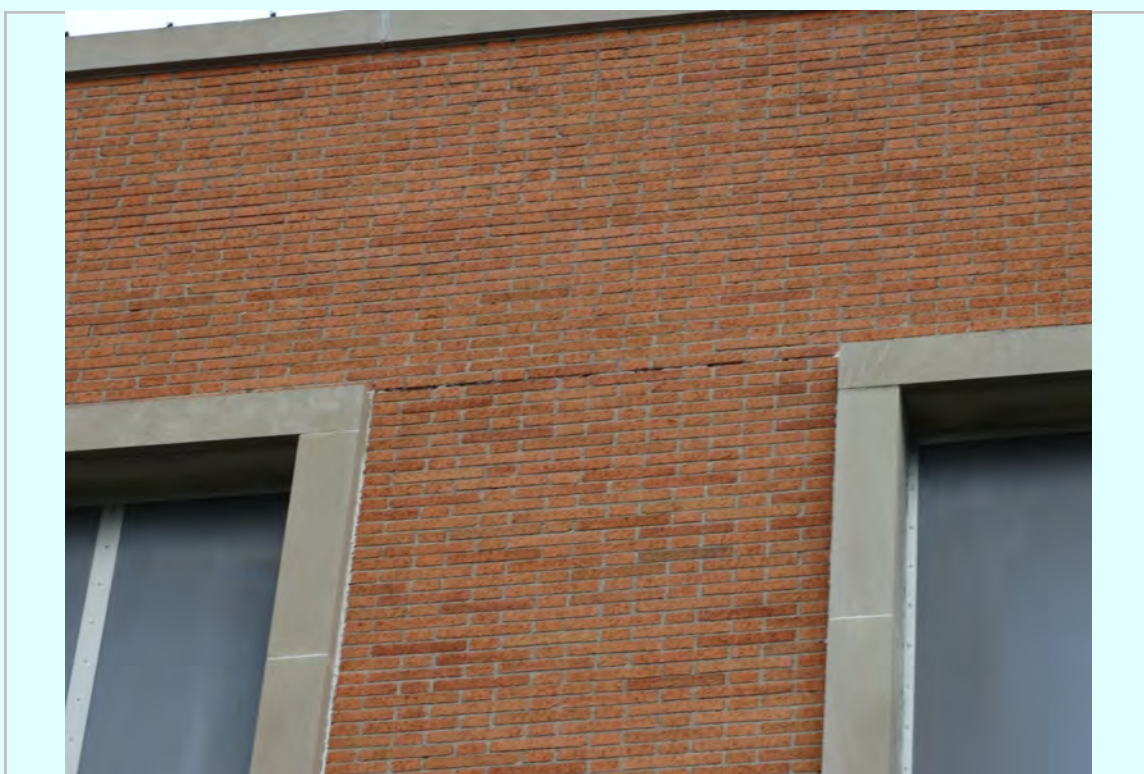
**Photo:** East Elevation, shelf angle joint deterioration

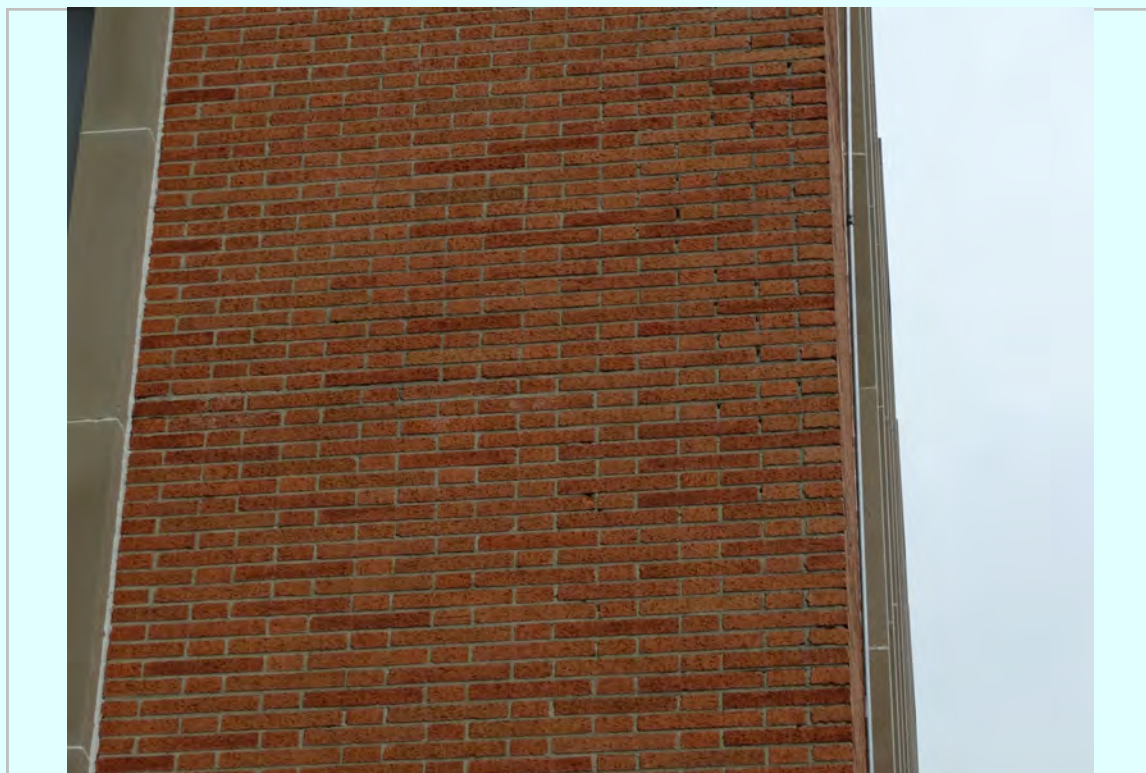
Photo: East Elevation, mortar joint deterioration

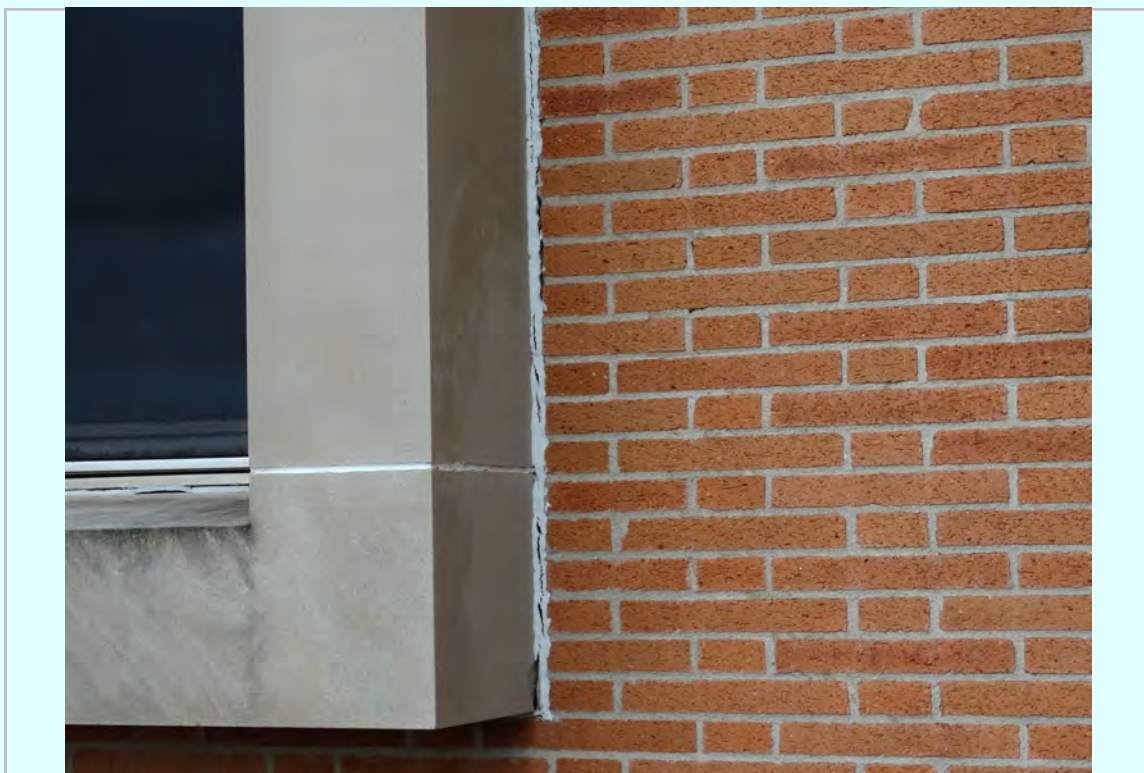
**Photo:** South Elevation, masonry juncture failing, replacement sealant failing

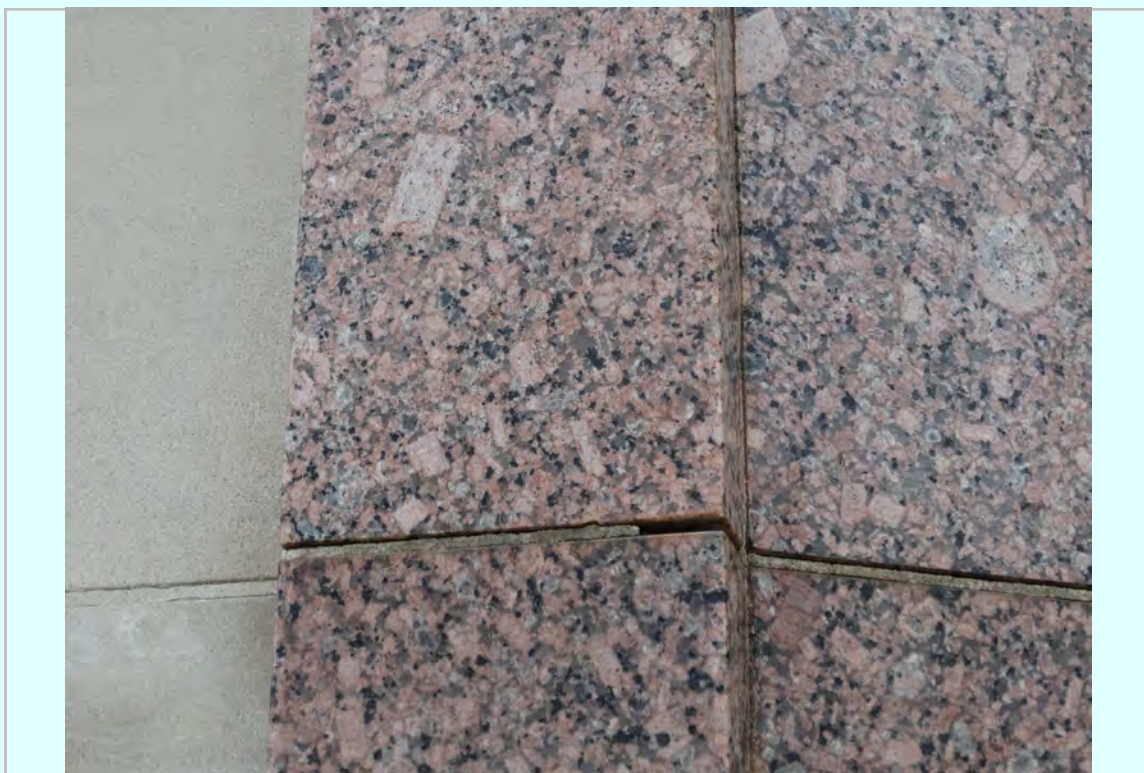
Photo: South Elevation, pink granite mortar joint failing

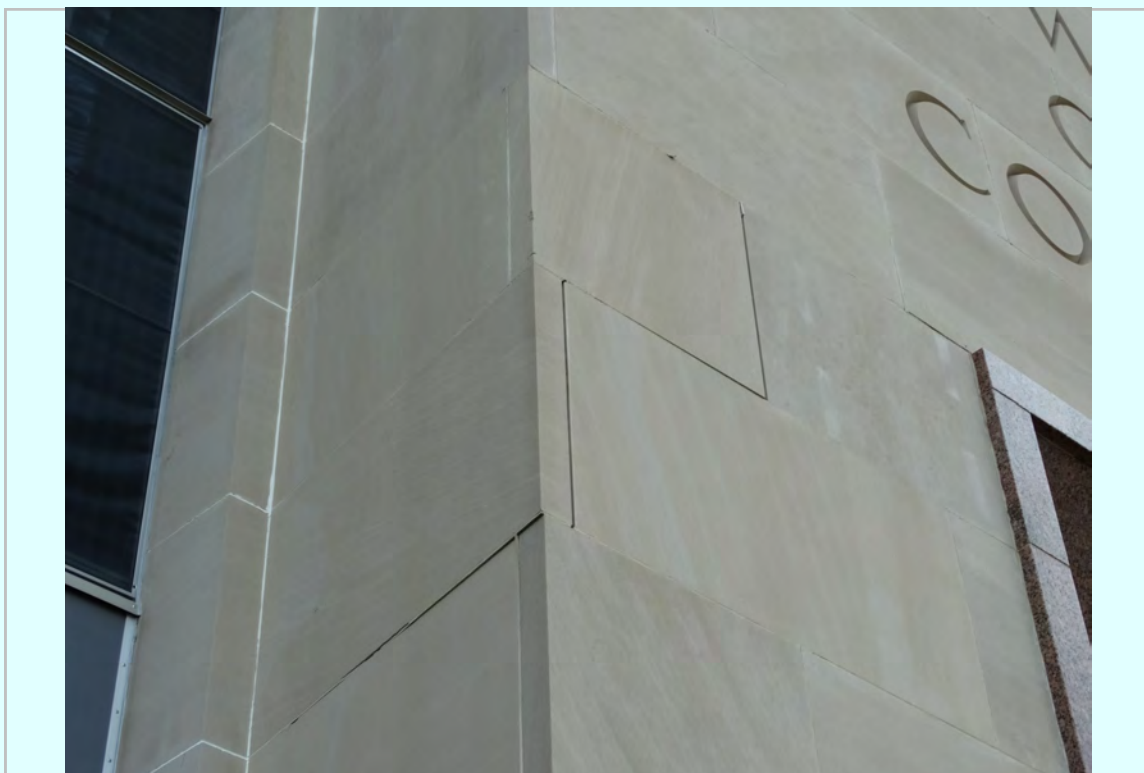
Photo: South Elevation, entry stone joints failing

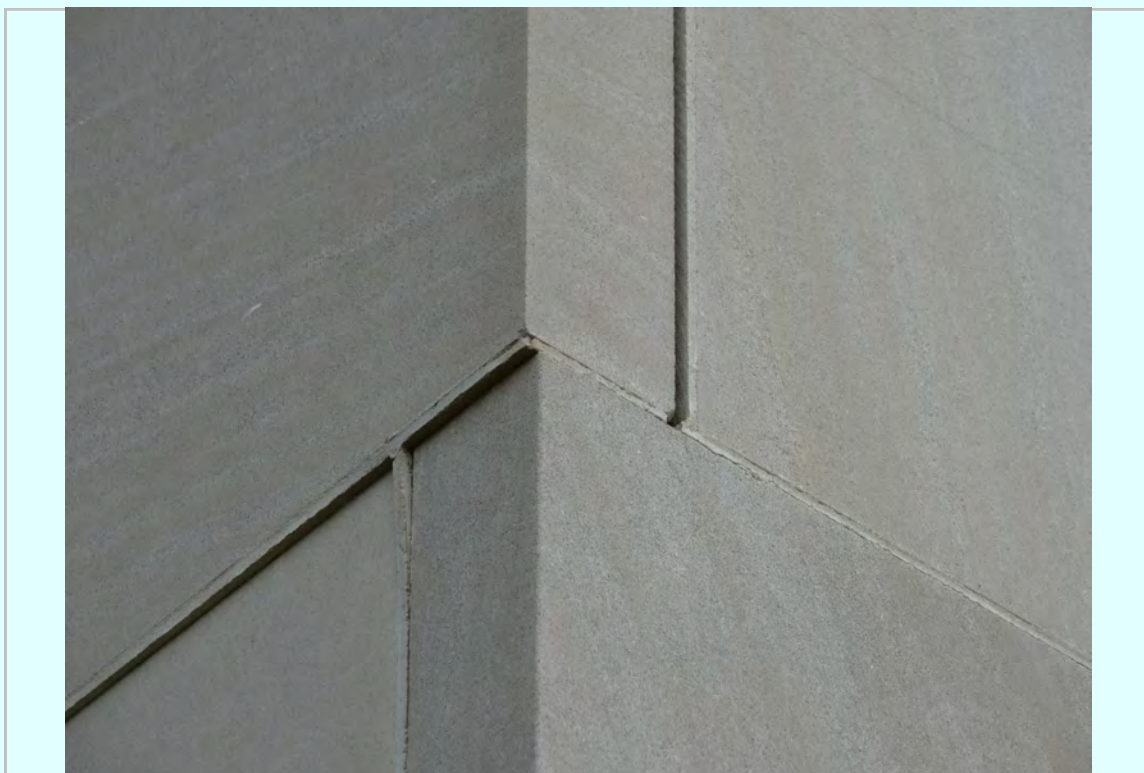
Photo: South Elevation, entry stone joints failing

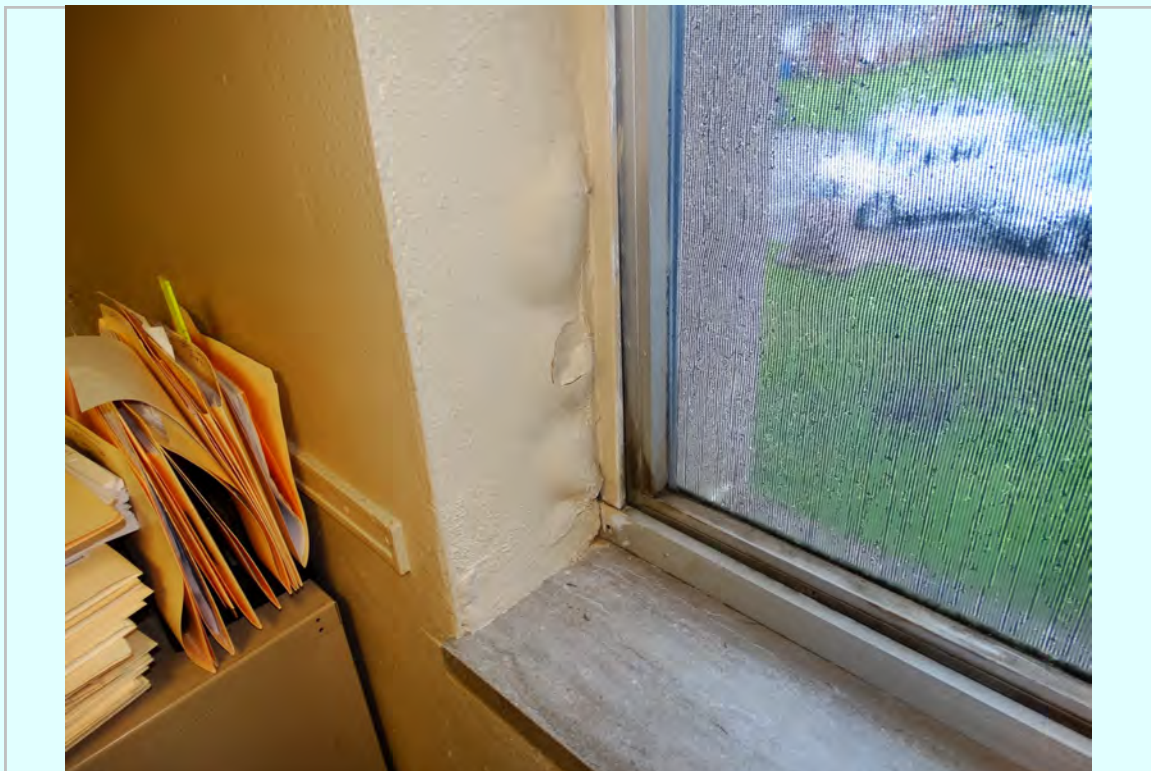
Photo: 2nd floor window existing moisture intrusion

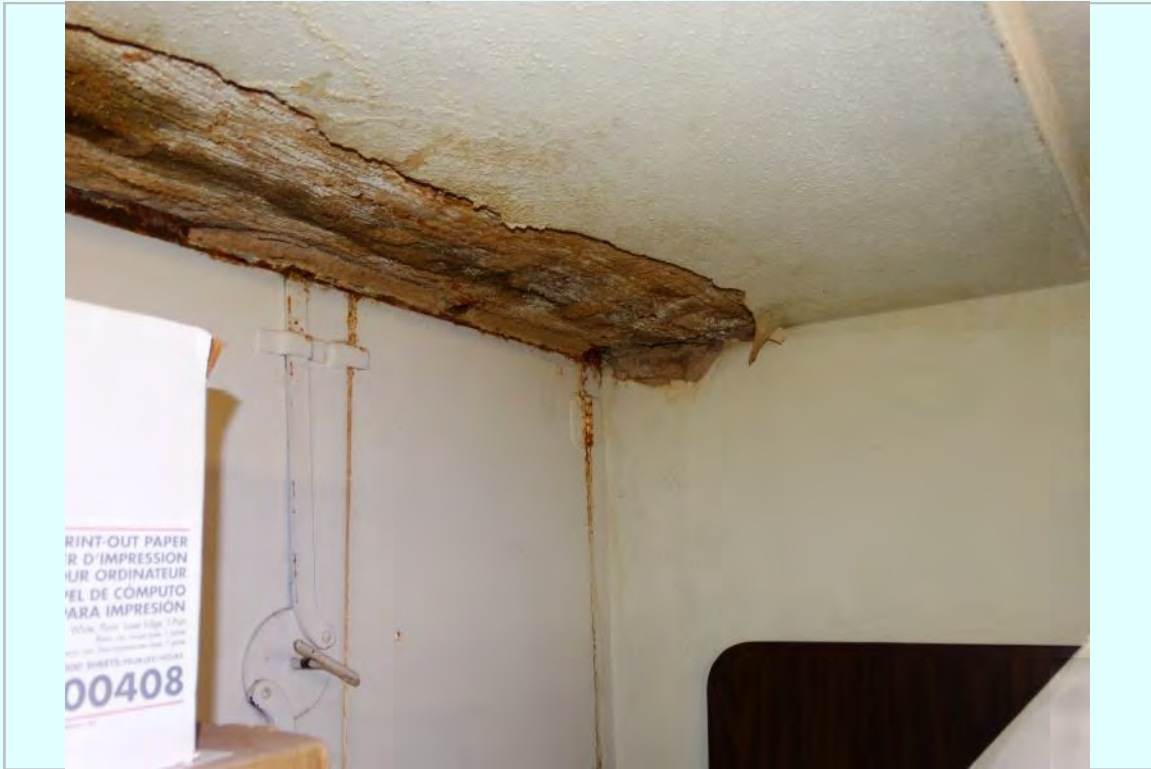
Photo: Severe moisture damage at ceiling in storage space below County Auditor

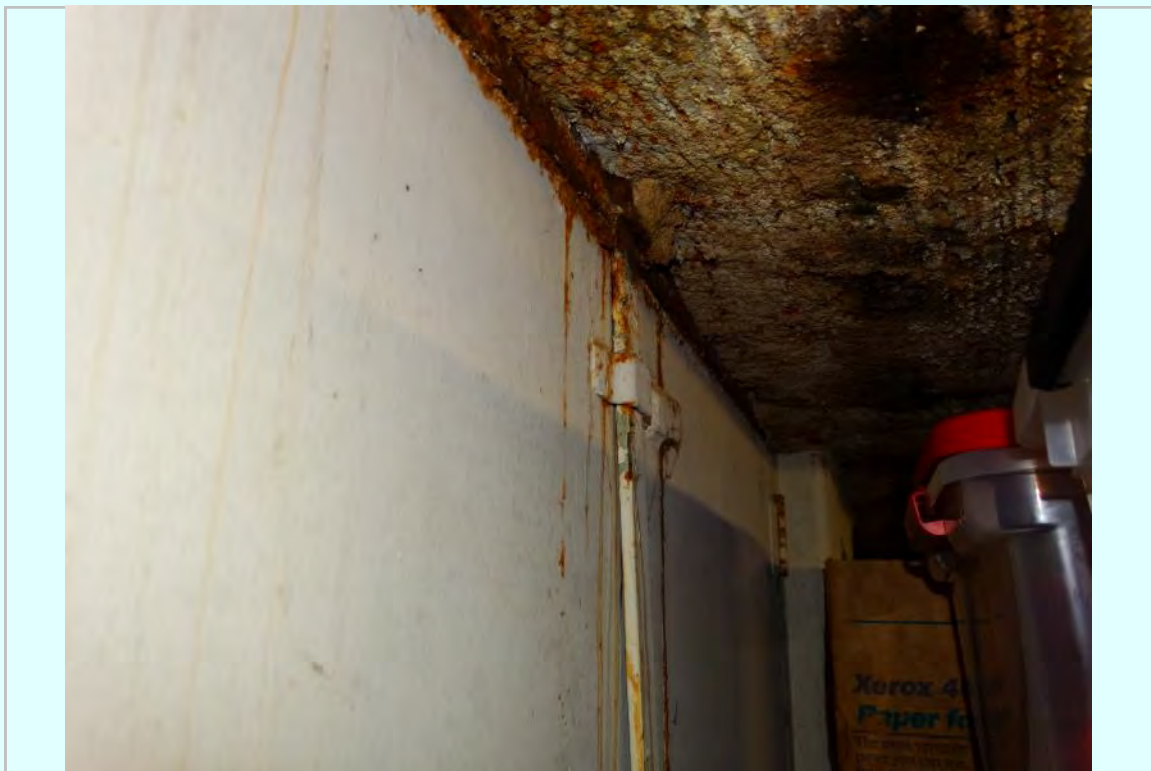
Photo: Severe moisture damage at ceiling in storage space below County Auditor

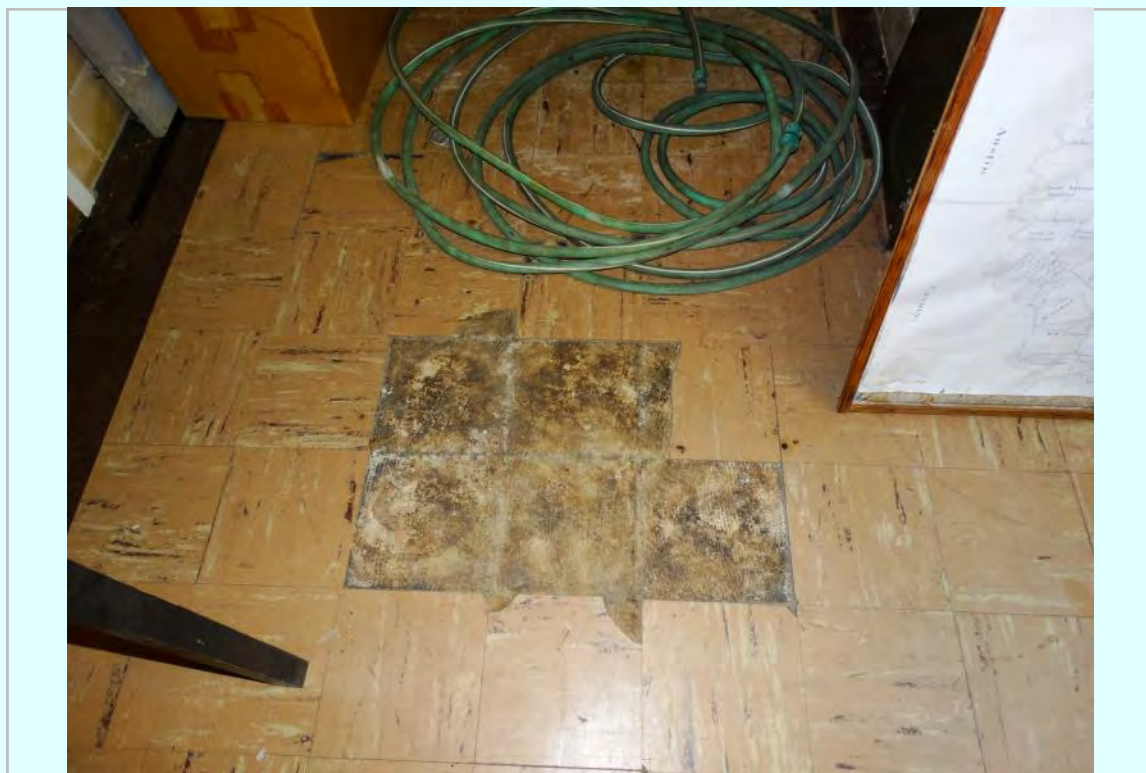
Photo: Storage space below County Clerk floor damage and possible asbestos

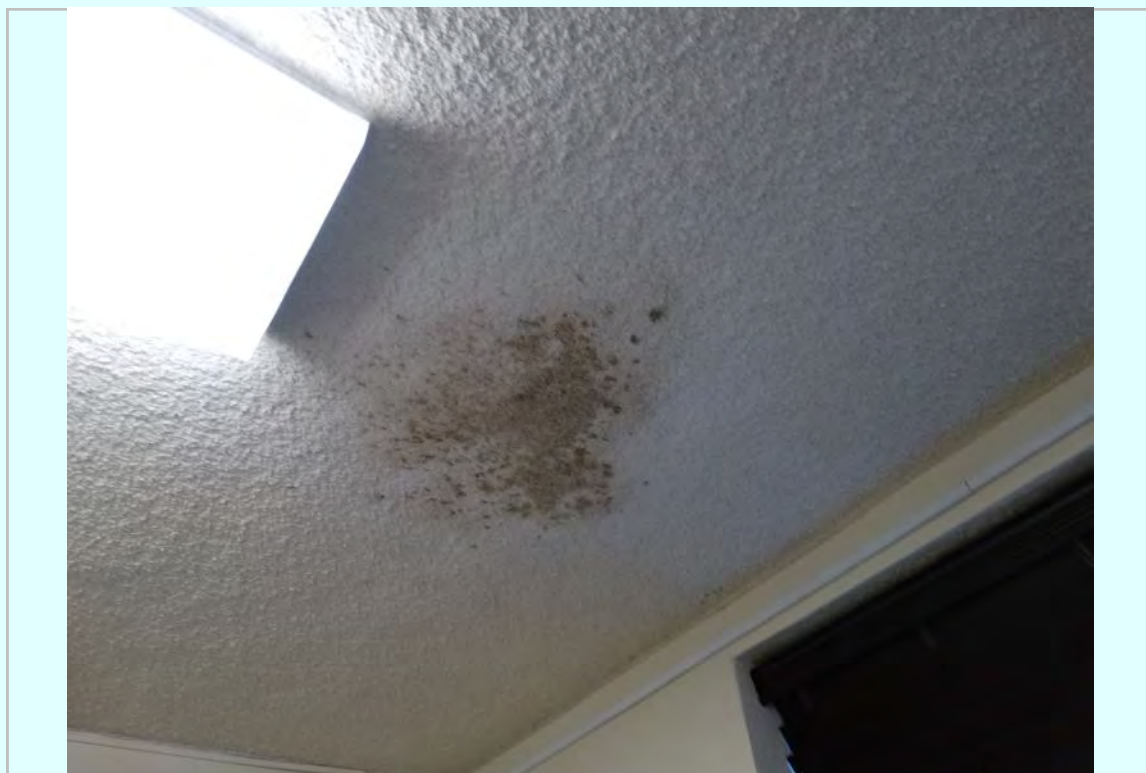
Photo: Third floor moisture damage at ceiling, biological growth

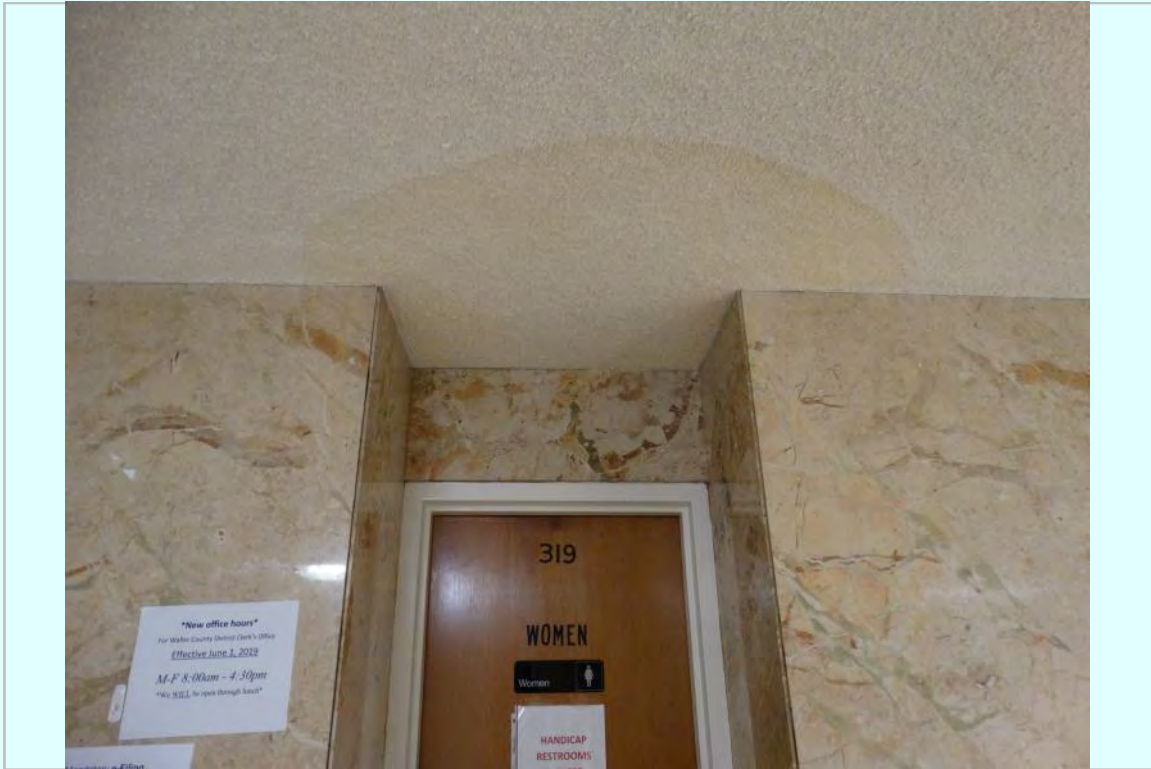
Photo: Third floor corridor moisture damage at ceiling
