# EXISTING CONDITION ASSESSMENT

**WALLER COUNTY COURTHOUSE**  
Hempstead, Texas

**836 Austin Street**  
Hempstead, Texas 77445

October 27, 2021

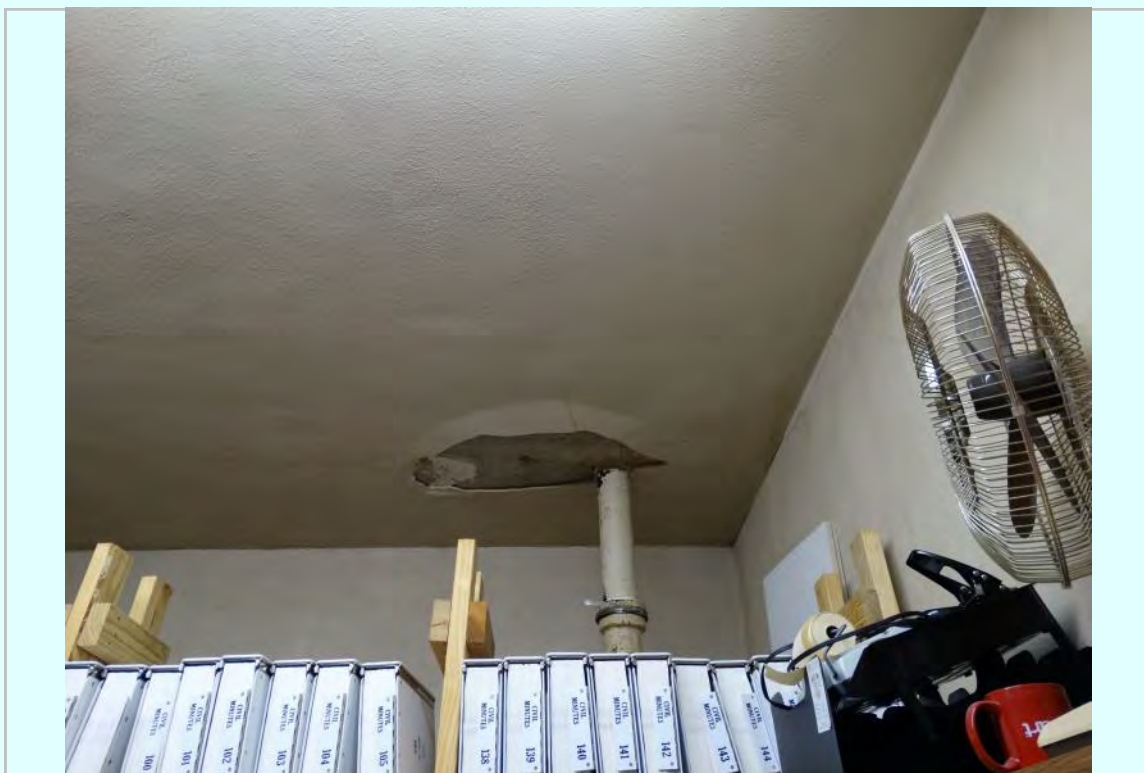
Photo: Third floor office space/storage ceiling damage, spalling

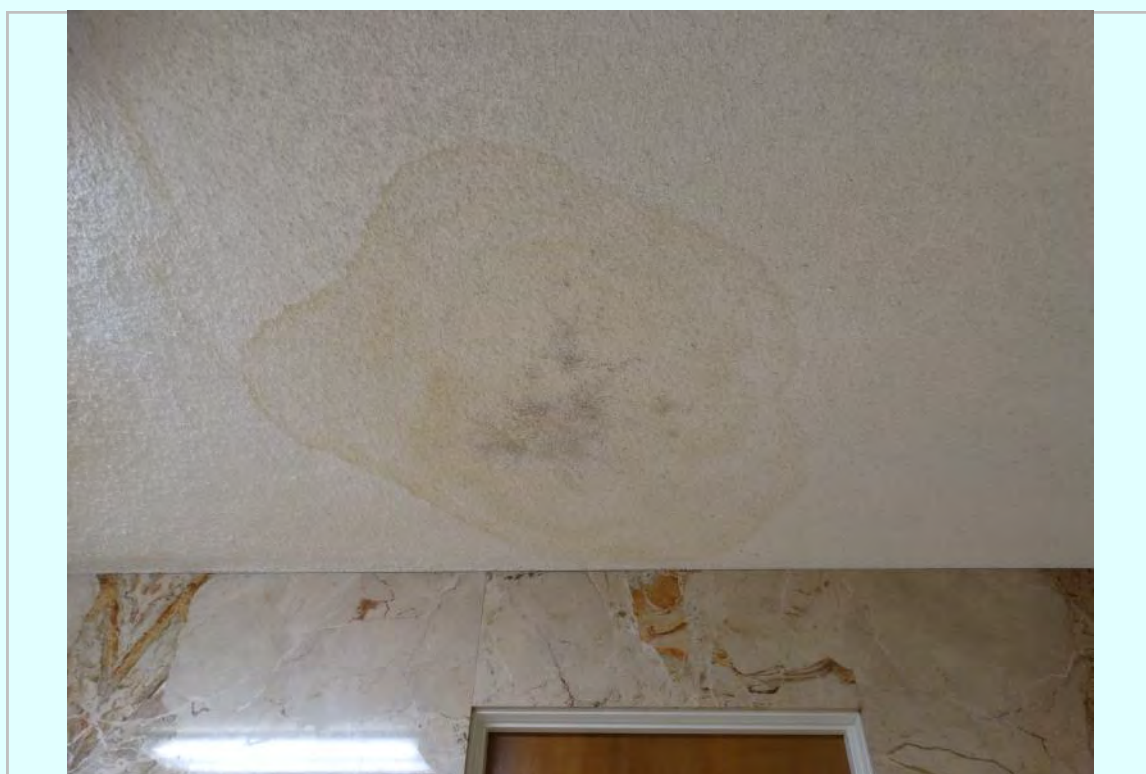
Photo: Third floor corridor ceiling damage and staining

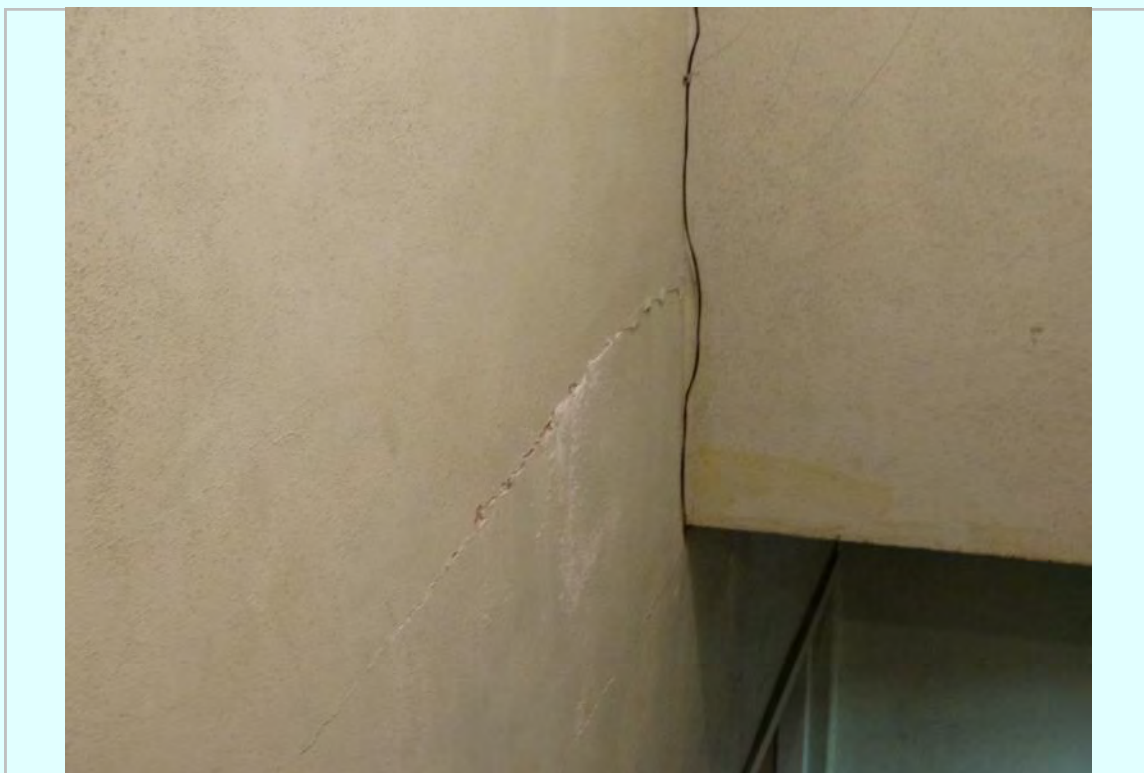
Photo: Fourth floor private stairs wall plaster cacking

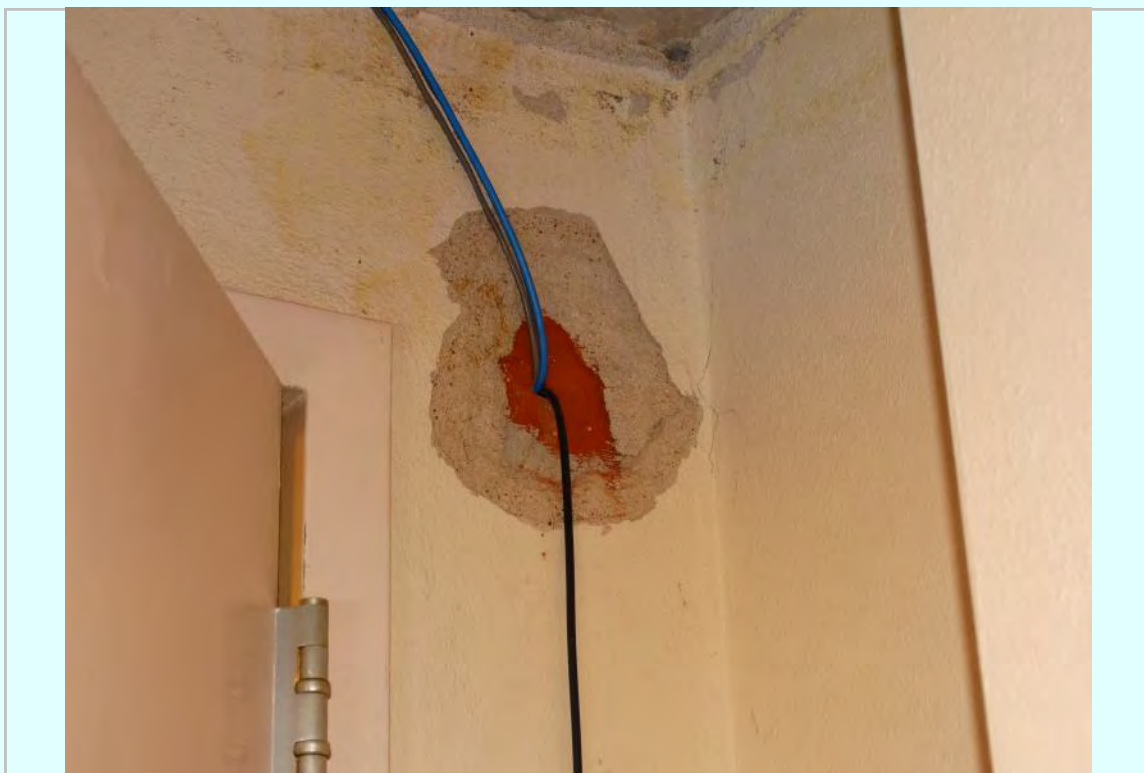
Photo: Fourth floor damage caused by updating for data

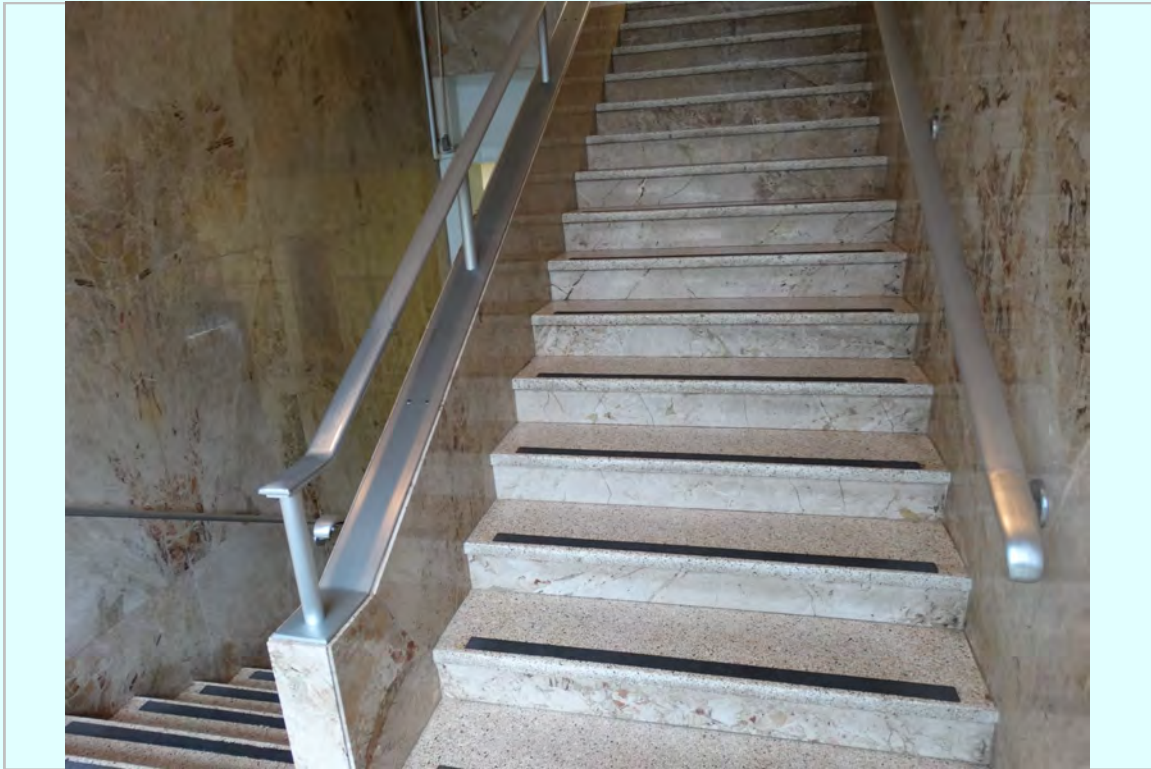
Photo: Central stair typical condition and non compliant handrail

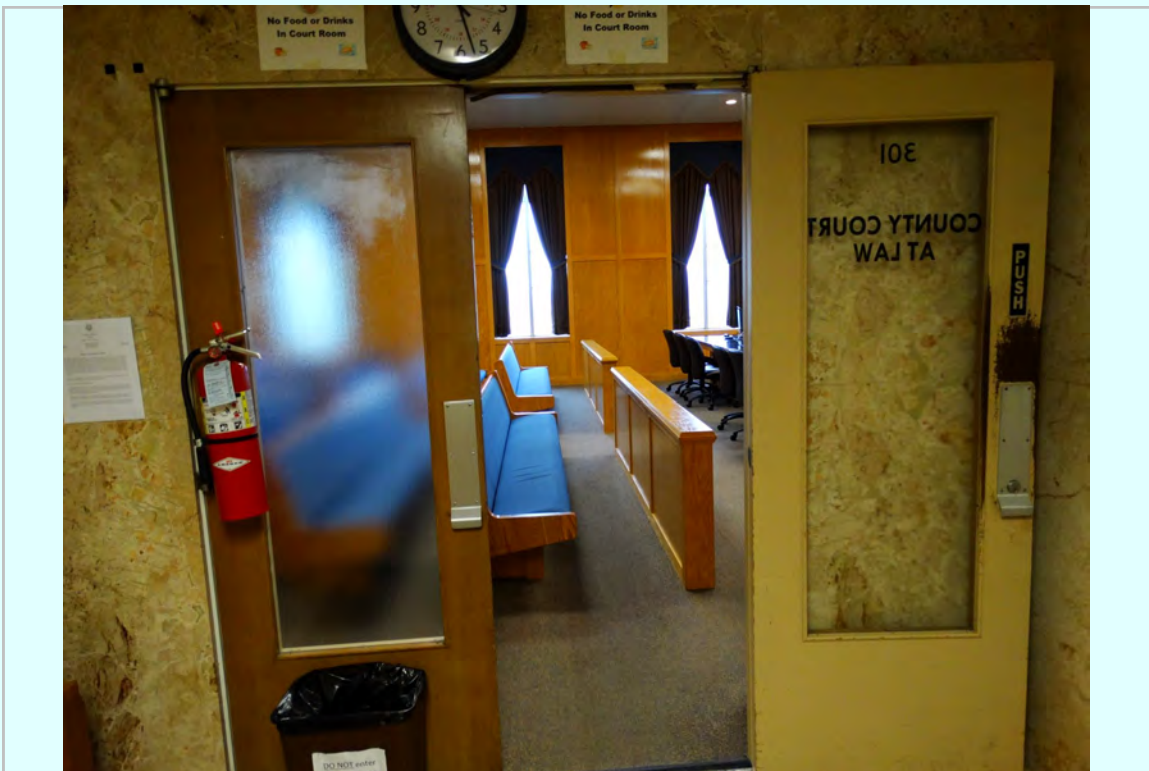
Photo: Non-compliant door
