The Waller County Commissioners Court is evaluating the viability of renovations and adding on to the existing Waller County Courthouse in Hempstead, possibly relocating to the former hospital or outlet mall in Hempstead or demolishing and replacing the courthouse.

The purpose of this report is to document the existing conditions of the mechanical, electrical, and plumbing systems and to identify deficiencies to determine the order of magnitude to design and install a functioning and energy efficient MEP systems.

### **WALLER COUNTY COURTHOUSE MEP SYSTEM DESCRIPTION**

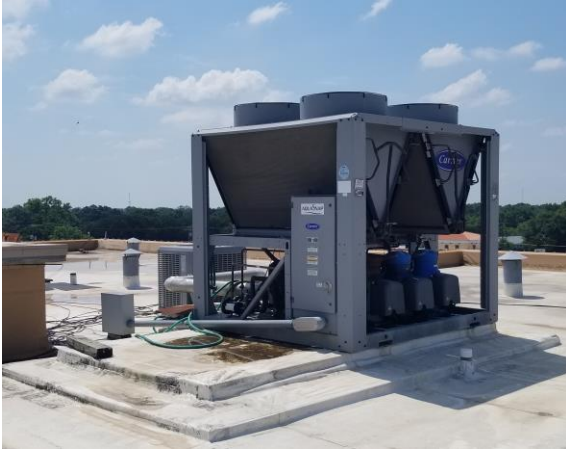
To determine the recommendations, our experience with similar systems and the ASHRAE median service life tables were utilized. Estimated equipment service life, according to the 2015 American Society of Heating, Refrigerating, and Air-Conditioning Engineers (ASHRAE) Handbook, is defined as the economic life of a system or component, or the amount of time it remains in its original service application. The remaining service life values reported in this document are based off the ASHRAE Equipment Life Expectancy Chart, as well as the ASHRAE Preventative Maintenance Guidebook, which use median years to provide an indication of expected equipment service life. Many factors effect equipment service life and with any average, some systems may have lifetimes far from average. However, these median lifetimes provide a reasonable basis for establishing the remaining useful life of existing systems.

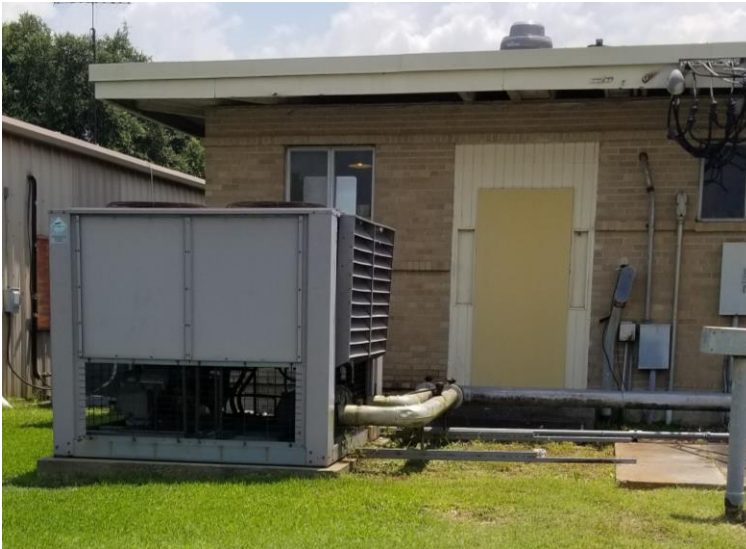
The existing Waller County Hospital was designed in the mid 1950's and is still used for County functions including Environmental and Maintenance. The building shows evidence of moisture in the building observed by the cupping of the tiles. This could be from several factors including envelope issues allowing warm humid air into the space, the HVAC system being off while the building was unoccupied, or the HVAC system not adequately conditioning the space due to age, improper functioning or inadequate sizing.

The original mechanical system consisted of two systems: one was a self-contained air conditioning unit with a condenser loop and the second system was a chilled water system with steam heat coils. The original chilled water system was a centrifugal chiller with a cooling tower located on the ground adjacent to the chiller room. The system now consists of an air cooled chiller system to condition the building. It appears the wall mounted convectors were added in the corridor after the original construction. Because of storage the mechanical equipment rooms were not observed.

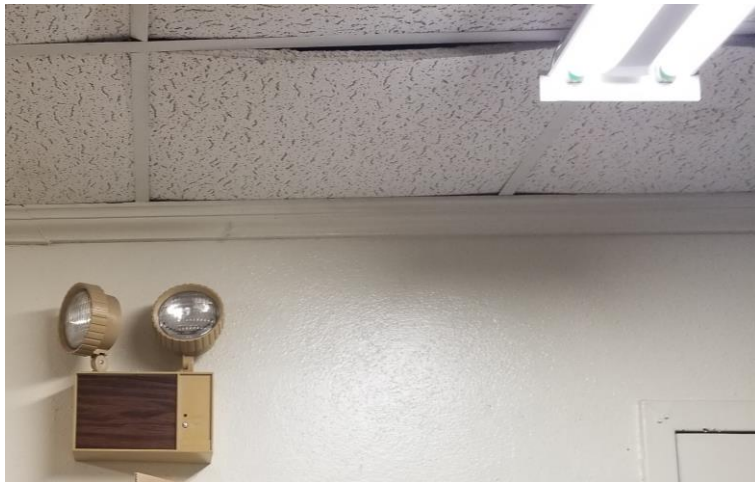
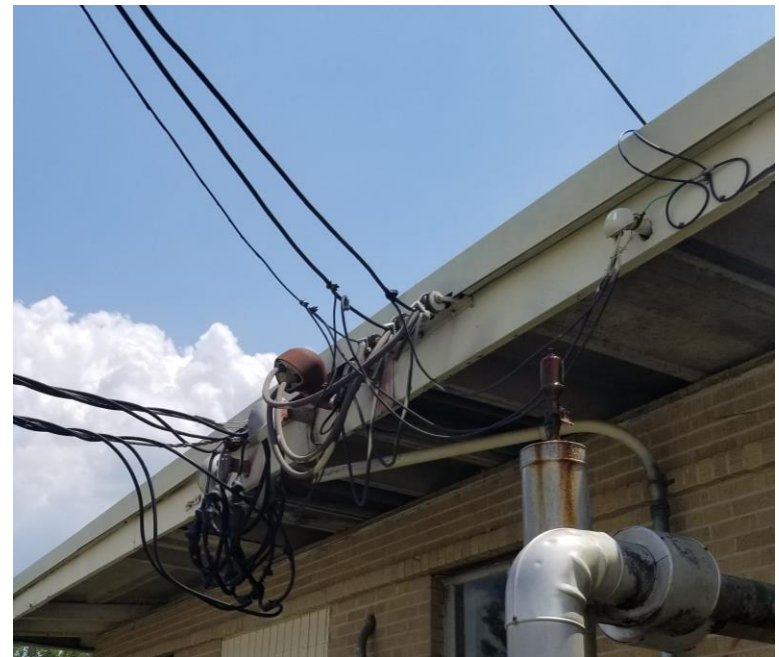
The lighting system consists of fluorescent lamps and surface mounted 2x4 lights in most of the spaces that were observed. The emergency light fixtures were battery powered “bug eye” fixtures located throughout the building. Batteries for these light fixtures should be checked or replaced every two years.

Based on the ASHRAE Equipment Life Expectancy Chart, most of the equipment has exceeded its anticipated life and would need to be replaced.
