# EXISTING CONDITION ASSESSMENT

**WALLER COUNTY COURTHOUSE**  
Hempstead, Texas

**836 Austin Street**  
Hempstead, Texas 77445

October 27, 2021

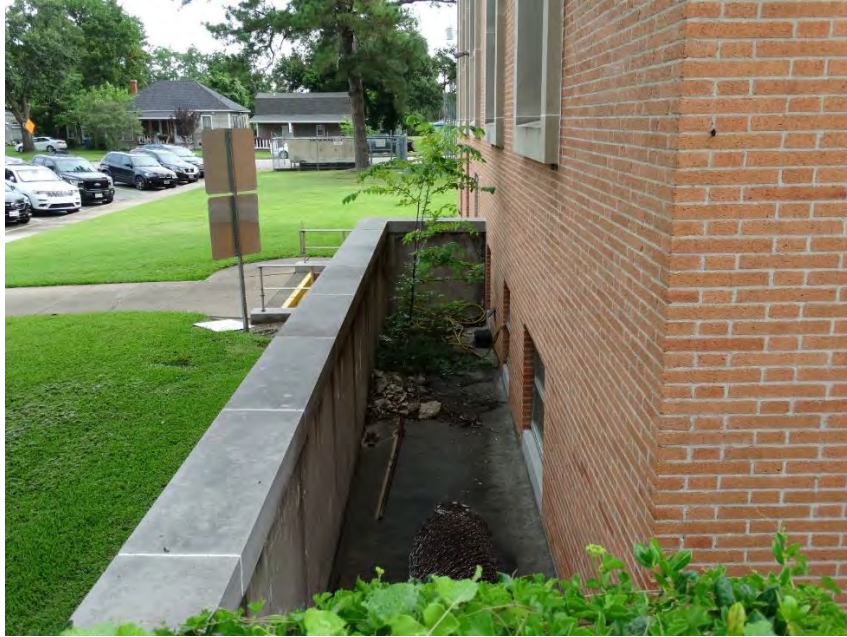
The outside retaining walls are in moderate/poor condition as the outside corner of the retaining walls are beginning to fail and buckle slightly. The mortar joints are failing and on the high side of the wall in the inside corners the ground is settling creating unsafe holes in the soils. There are also sink holes at the base of the foundation wall in which the County has had to place caution cones to prevent any injuries to pedestrians. There is also a high degree of biological growth on the masonry mortar joints. There is evidence of a recent intervention at the failing joints of the coping stones that show a white sealant along the entire perimeter of the wall.

***Figure 6. area well on west façade, showing wild planting and ponding of debris***

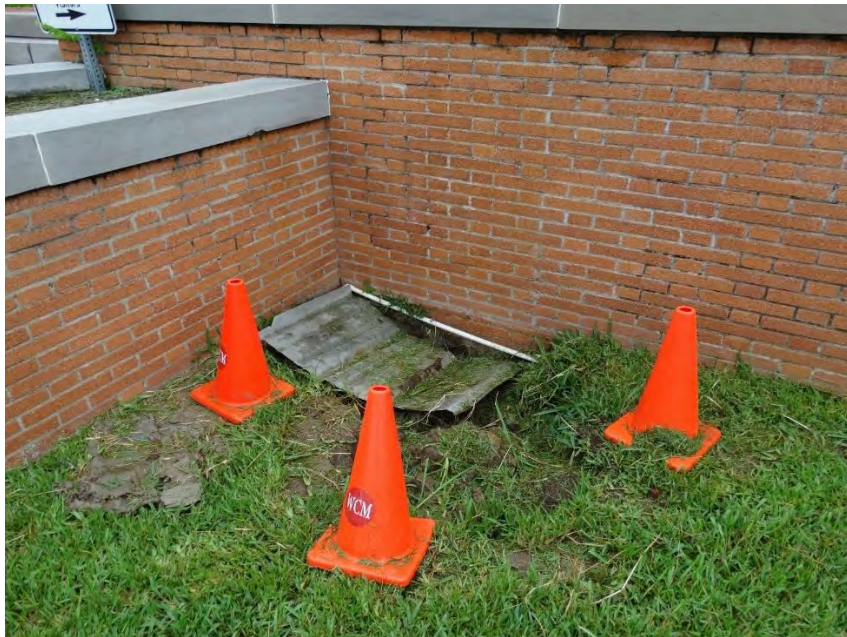
***Figure 7. South lawn inside corner of cheek wall and east retaining wall, where there has been soil erosion***

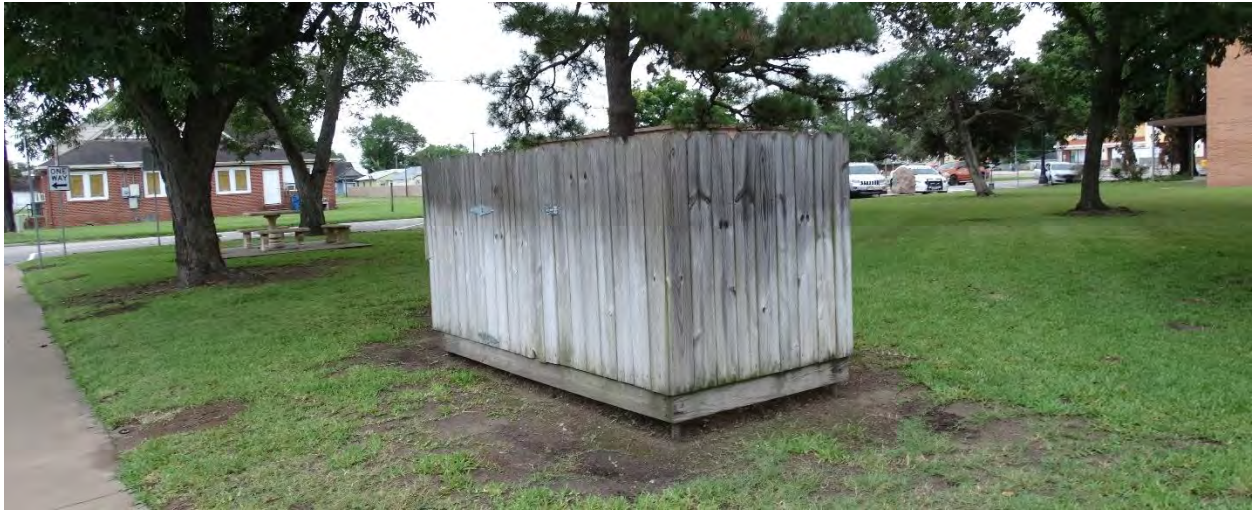
Located at the northeast corner of the square is an approximately six-foot-high wooden fenced area with a single gate. Inside the fenced area is an older cattle guard type iron fencing. And centered in the space appears to be a gas line and meter. The wooden fence is in moderate condition and the older iron fencing is in poor condition.

**Figure 14. Wooden fence protecting exposed gas lines**

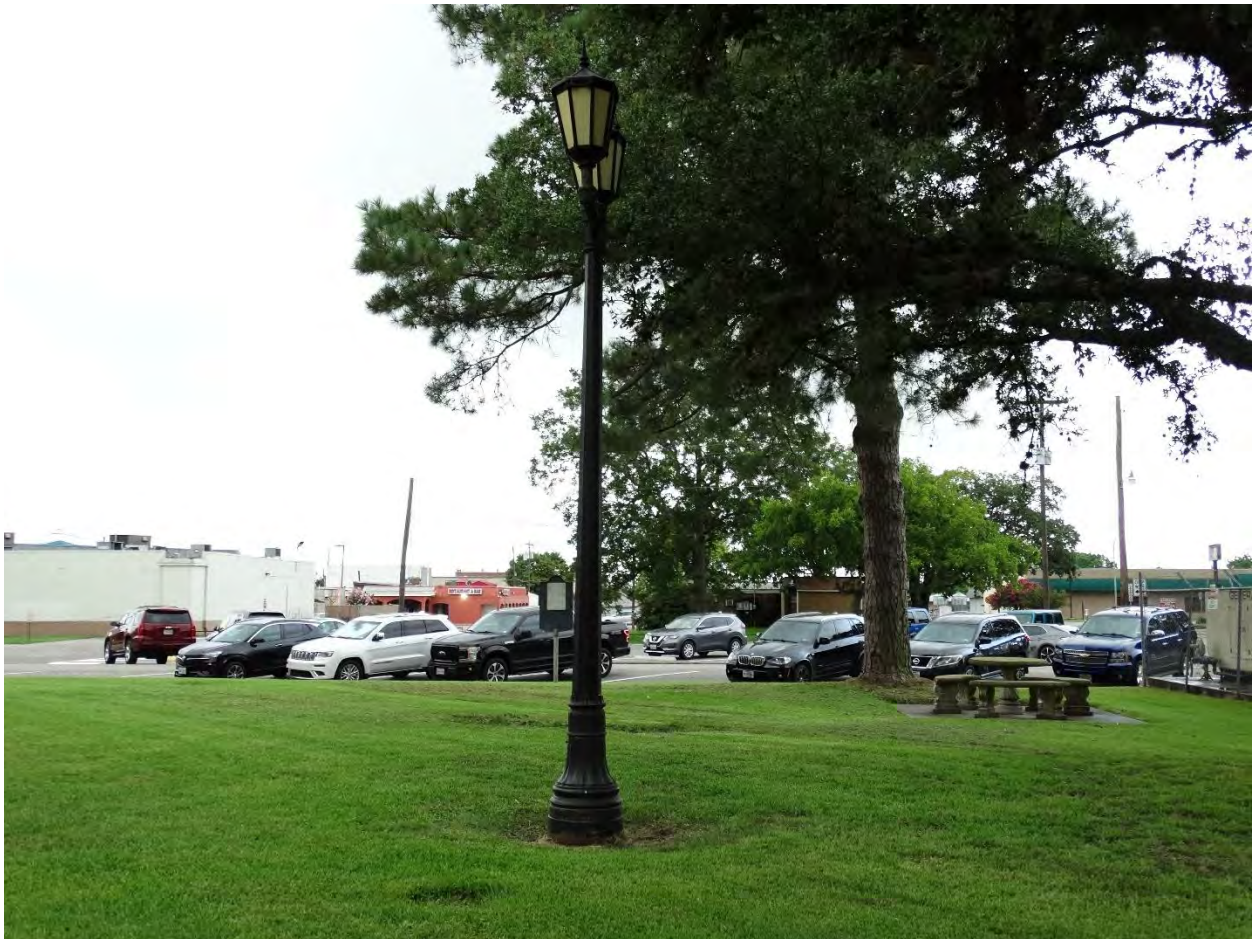
The light standards around the site are deceiving, as the style does not coordinate with the style of architecture found on the courthouse. Upon review of the original design drawings the light standards were originally installed as part of the design for the 1955 courthouse; even though they look more appropriate for the previous courthouses that have been demolished. Komatsu can only assume this might have been an owner's request as they do not fit or match the style of the 1955 courthouse architecture or are even aligned to the walking paths. They are spread around the courthouse in the open lawn areas, and some have even been lost by either age or storm damage.

*Figure 16. North lawn with light standard and concrete benches in the rear*

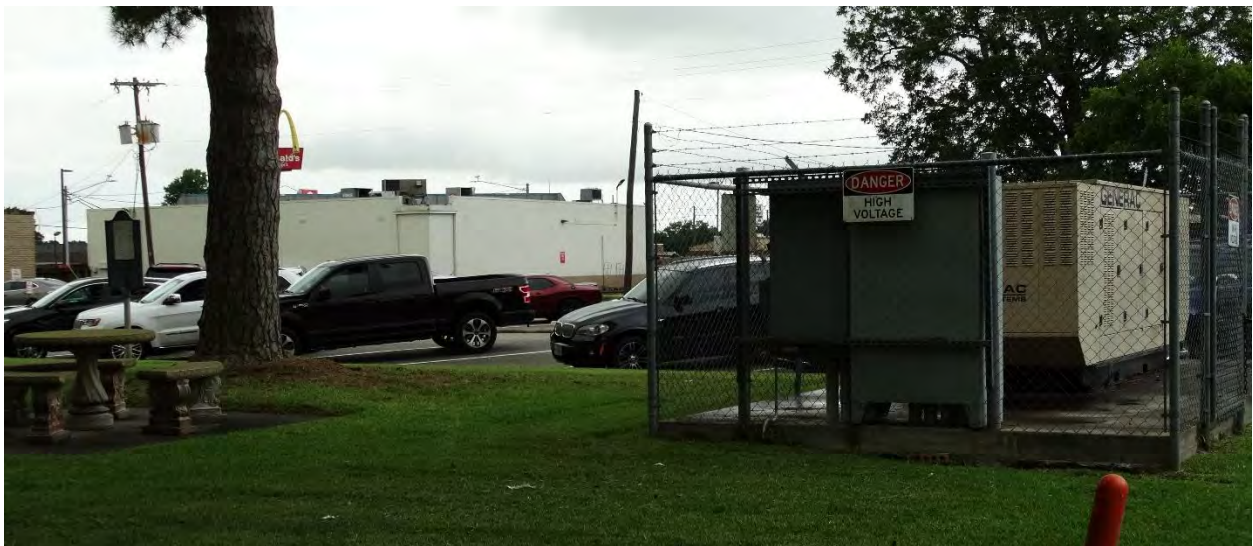
*Figure 18. Chain linked fence electrical yard, for backup generator at northwest corner*

Close to the table and benches to the west sits a large concrete slab and chain linked fenced in electrical yard. The yard appears to contain a large backup generator and distribution panels. It is tucked into the northwest corner of the site. While it is mostly out of site from most viewpoints of the courthouse, future work should relocate this off the Square completely if feasible.

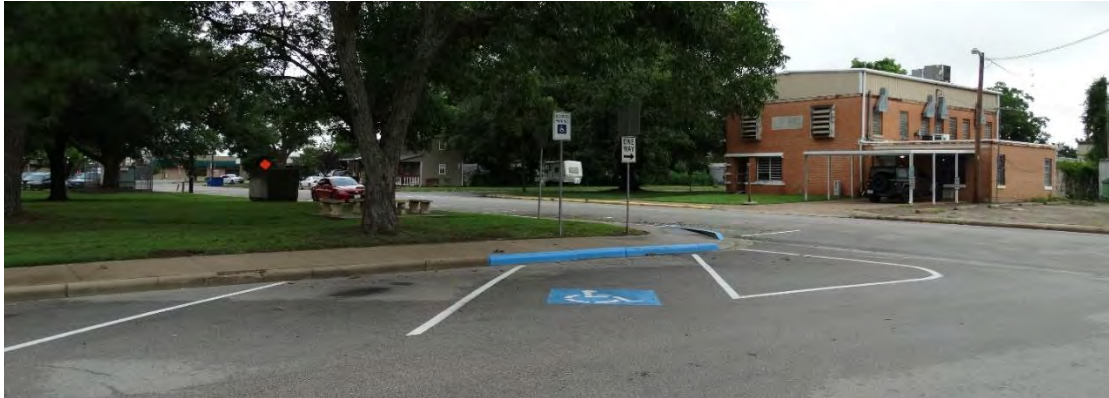
The parking areas are along the entire border of the Square. There are diagonal parking spaces available along the east and west boundaries and parallel parking spaces available along the north boundary. The parking spaces to the north all are reserved. The fire lane sits just outside of them. There are two accessible parking spaces on the northwest corner of the Square, both of which are non-compliant.

*Figure 19. Non-compliant handicap parking spaces at northeast corner of square border*

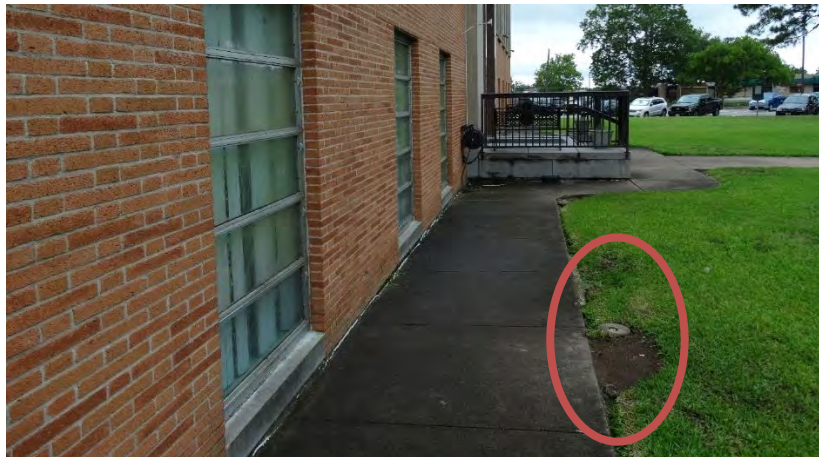
The south and north lawns of the courthouse contrast greatly. The north lawn is fairly flat and is only a few feet from the interior finished floor level, while the South lawn contains a large retaining wall that creates a continuous light well for the south façade first level windows. The south lawn finish grade below the retaining walls is more leveled and aligned to the north lawn finish grade. There was no ponding on the site and while being flat there seems to be just enough drop and slope to the grade to provide enough positive drainage. This will need to be confirmed by as topographic survey and civil engineer. There is evidence of some negative sloping on the north side of the building along the concrete walkway adjacent to the building face. There is erosion occurring along the walkway. Overall, the most problematic area seems to be the area wells and retaining walls along the south façade.

*Figure 20. soil erosion occurring along north elevation walkway*

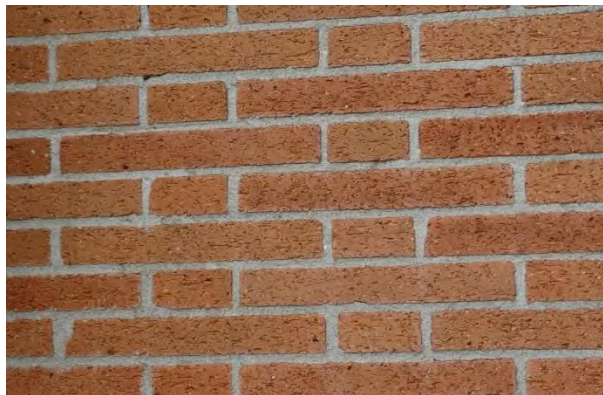
The masonry face brick is in overall good condition. There are a few areas of cracking, spalling, and failed mortar but approximately eighty percent of the masonry appears to be in good condition. There also seems to be very little mortar replacement completed as well. The areas where most of the damage is occurring appears to be in areas that shelf angles and flashing are likely in place.

*Figure 21. Typical face brick masonry*

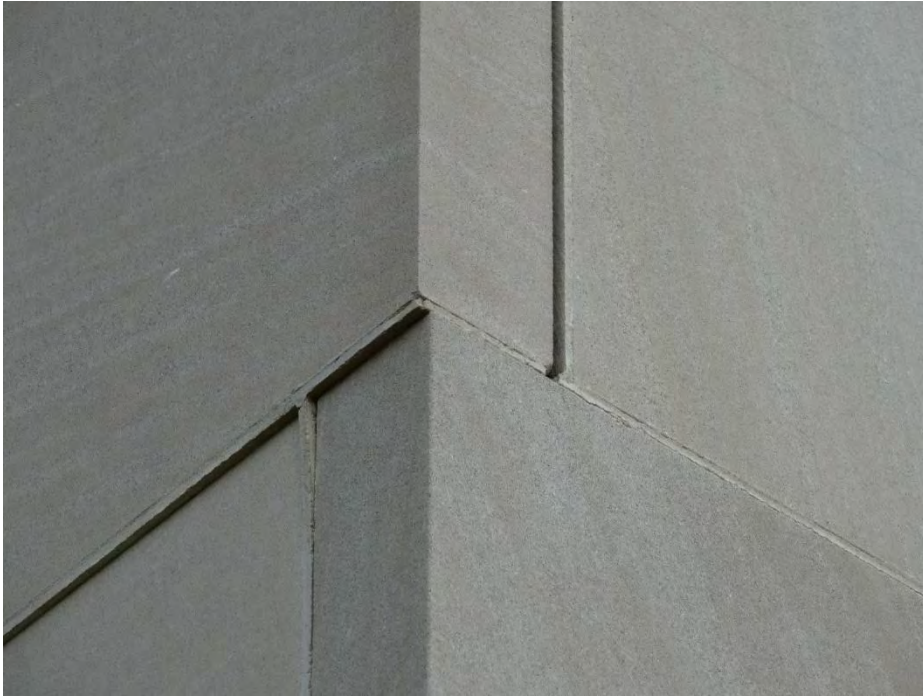
**Figure 24. Limestone mortar and movement damage on south façade masonry**

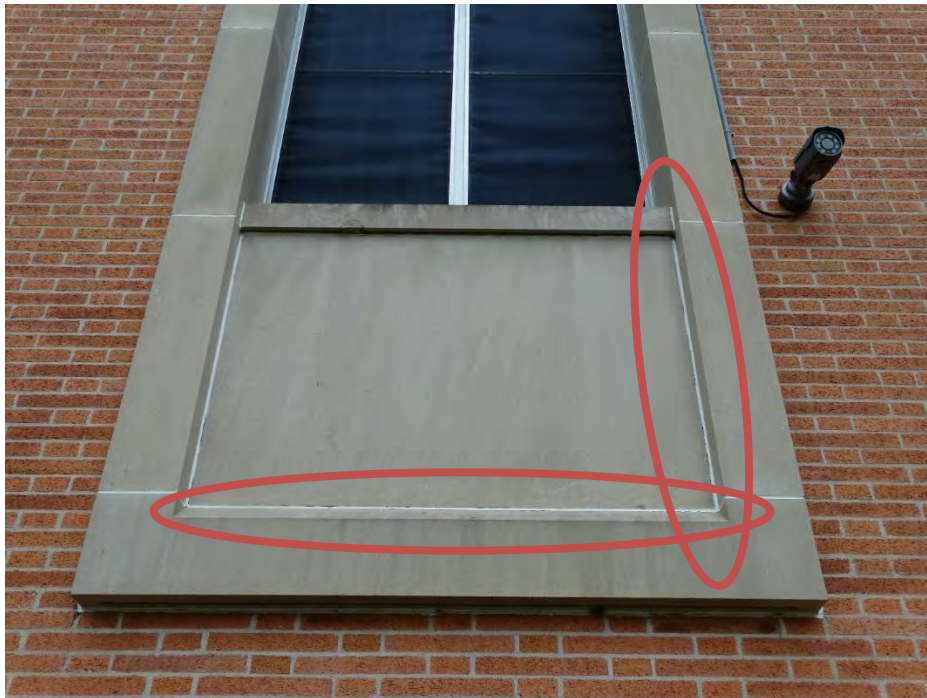
**Figure 25. Limestone mortar replacement with non-compatible caulking, typical at all windows**

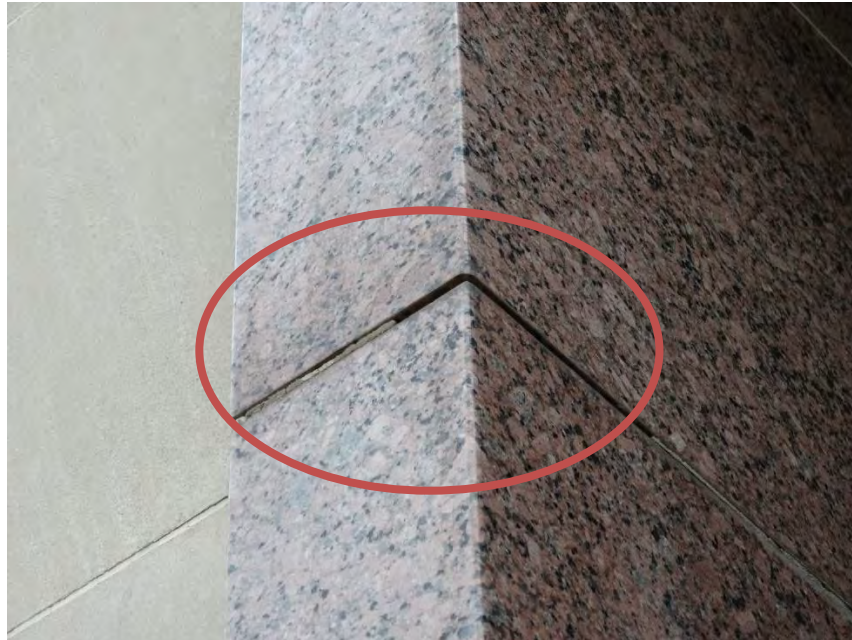
Located only on the north and south elevations, the building uses a pink granite stone as an accent banding only around the entry curtain walls. The stone joints align to the adjacent limestone masonry and is in overall good condition. The mortar joints on the north elevation are in poor condition and have deteriorated and spalled out. There is around fifty percent of the mortar that needs to be repointed. The south accent banding is in better condition than the north, with only a few areas that need to be repointed.

*Figure 26. Typical mortar joint deterioration at north pink granite entry*

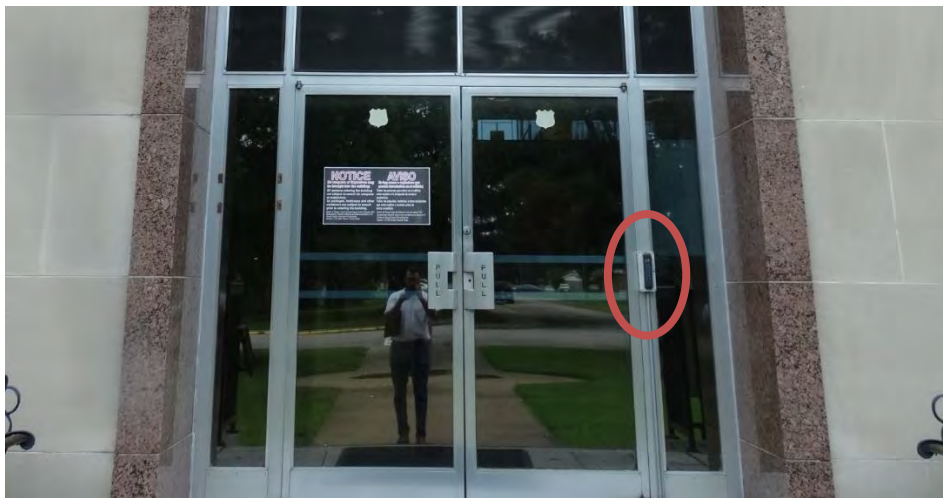
*Figure 27. Keypad modification at original north entry doors*

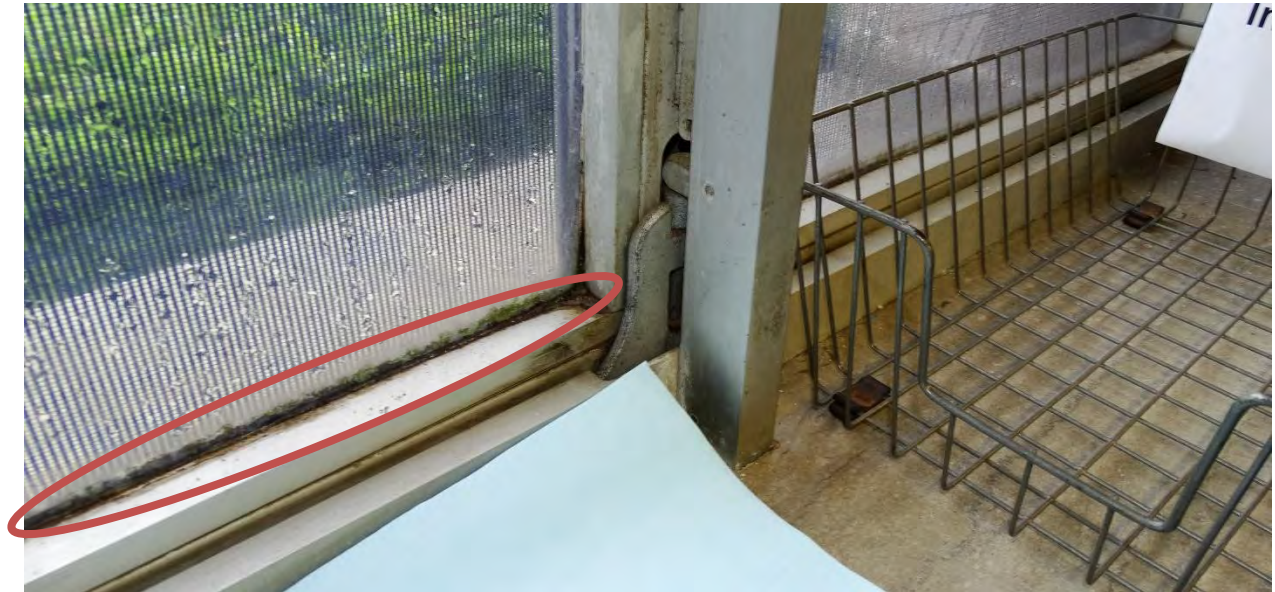
The windows are in moderate condition. It was observed from the interior, that large amounts of condensation builds up on the exterior face of the plate glass. Which is likely causing the visible biological growth to occur on the lower sash railing throughout the building. This is also the place where most of weathering of the windows appear. The hardware all appears to be original and in moderate condition. The modifications that occurred on the interior were mostly window treatments/blinds/curtains and additive wood stools, which was observed in a few offices. Most of the stools were still stone or tile as delineated in the original drawings.

*Figure 30. staining and biological growth at lower window sash*

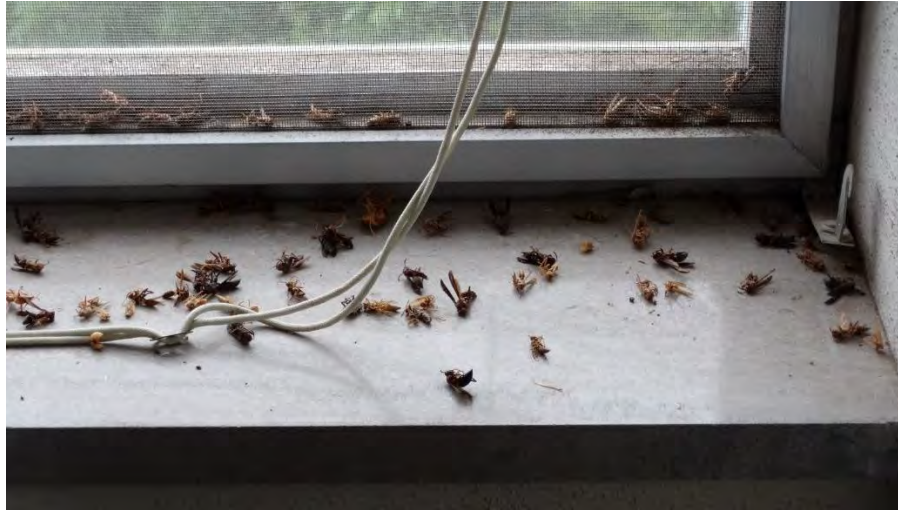
On the fourth floor there was a large wasp infestation. At the time of the site visit, the wasps did not appear active, but were able to get into the storage space on the fourth floor somehow. This leads to the conclusion that there are presently envelope issues at those windows.

*Figure 32. Wasp infestation at fourth floor windows, not active*

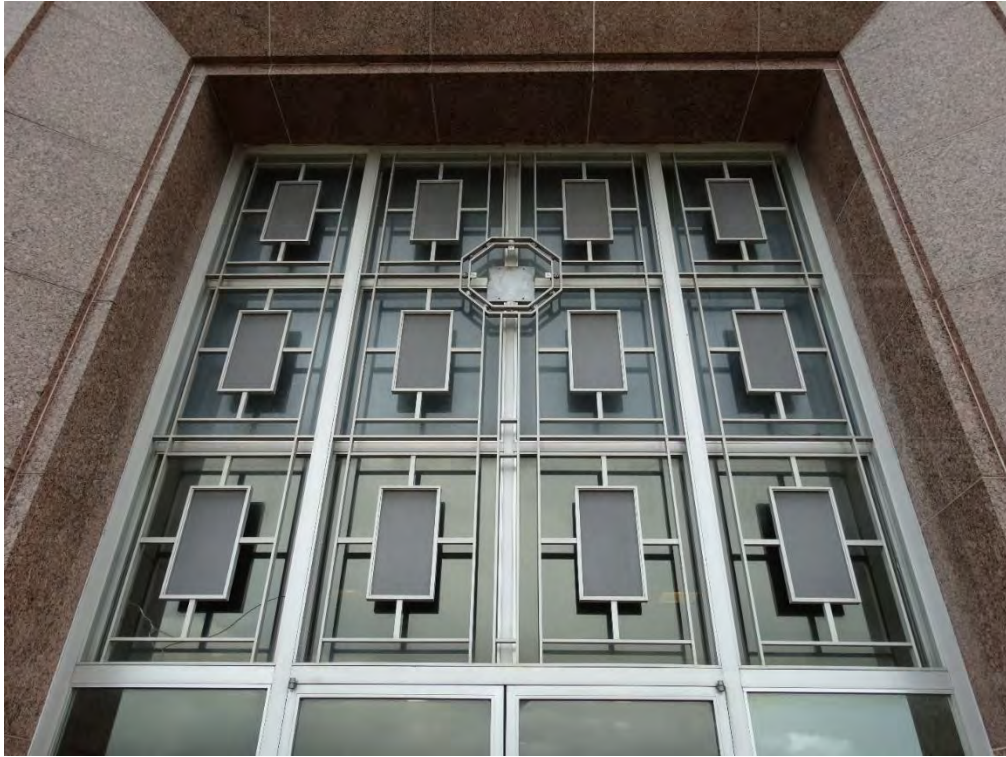
The aluminum grille has gray inserts that match the spandrels on the rest of the building. There is presently a void octagon at the upper center of the grille. It was the previous location of a clock, that first appears in a 1958 photograph. It was not originally delineated in the drawings provided. A similar clock form is found on the North elevation above the entry centered on the stone. In the 1958 photo, there is also evidence of no shade screen install as well as what the original interior window treatments were.

*Figure 33. South façade curtain wall with aluminum shade grille and missing clock*

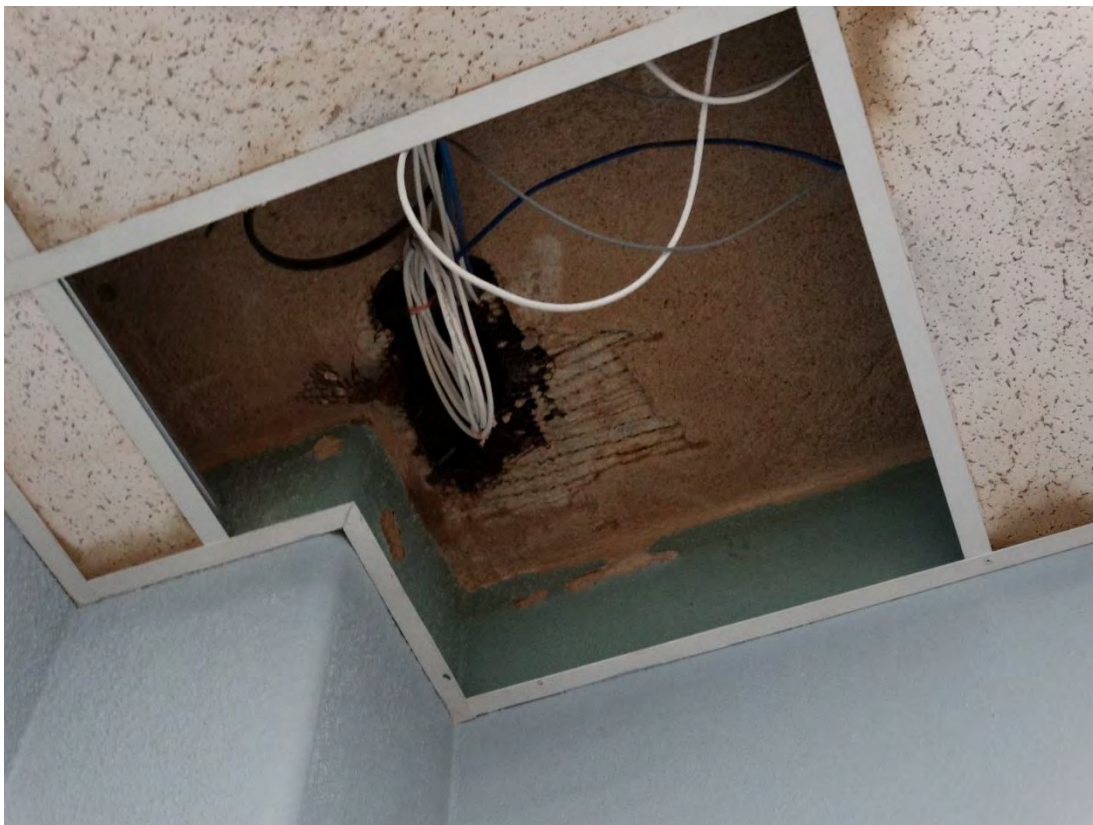
*Figure 35. Original acoustical plaster ceiling and possible color*

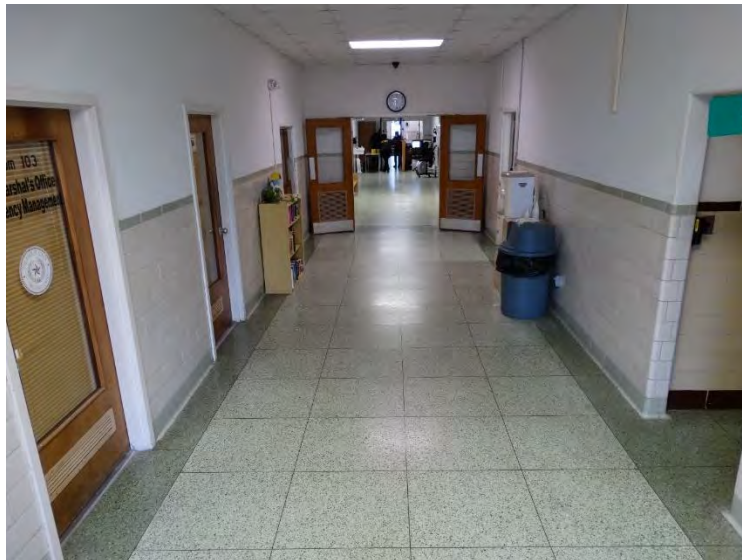
The original first floor mostly exists in its original formation based on the original floor plans. The main corridor has its original terrazzo flooring and wainscot glazed structural wall tile. Doors and hardware all appear to remain intact and in good condition. Some of the structural wall tile found behind the corridor in offices have been painted. In these office spaces there is also interventions on the floor, with contemporary vinyl floor material. Most of these changes occur in the northwest quadrant of the floor plan. These spaces are not of high historic significance.

*Figure 36. Existing first floor corridor, terrazzo and glazed structural wall tile*

- All terrazzo floors shall be cleaned and repaired as needed.
  - Glazed structural tile shall be retained and cleaned.
- Grand Central Stair
  - Clean all marble walls and risers and repair as needed.

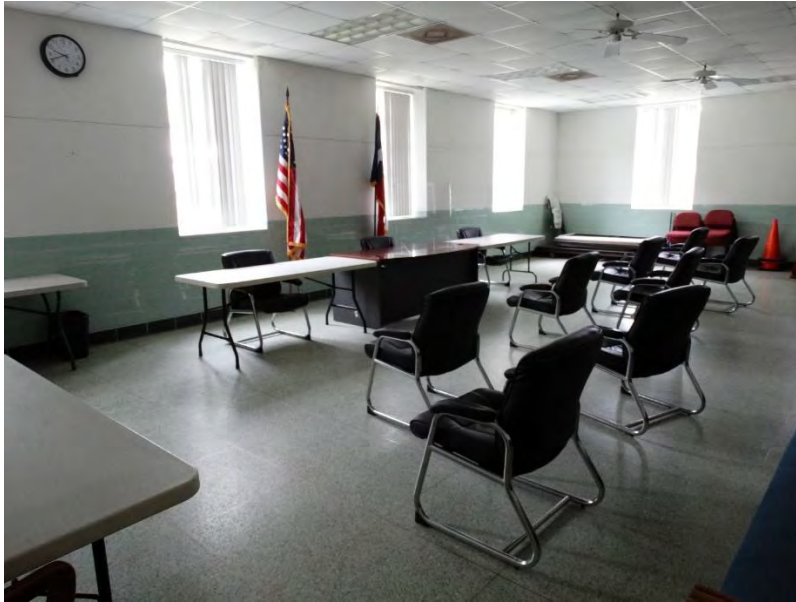
The first-floor restrooms, while not code compliant, do remain intact and original. There are stone toilet partitions, that could be salvaged and possibly reused for any future projects. The most significant space on the first floor is an assembly space on the northeast quadrant of the floor plan. Other than the lay-in ceiling, it also appears to be in-tact and in good condition.

*Figure 38. Existing first floor assembly space*

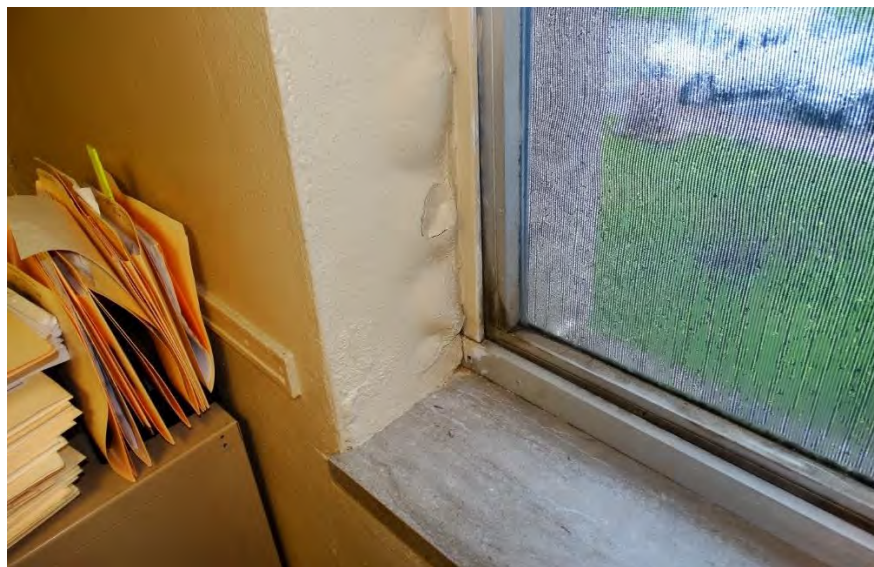
*Figure 43. Existing moisture damage at County Clerk office*

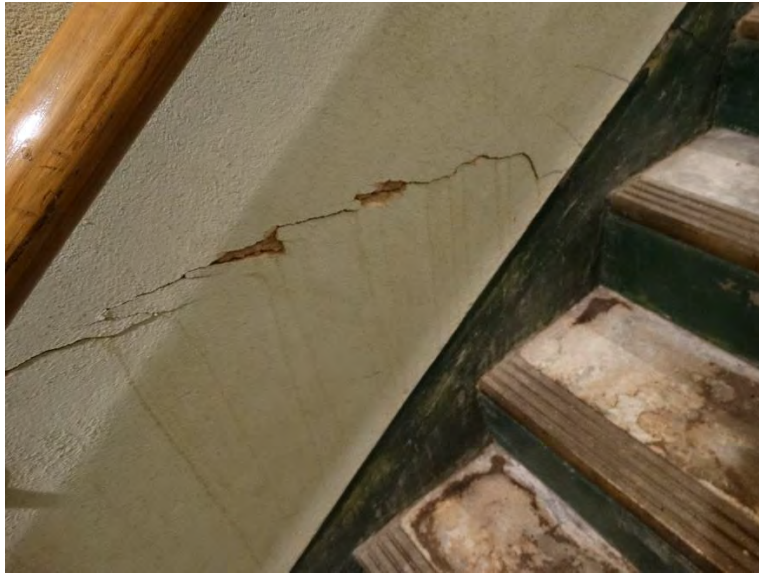
The fourth floor is only a half floor and is all currently being used as storage but was originally the Jury Dormitory and mechanical space. The space appears to be intact from its original design. All the restrooms and dorm spaces exist as time capsules, filled with files and general storage items. The only access is from the private stair at the County Court-at-Law Judges office. The stair exists likely how it was originally constructed. The plaster finish is also likely original, but in poor condition, as there are signs of stress, as large cracks and moisture trails were visible throughout the stair well.

*Figure 47. Existing damage at the private stairs to the fourth floor*

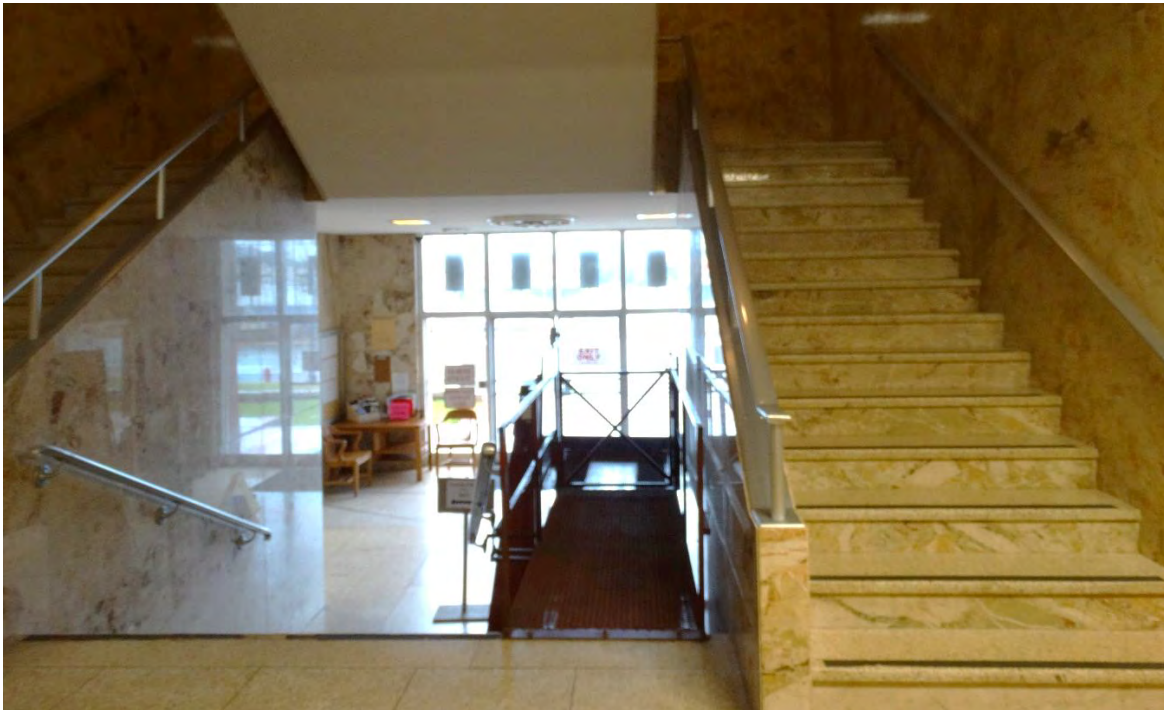
The central stairs have solid marble walls with terrazzo treads and marble risers from the first floor through the third floor. The fourth floor is only accessible from private stairs in the County Court-at-Law Judge's office. The handrails are an extruded aluminum profile up on aluminum post that sits on a continuous solid aluminum cap. The stairs and railings are in good condition with only a few areas in the risers and landings where cracks were found. All of which are easily repairable. The stairs are not code compliant per Texas Accessibility Standards.

*Figure 49. Existing Central stair well leading down to the mezzanine level*

- Clean all terrazzo treads and landings and repair as needed.
  - Provide code compliant compatible guardrail and handrail in coordination with THC.
- Spaces

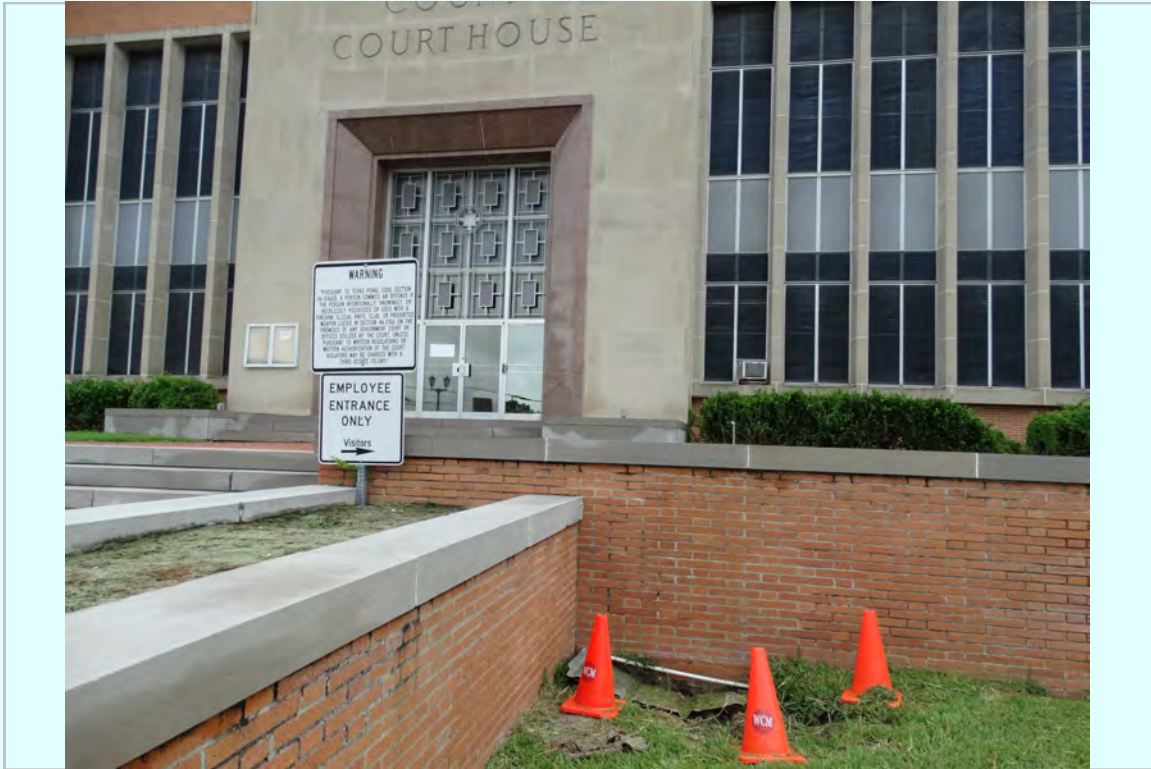
Photo: South entry East retaining wall and erosion

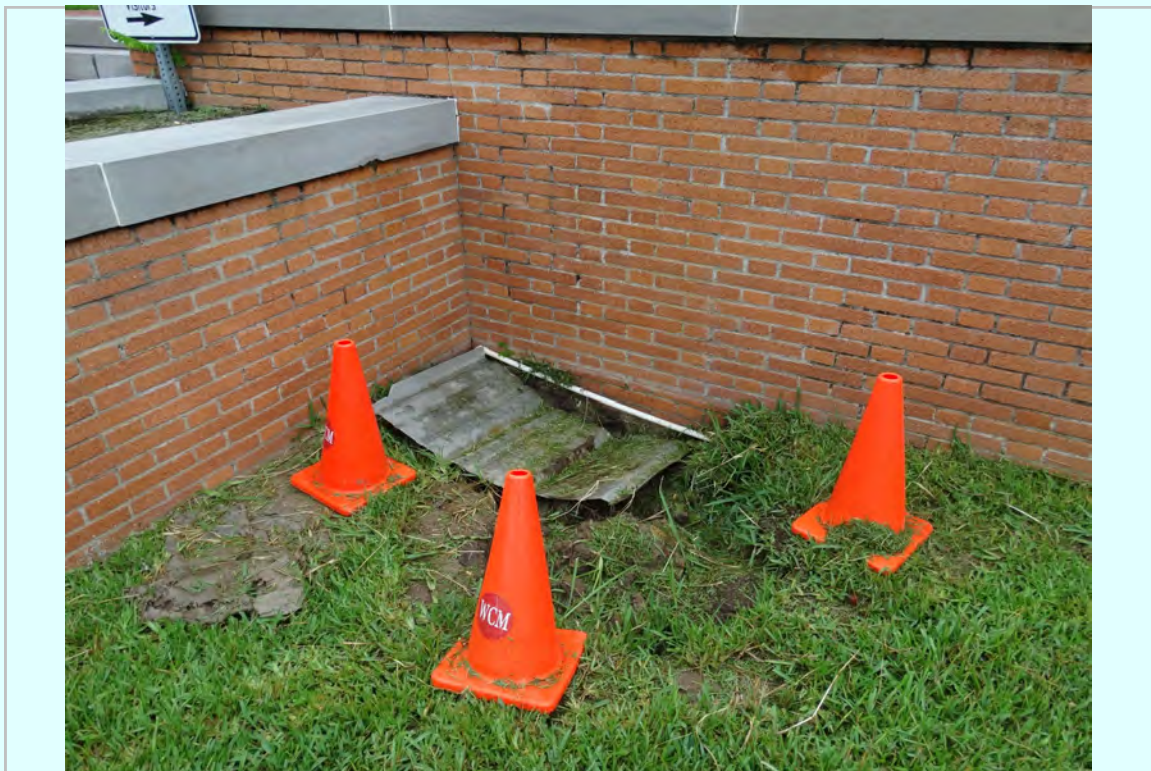
Photo: Site erosion/drainage pot hole

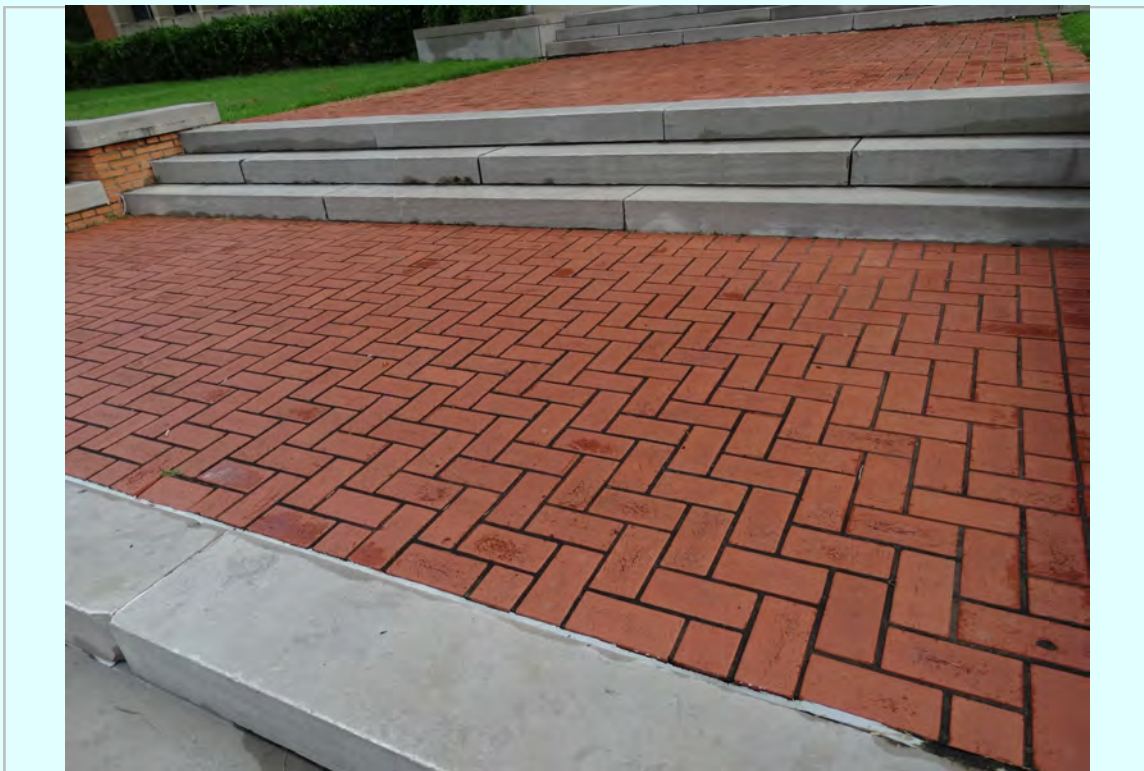
Photo: South entry clay pavers condition

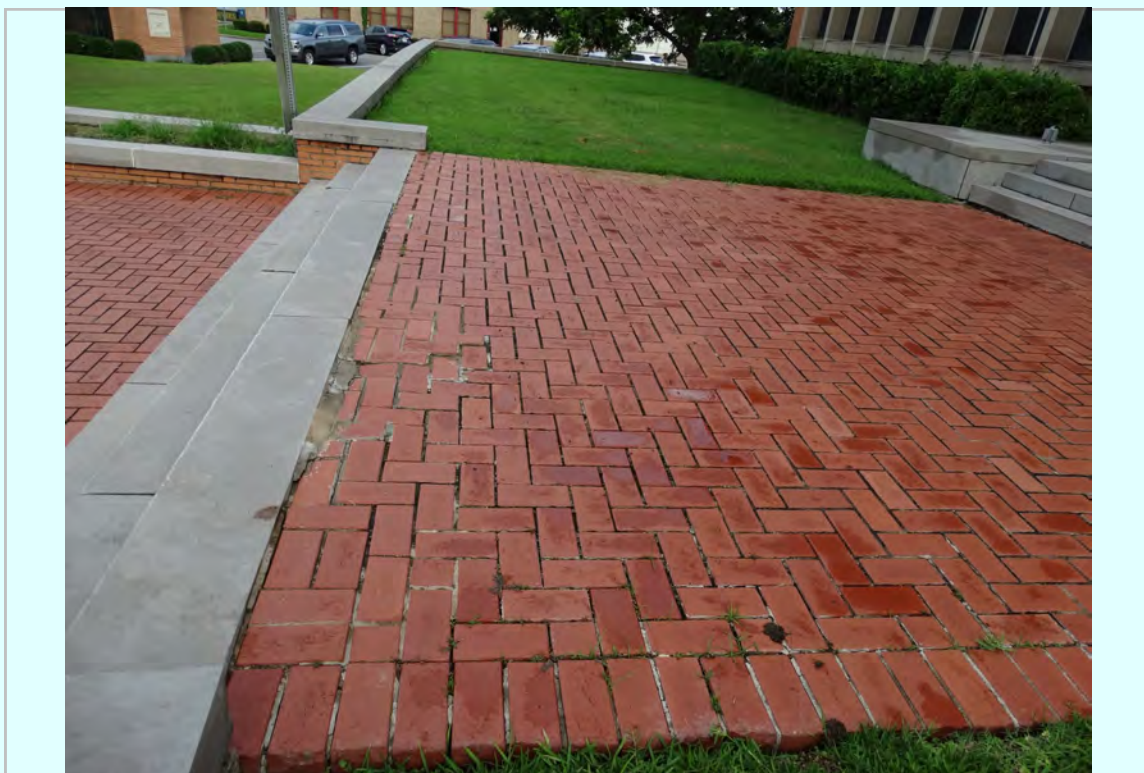
Photo: South entry clay paver existing condition

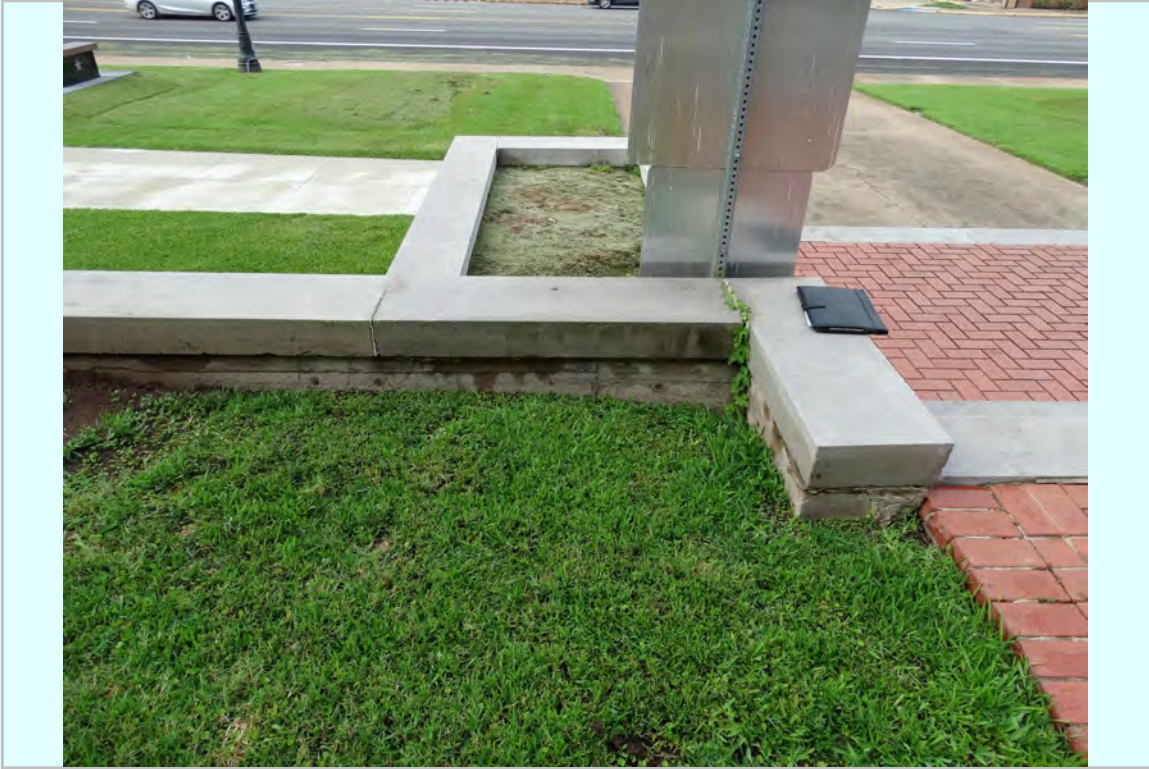
Photo: South entry retaining wall condition

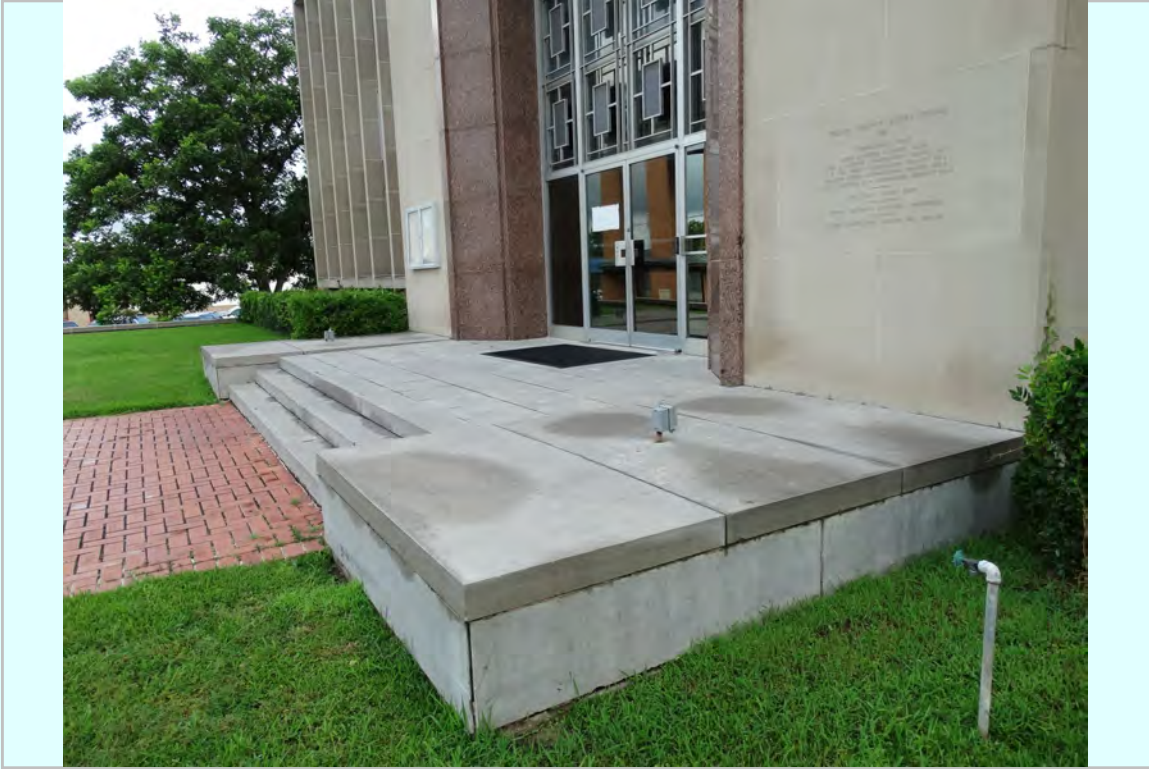
Photo: South entry patio stone condition

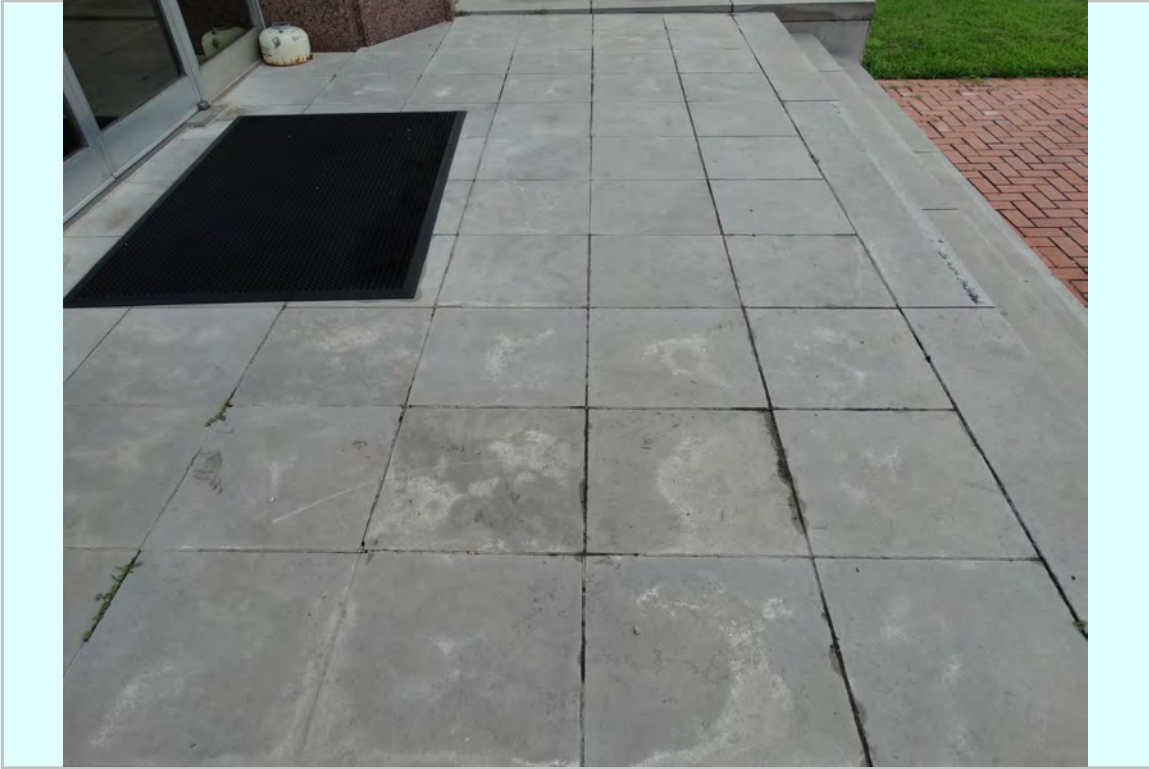
Photo: South entry patio stone paver condition

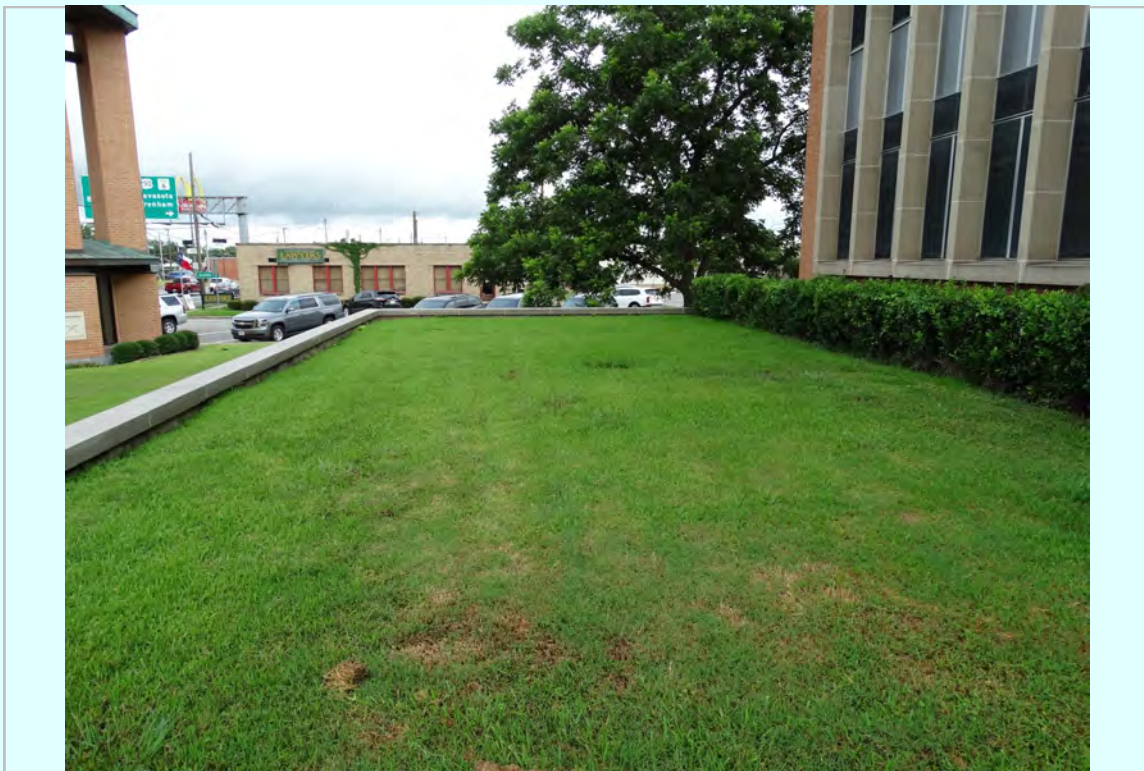
Photo: South west retaining wall lawn
