# EXISTING CONDITION ASSESSMENT

**WALLER COUNTY COURTHOUSE**  
Hempstead, Texas

**836 Austin Street**  
Hempstead, Texas 77445

October 27, 2021

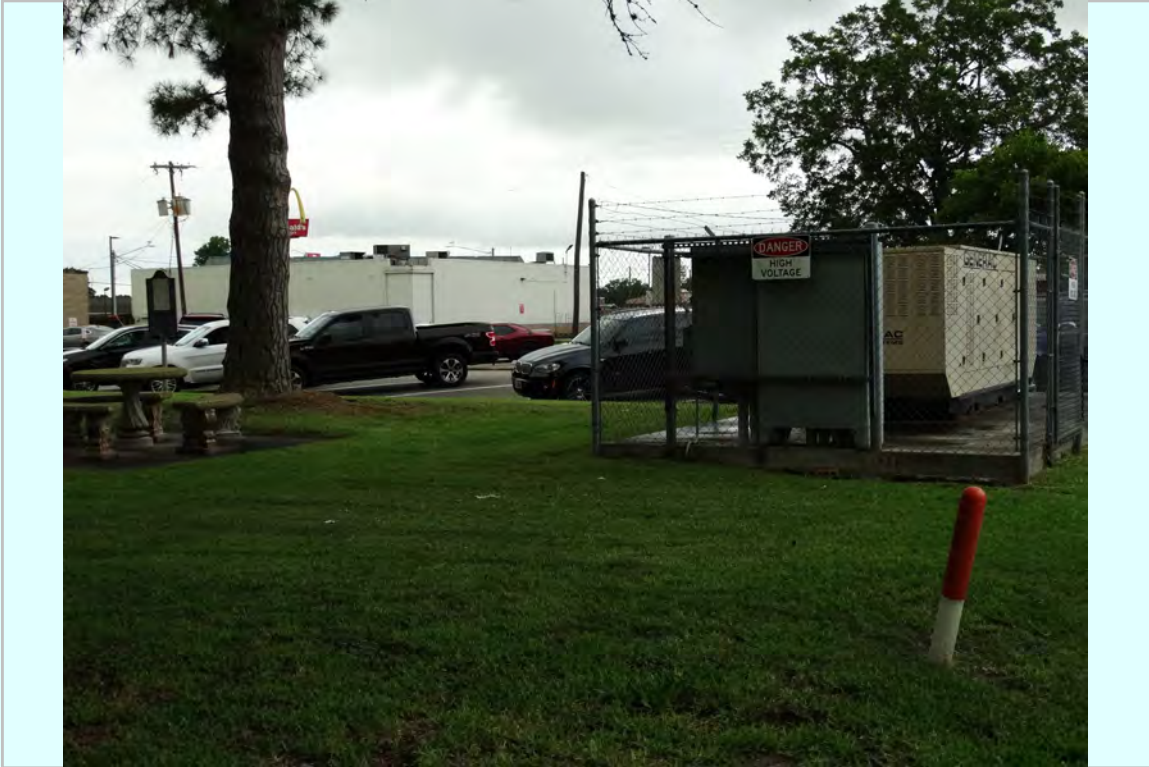
Photo: Mechanical Yard at north west corner of square

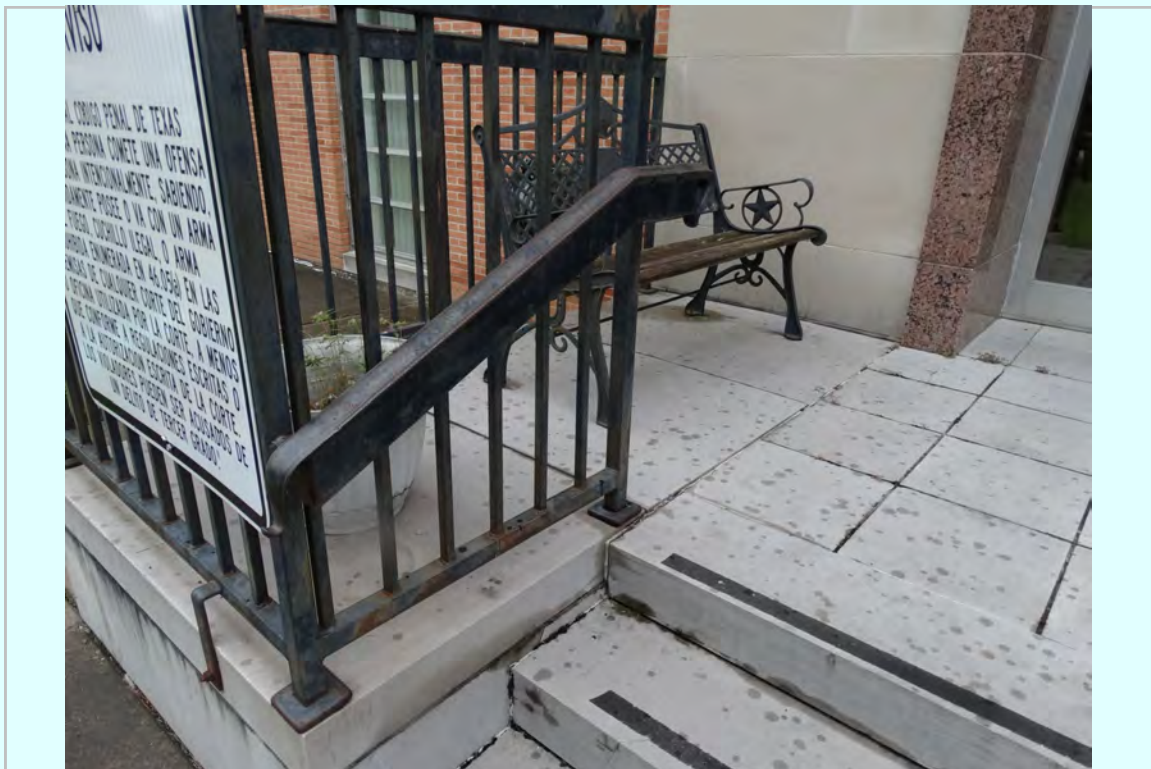
Photo: North Entry , non compliant railing

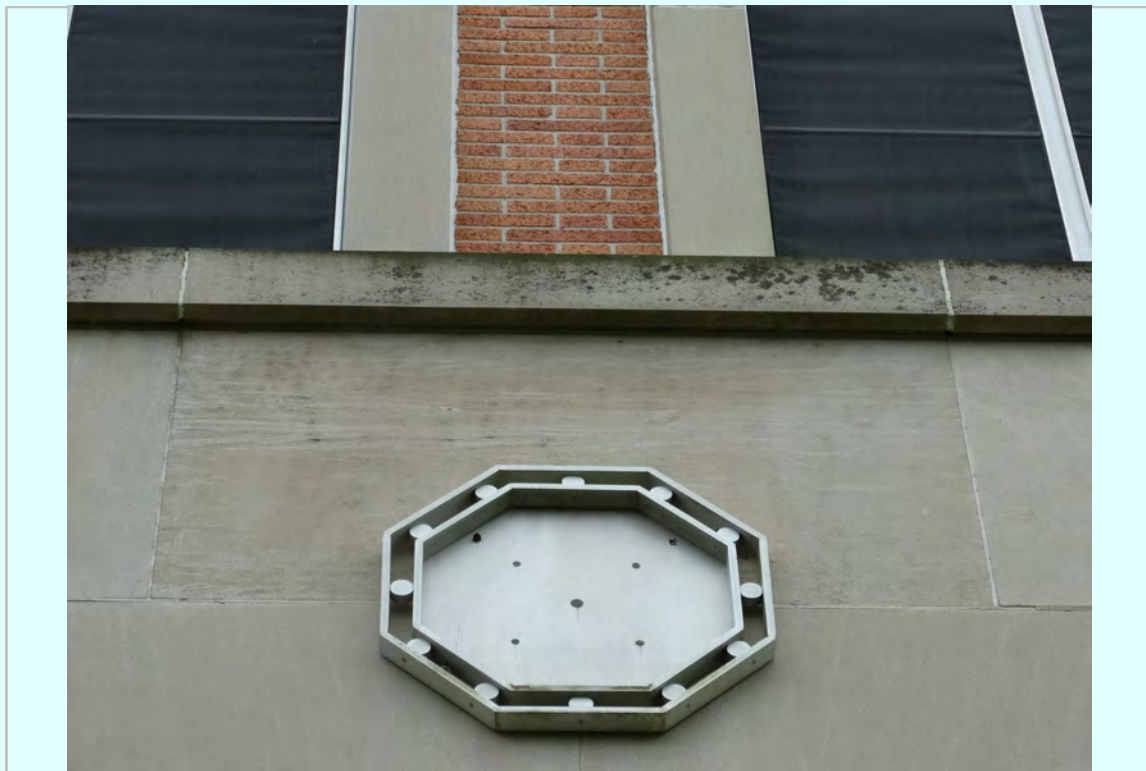
Photo: North entry, missing element, coping moisture staining and biological growth

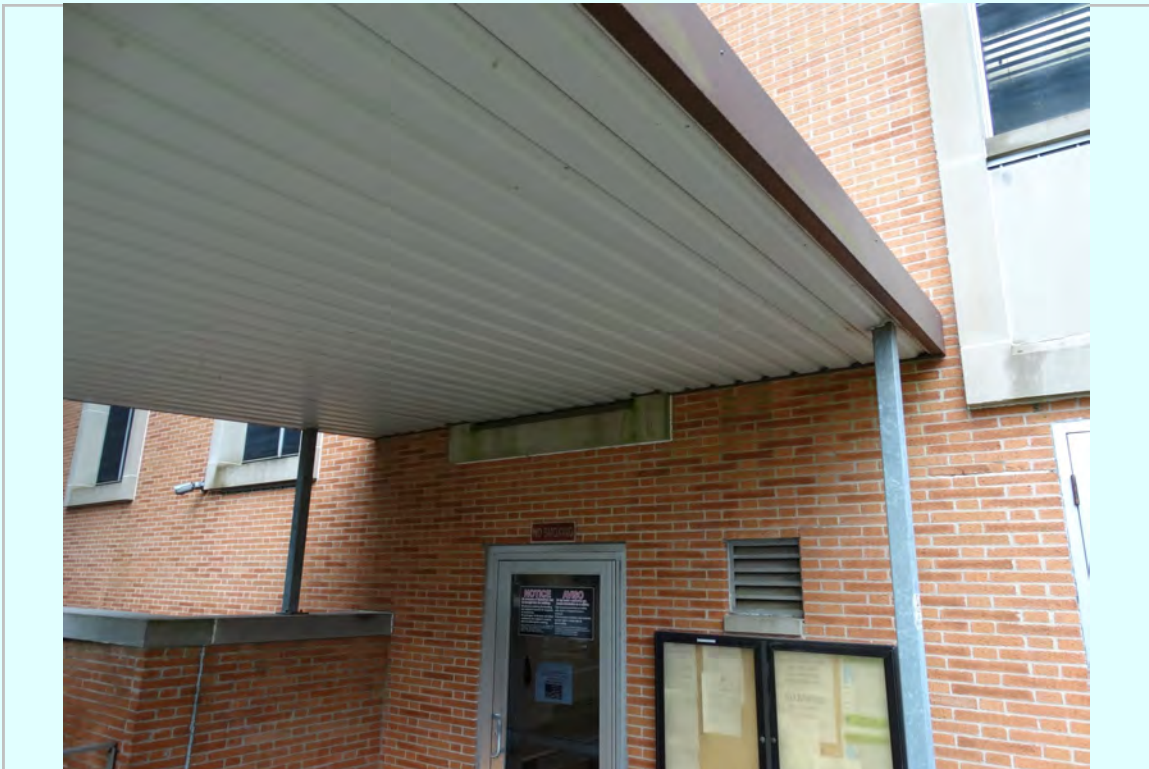
Photo: East Elevation, non original entry canopy, at window sill

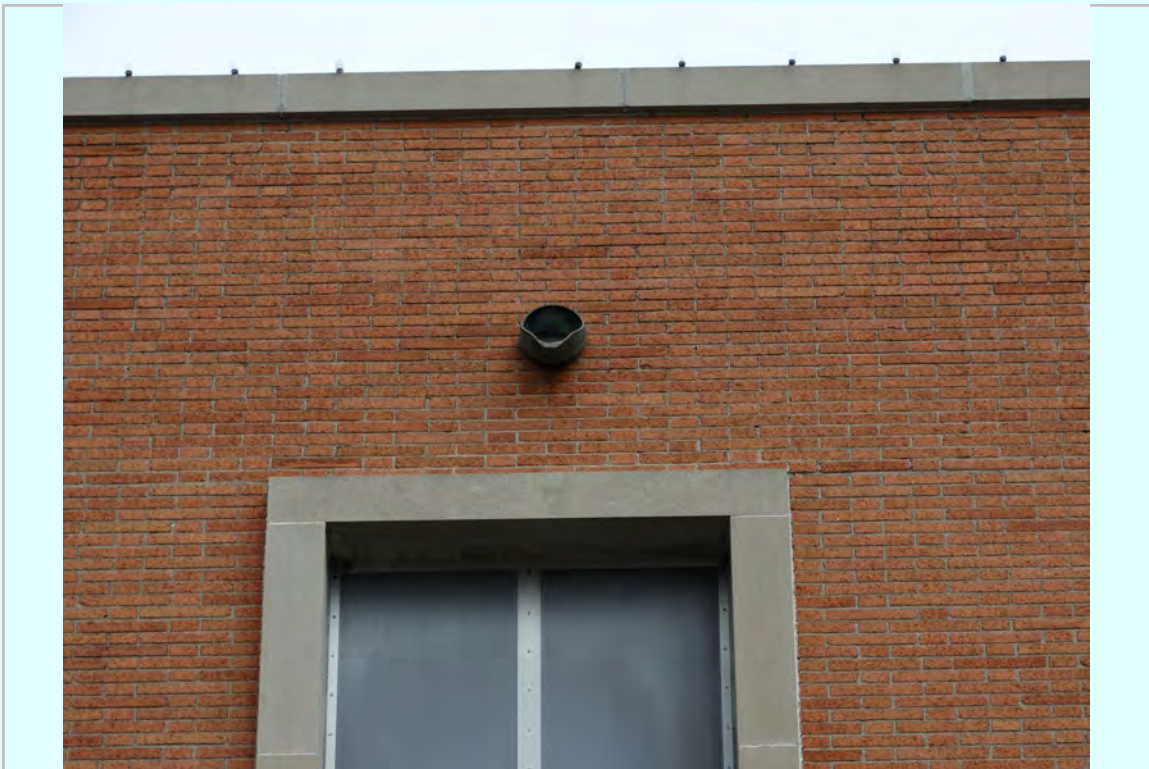
Photo: East Elevation, thru wall scupper, assuming original

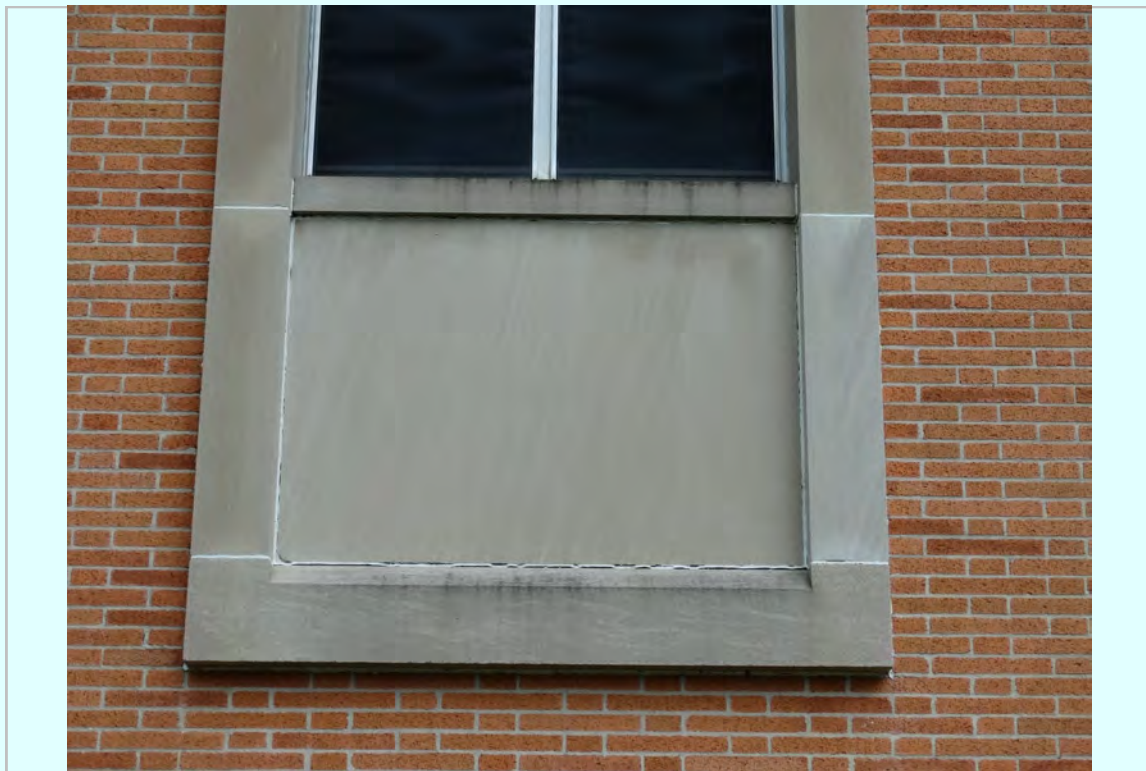
Photo: East Elevation, spandrel panel, assumed original, failing masonry joints

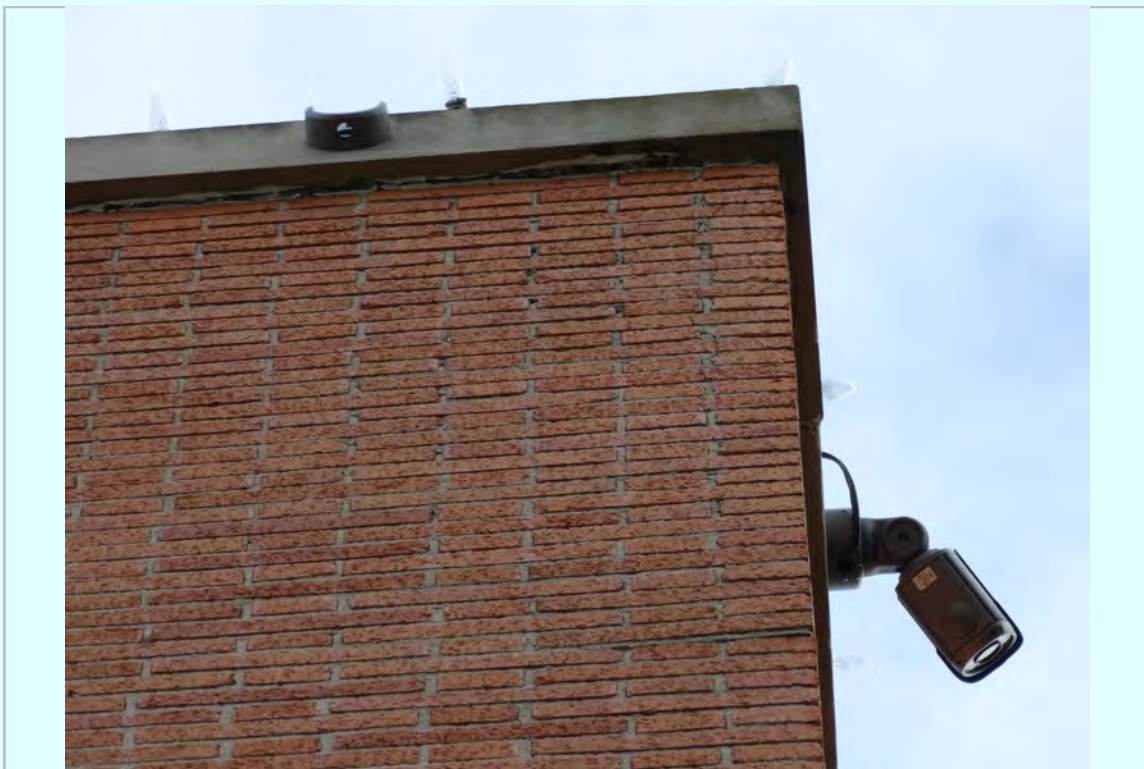
Photo: South Elevation, masonry mortar failing

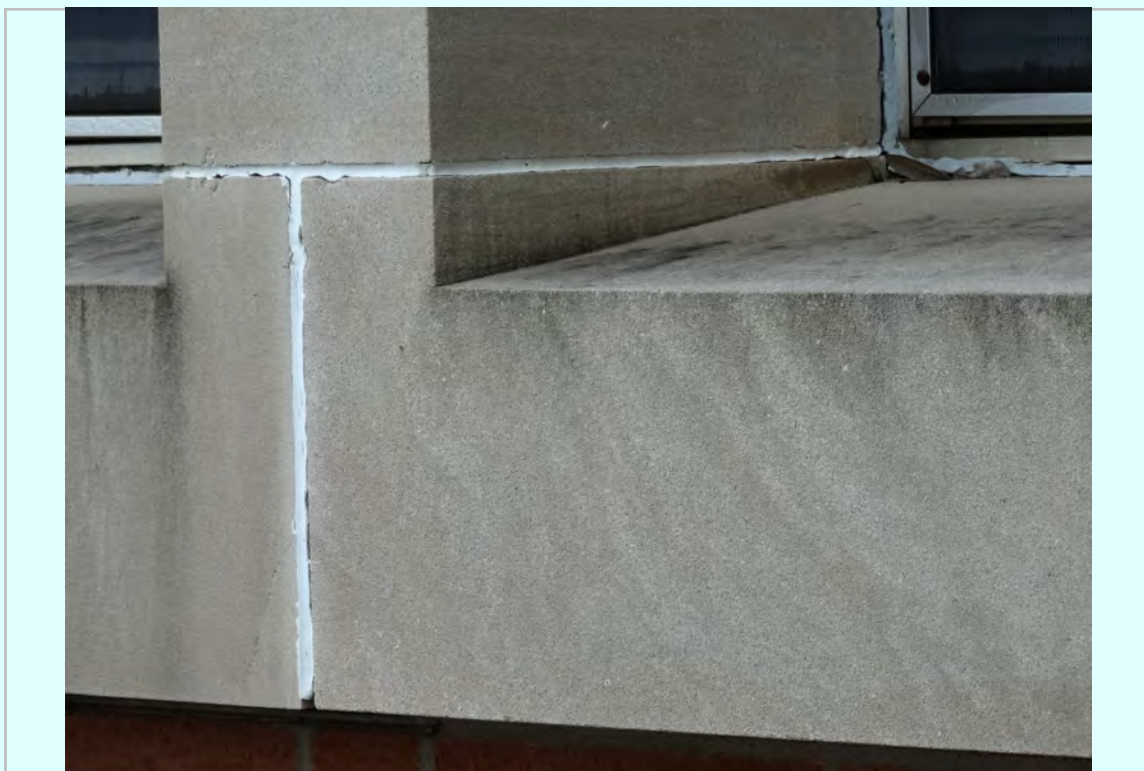
Photo: South Elevation, masonry junction failing, replacement sealant failing

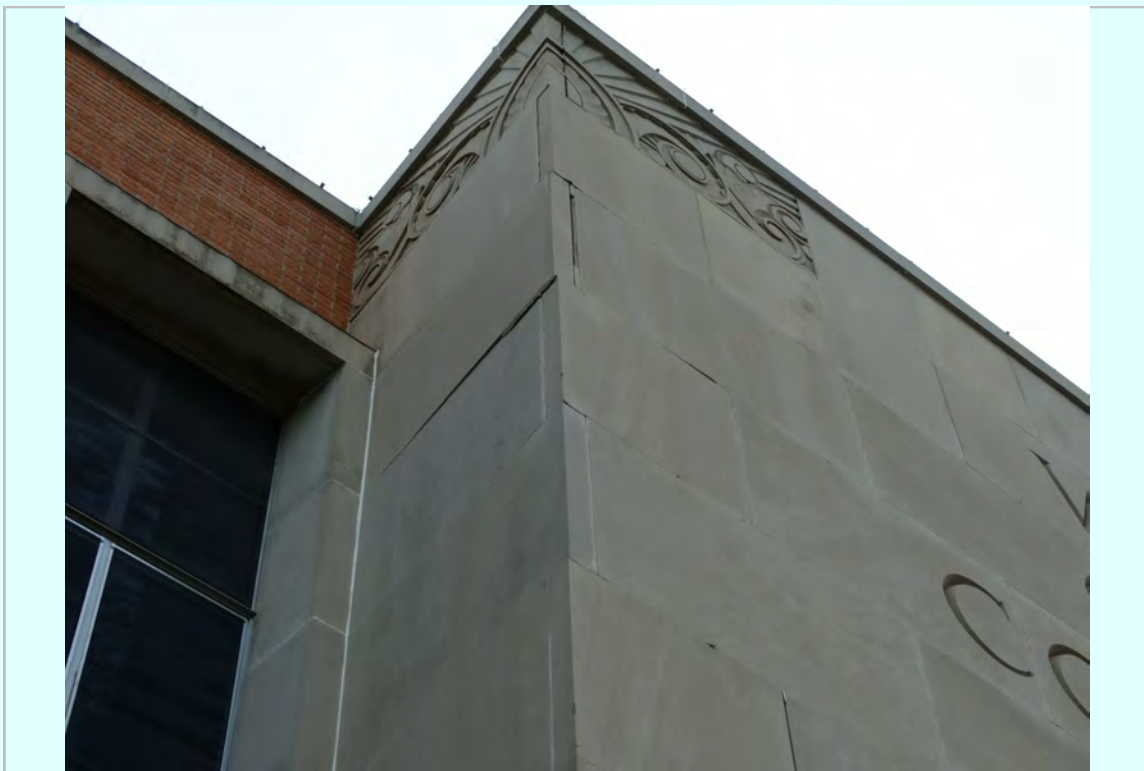
Photo: South Elevation, entry stone joints failing

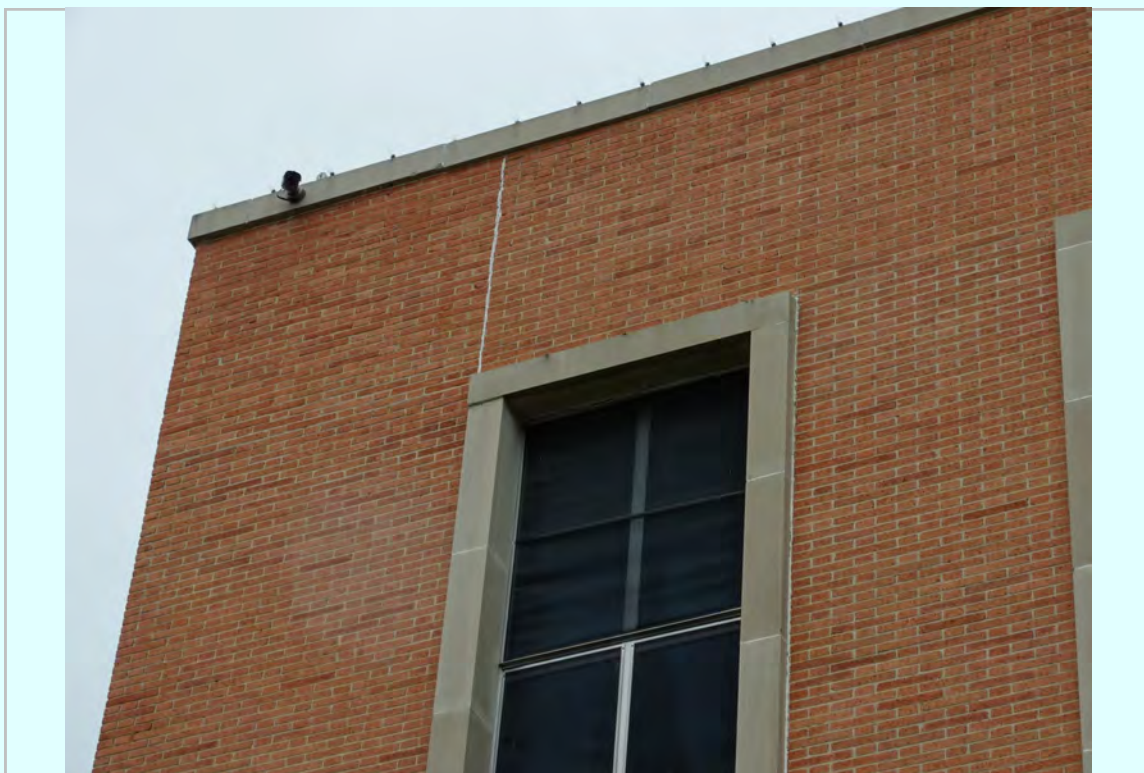
**Photo:** West Elevation, masonry control joint, discolored clay bricks

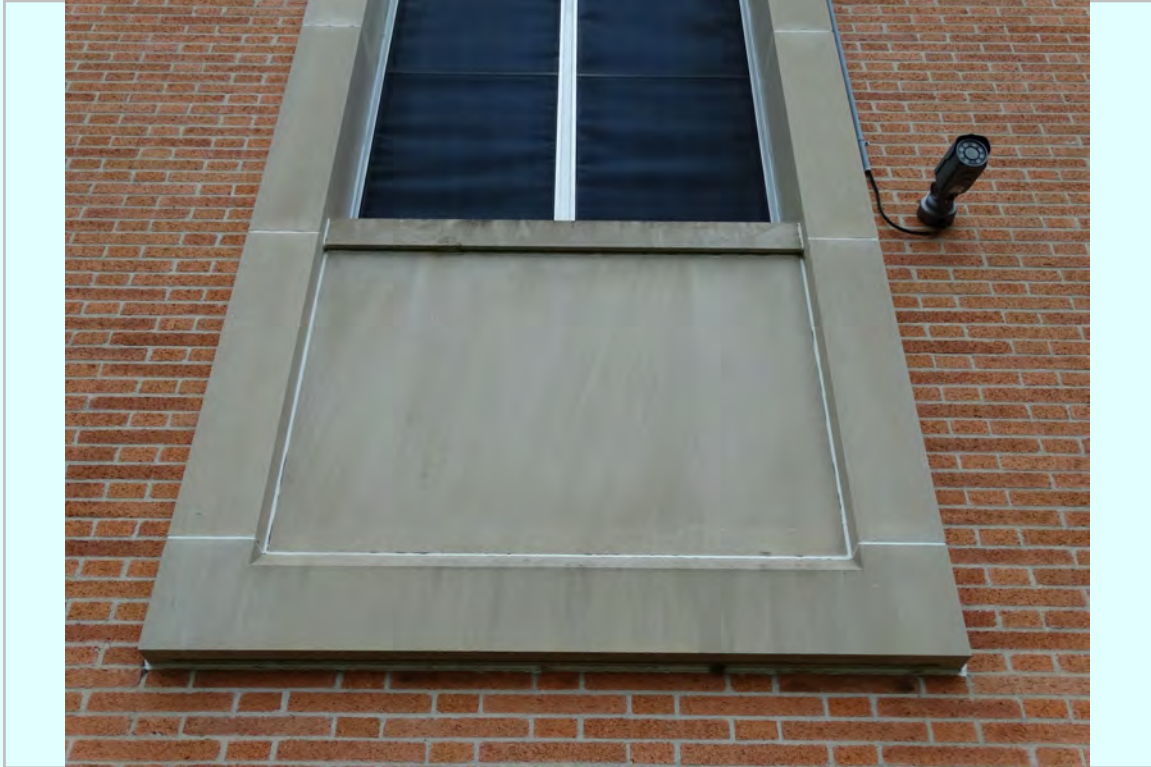
Photo: West Elevation, spandrel panel joint mortar replacement

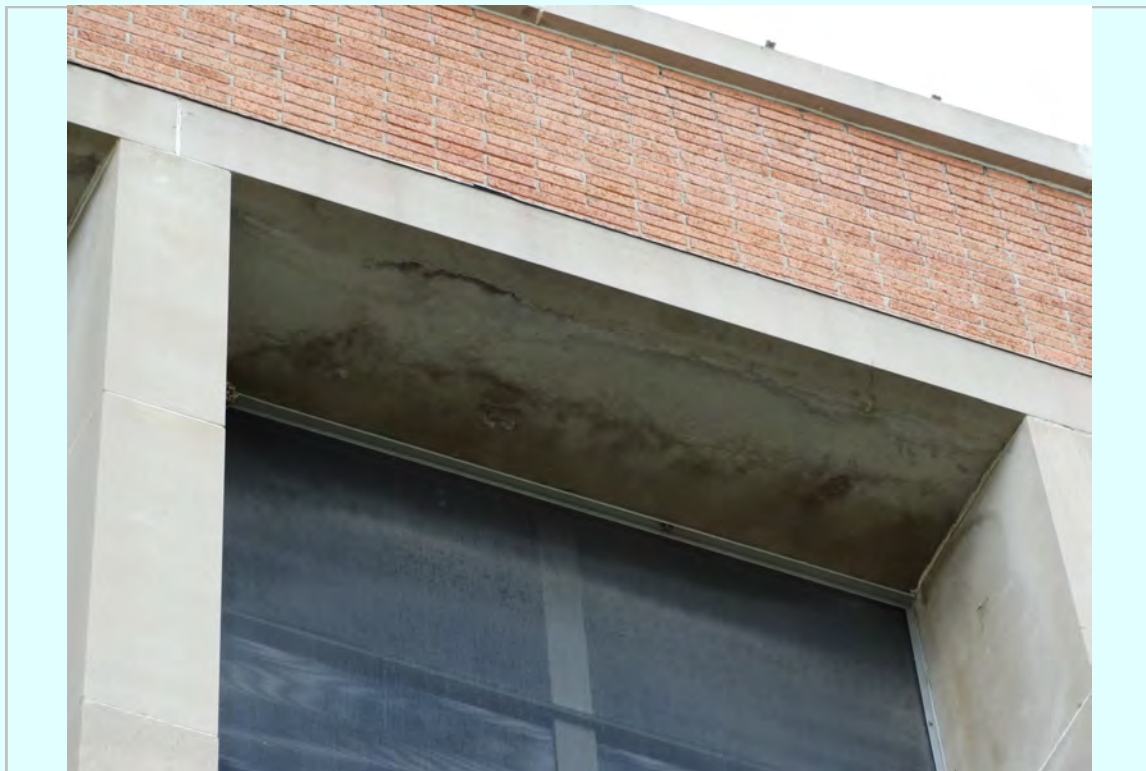
Photo: Typical screens and stone condition at curtain wall

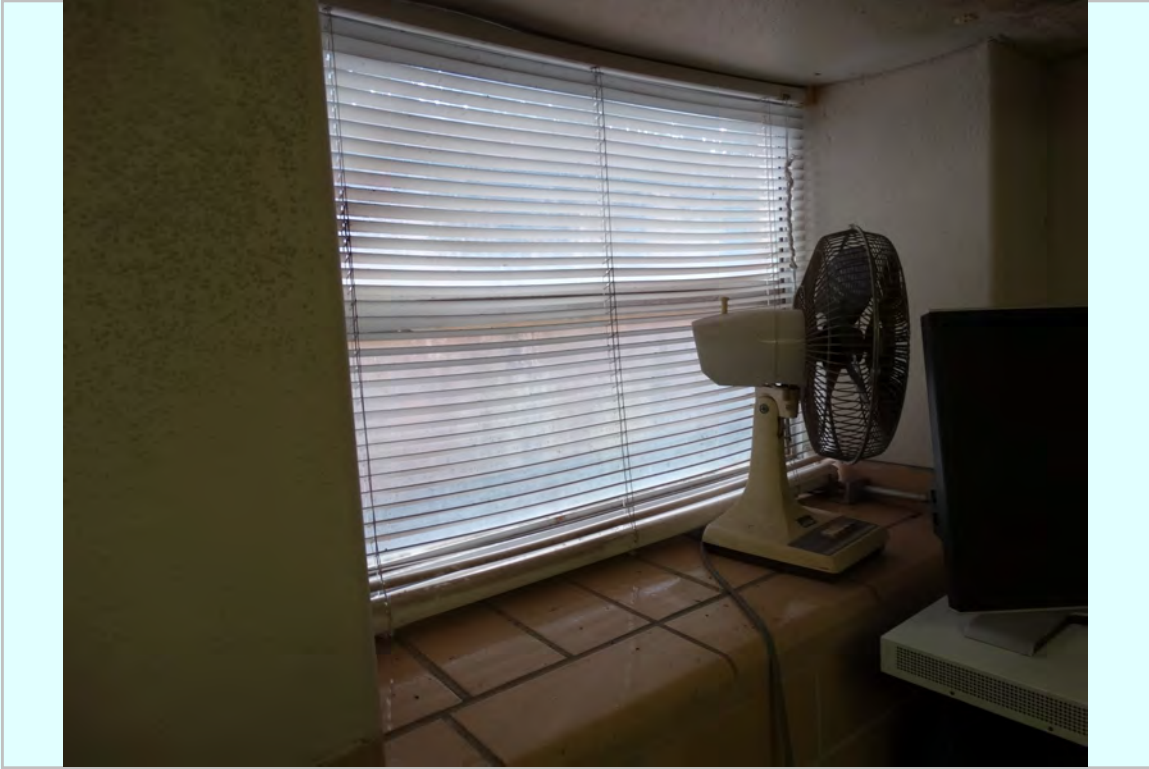
Photo: 1st floor window existing condition

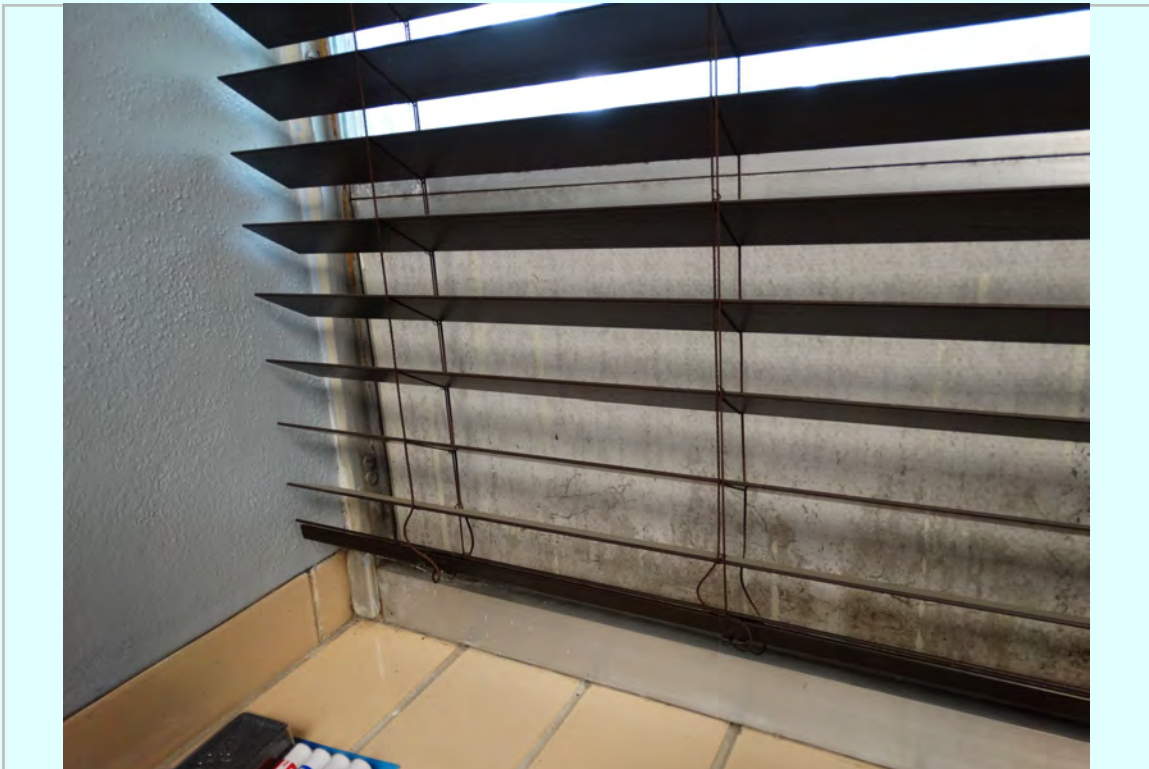
Photo: 1st floor window existing condition

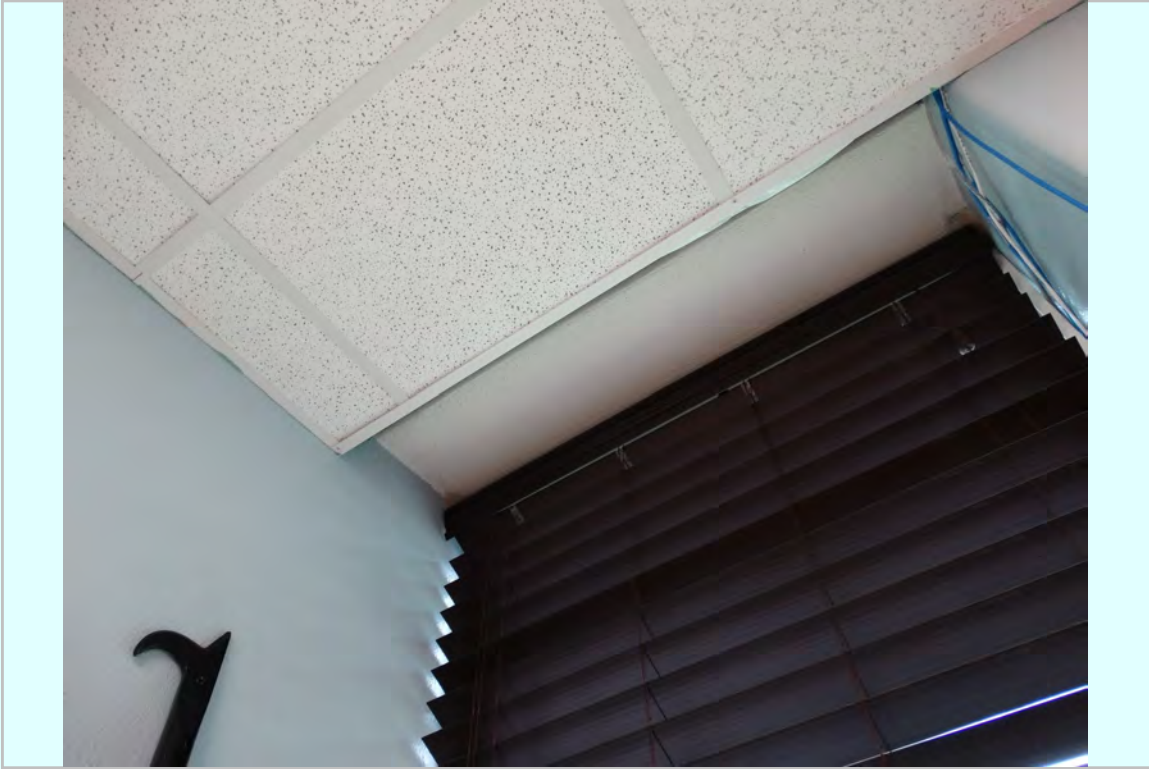
Photo: 1st floor window existing condition

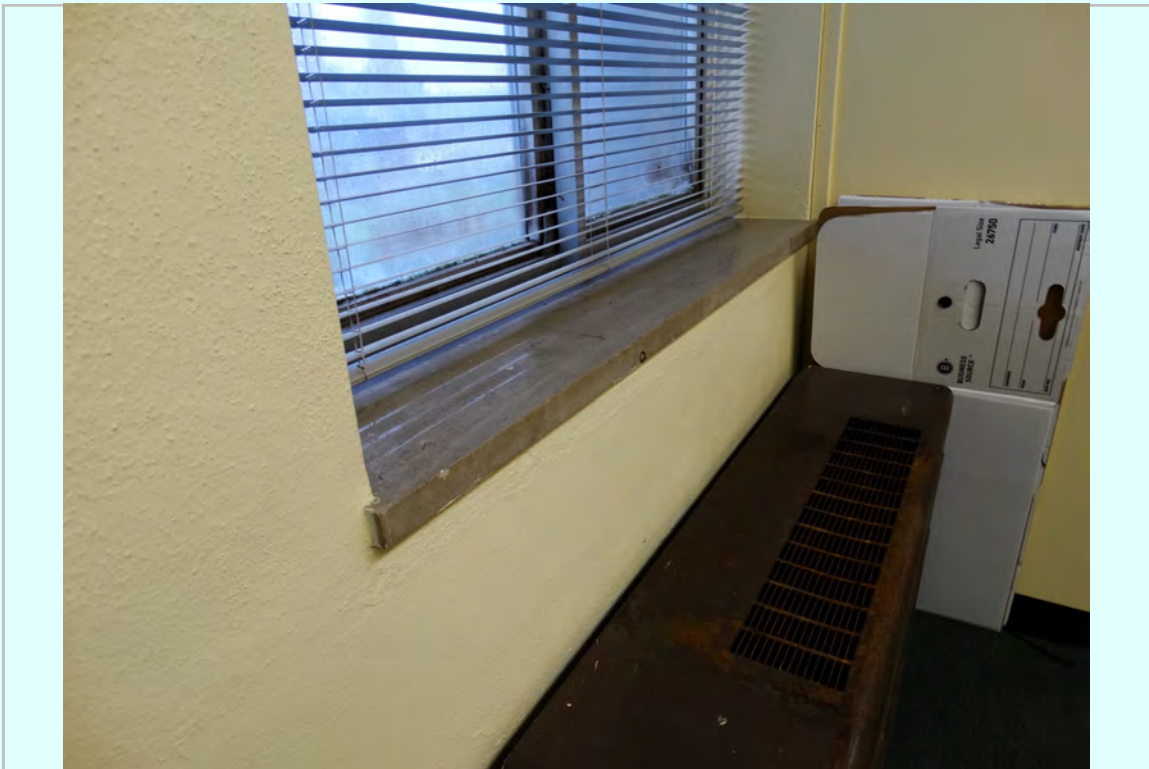
Photo: 2nd floor window existing condition, stone stool

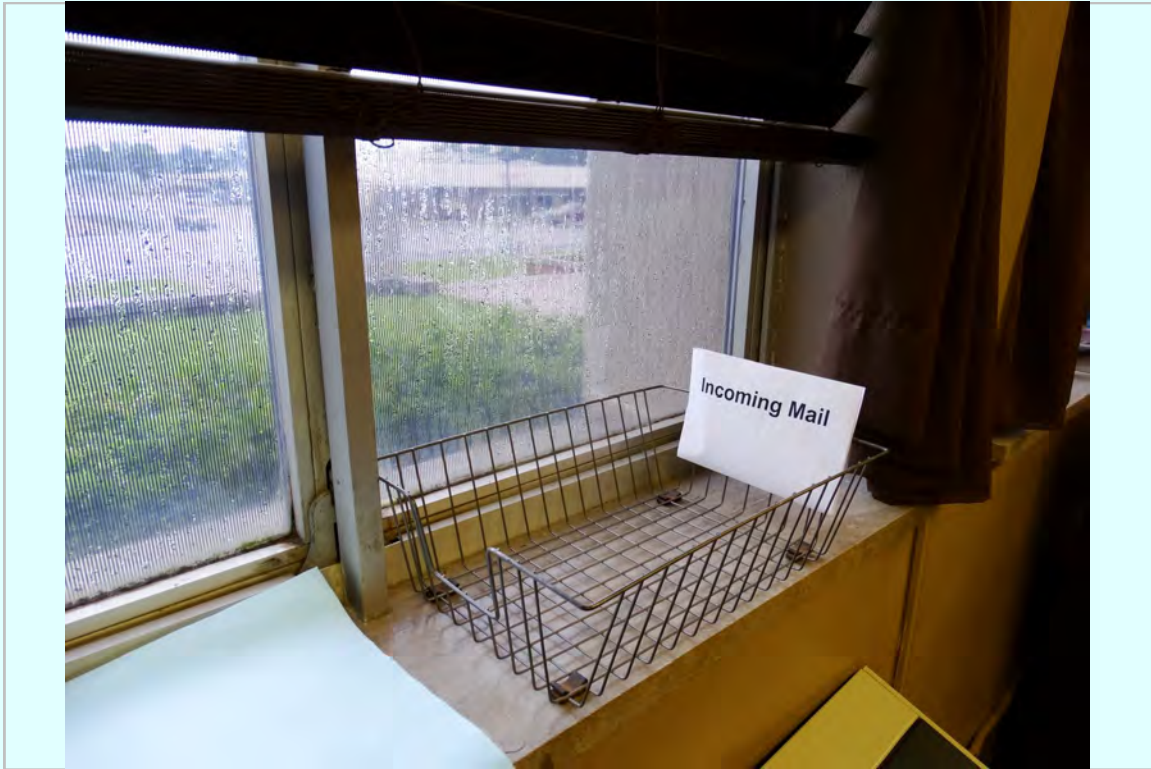
Photo: 2nd floor existing window stool

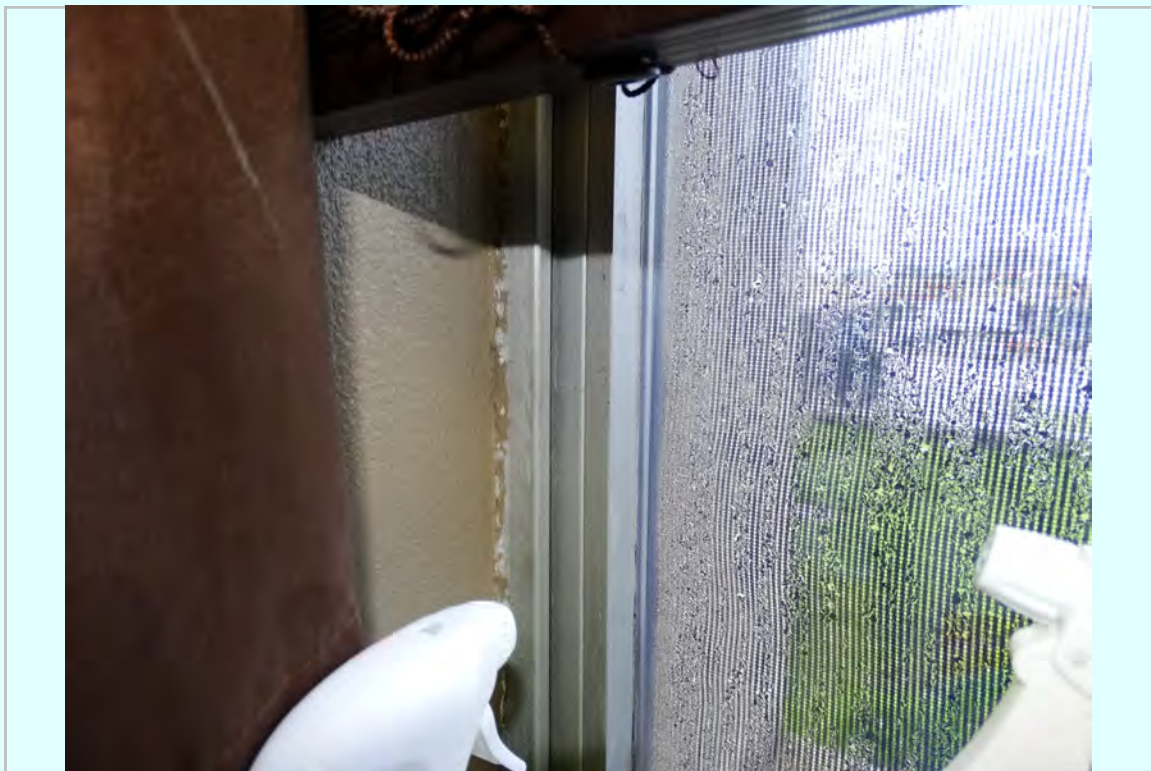
Photo: 2nd floor window existing condition at jamb

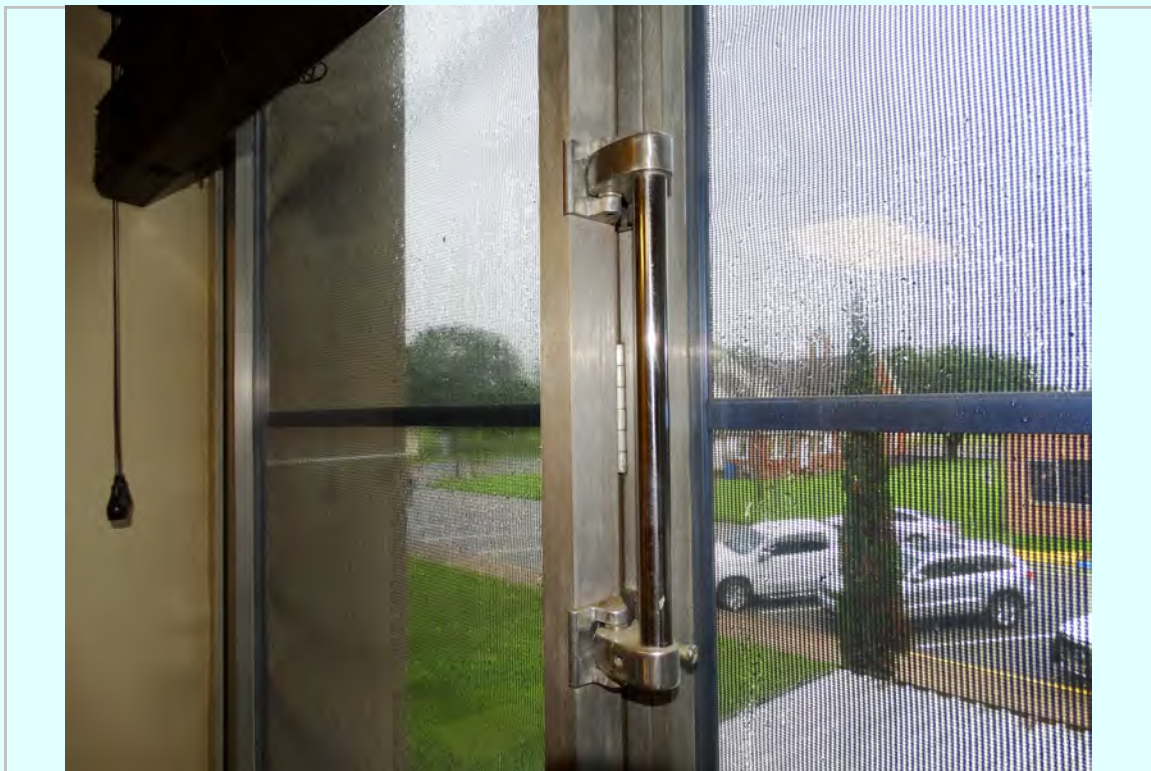
Photo: 2nd floor window existing condition at operator hardware

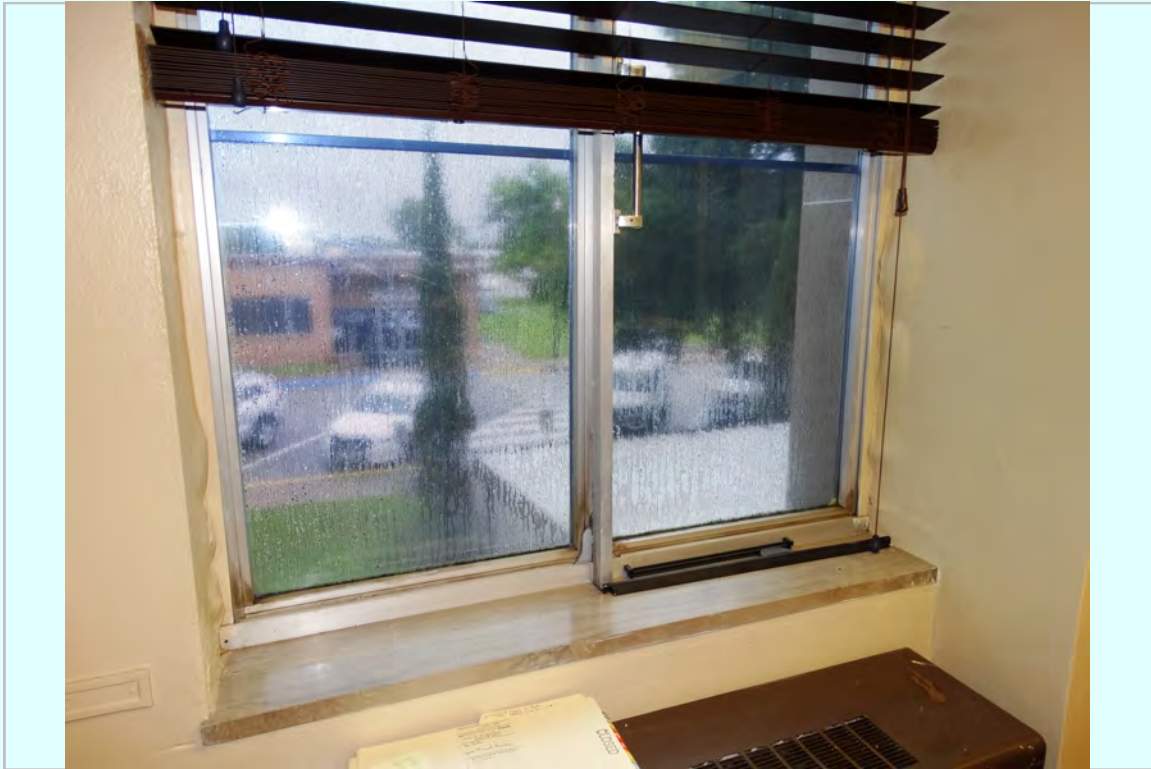
Photo: 2nd floor existing window condition

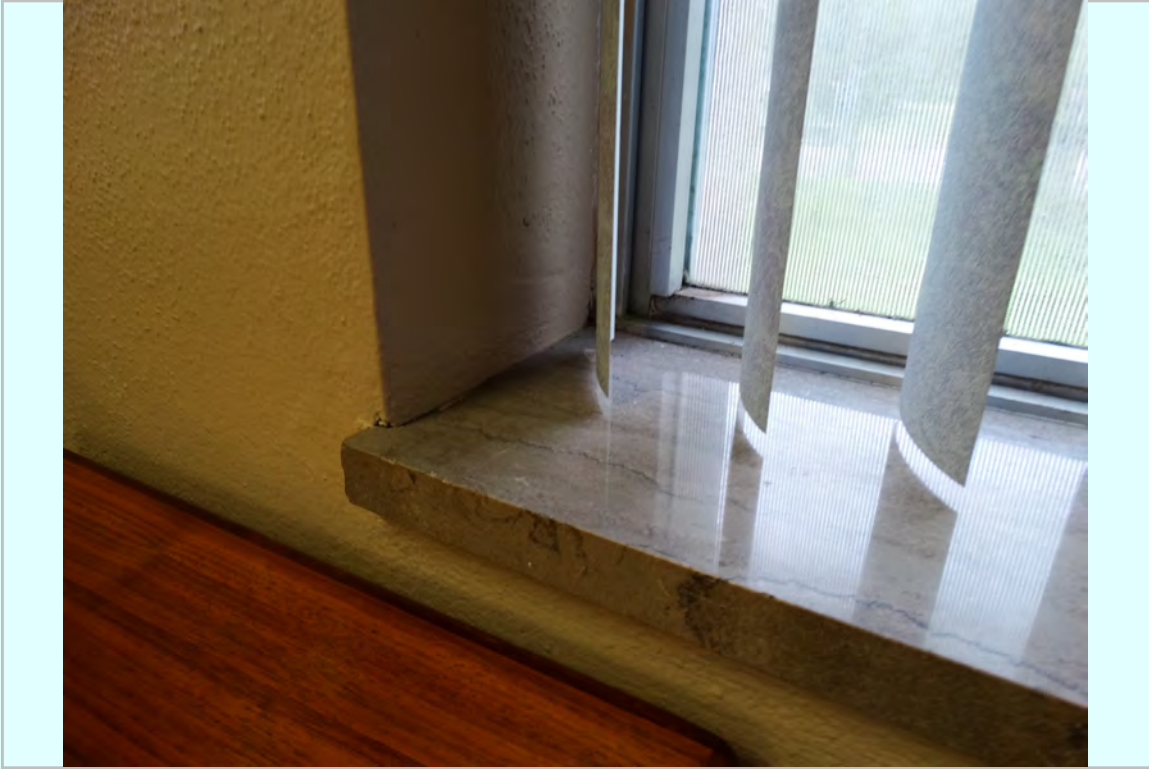
Photo: 2nd floor existing window condition

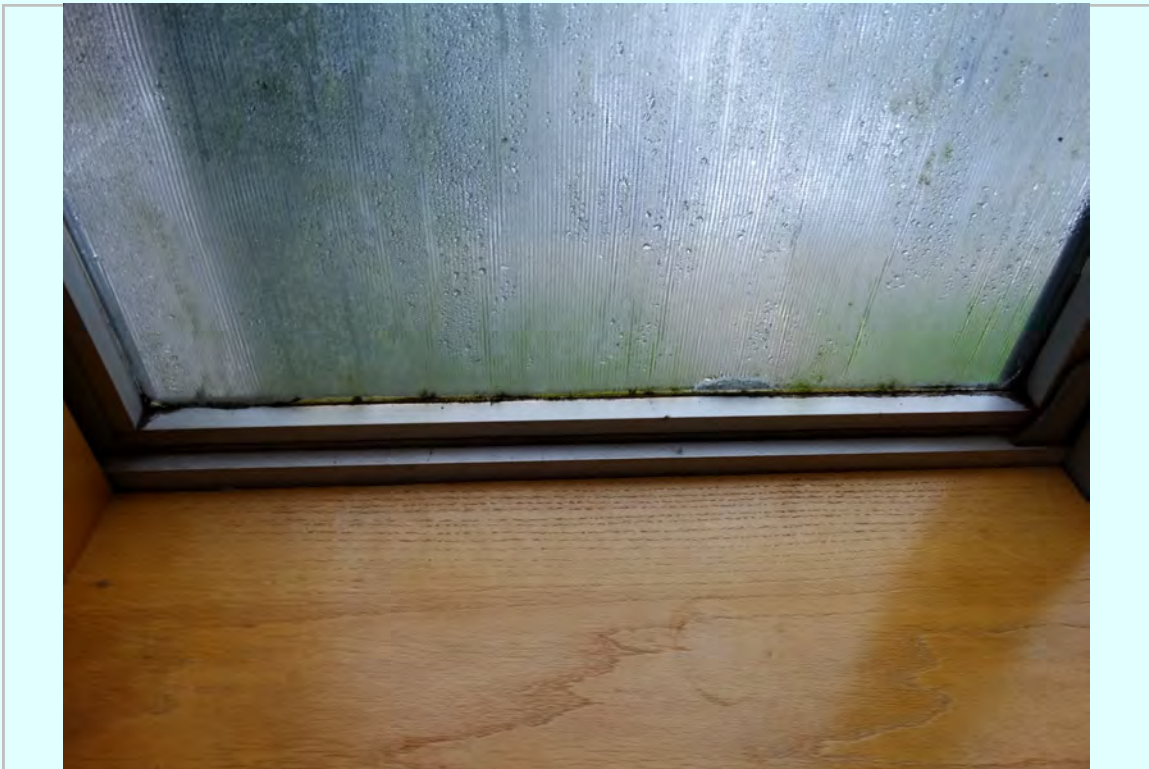
Photo: 3rd floor existing window at stool

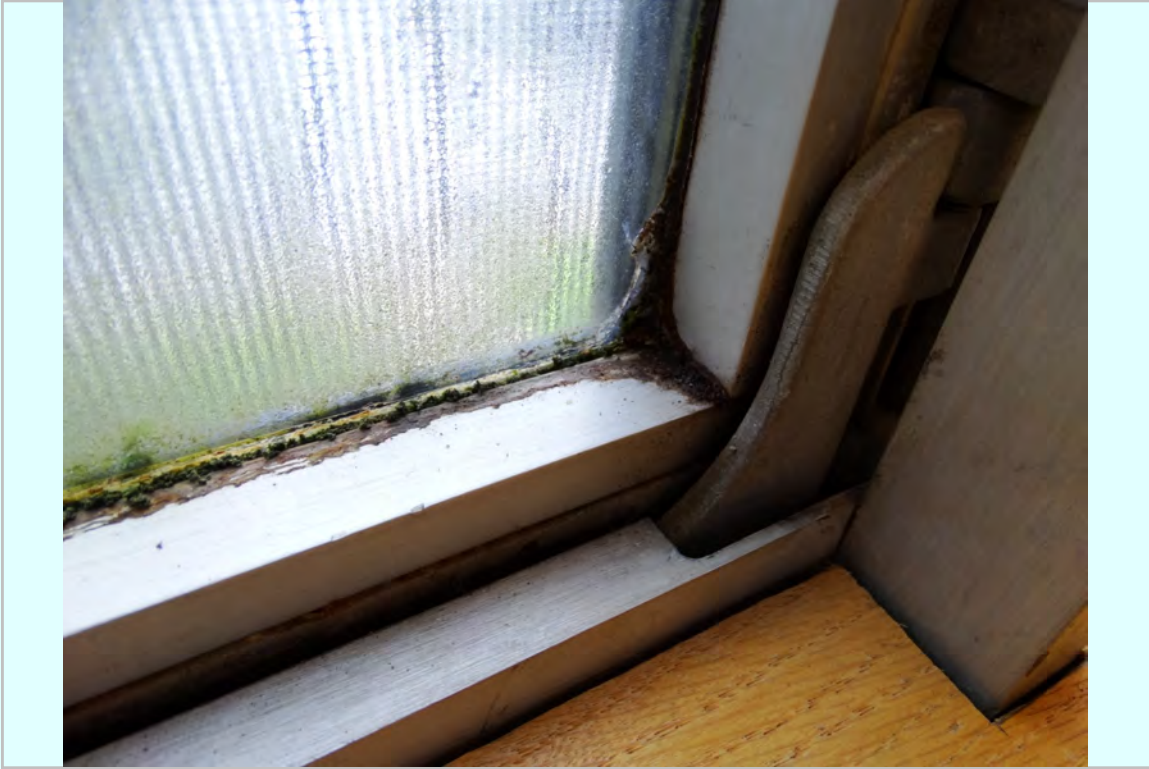
Photo: 3rd floor existing window condition

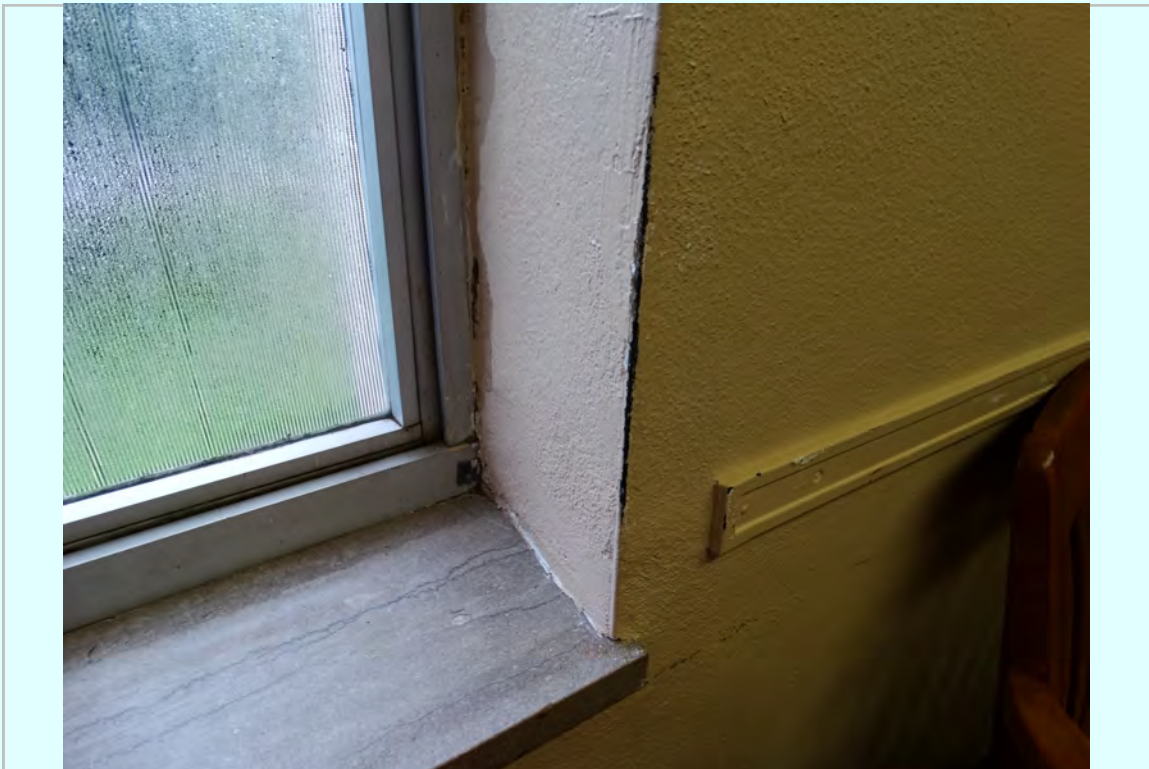
Photo: 3rd floor existing window at stool

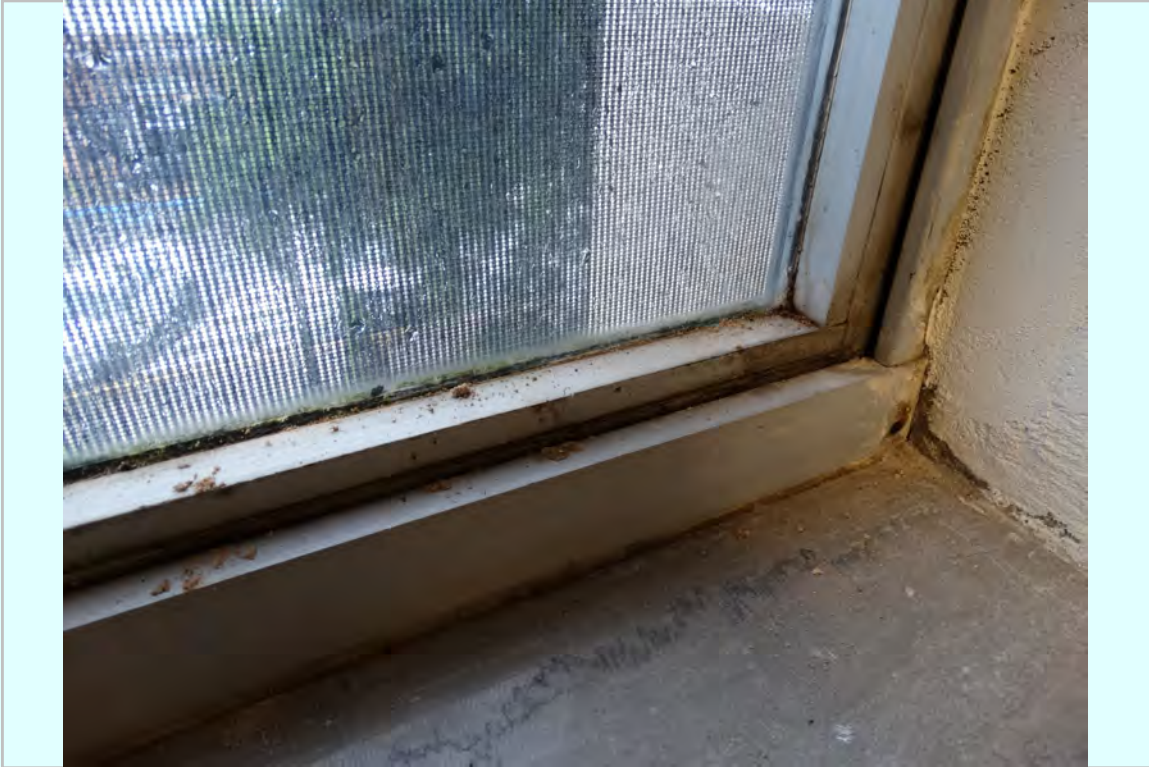
Photo: 3rd floor existing window condition

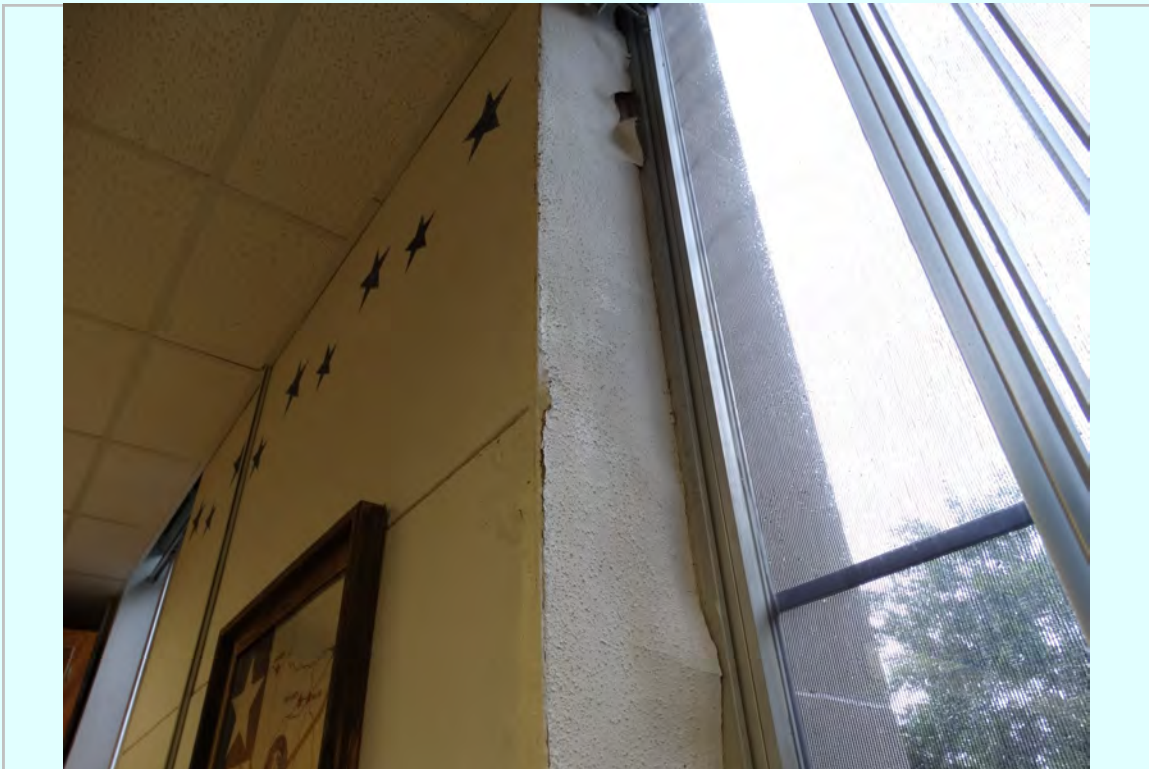
Photo: 3rd floor existing window moisture infiltration and damage
