# EXISTING CONDITION ASSESSMENT

**WALLER COUNTY COURTHOUSE**  
Hempstead, Texas

**836 Austin Street**  
Hempstead, Texas 77445

October 27, 2021

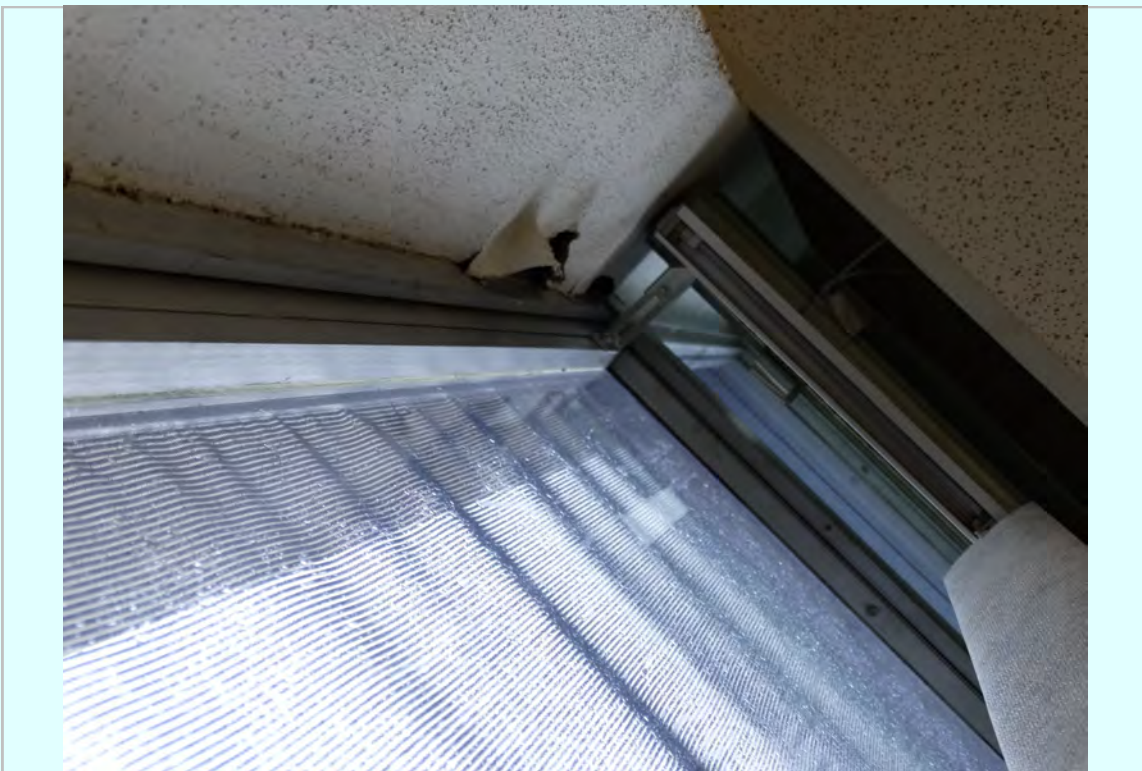
Photo: 3rd floor existing window pocket at ceiling

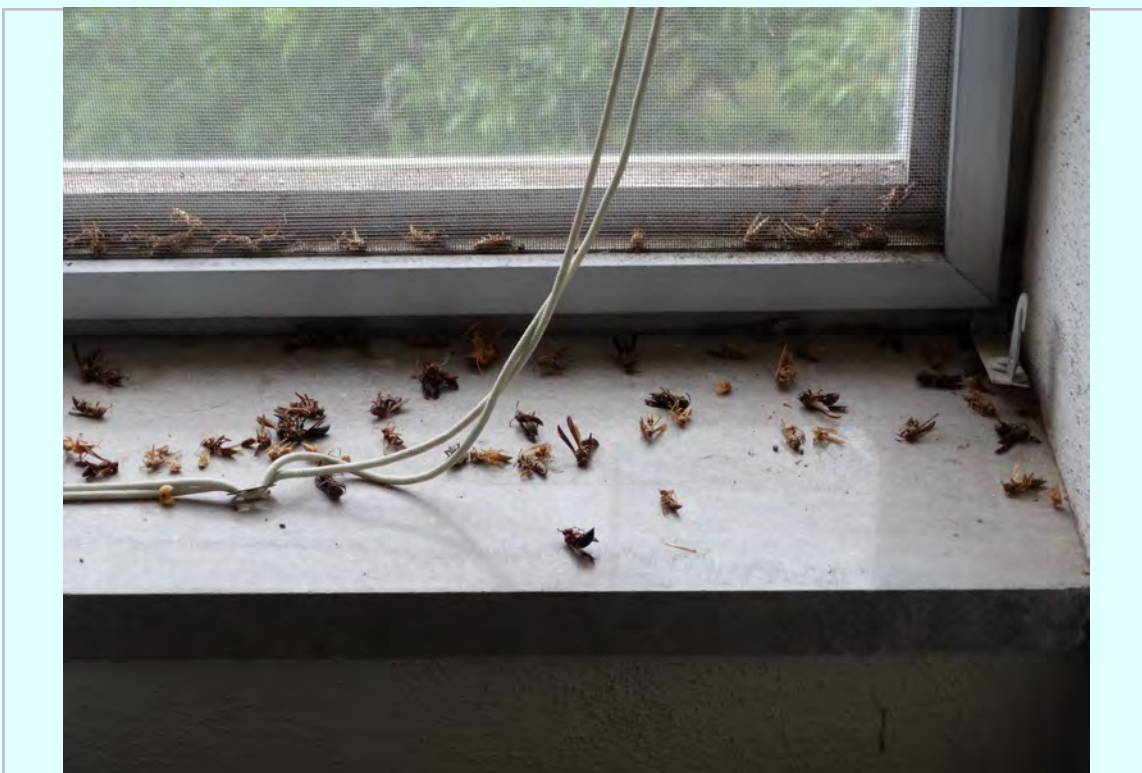
Photo: 4th floor existing window failure and insect infestation

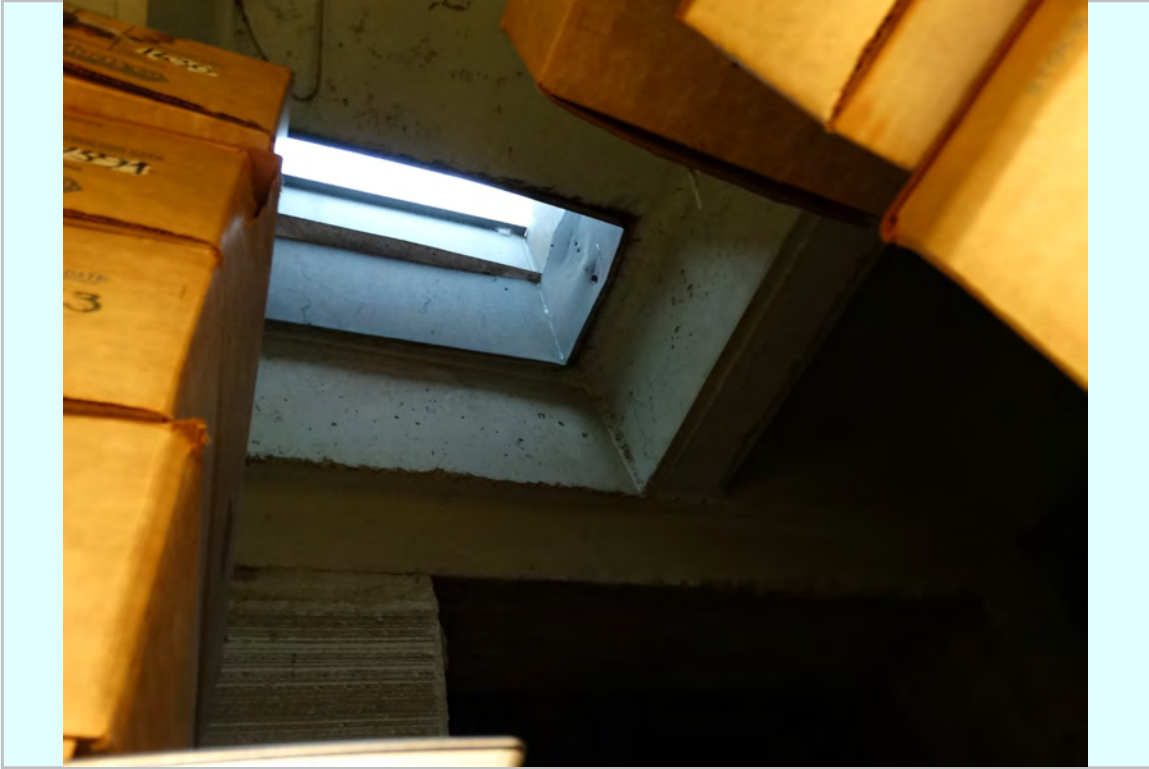
Photo: 4th floor existing skylight

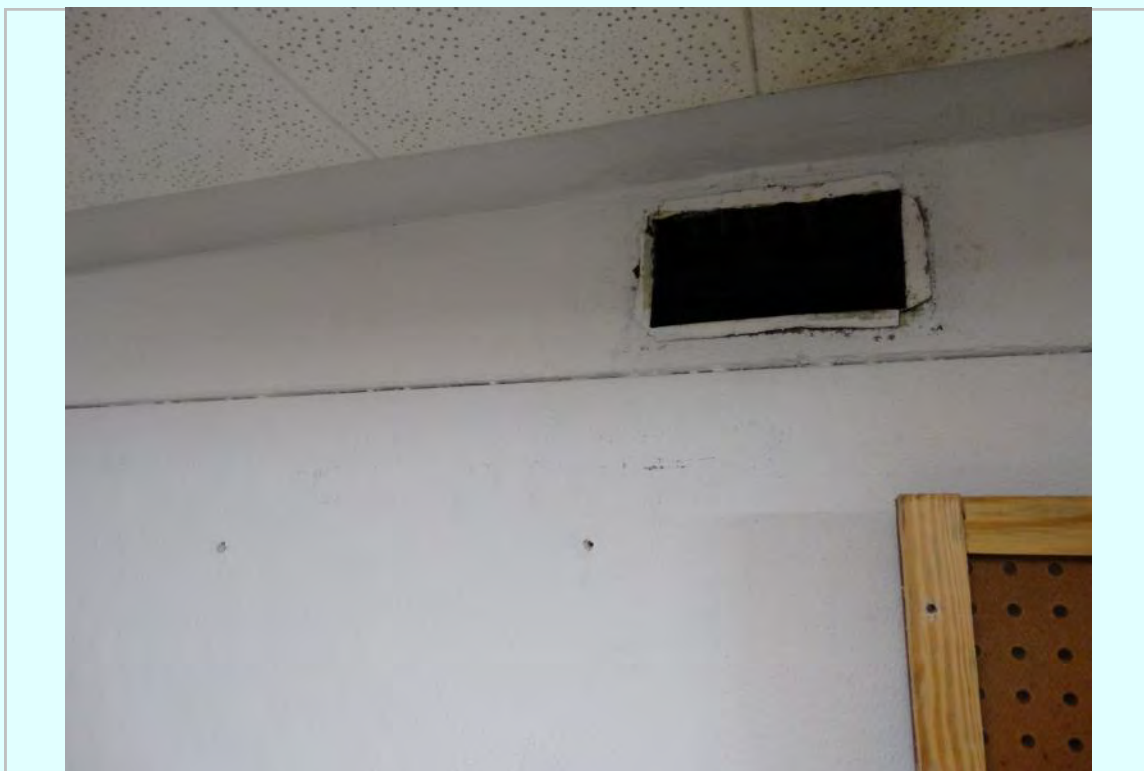
Photo: First floor office HVAC improper supply vent, missing grille

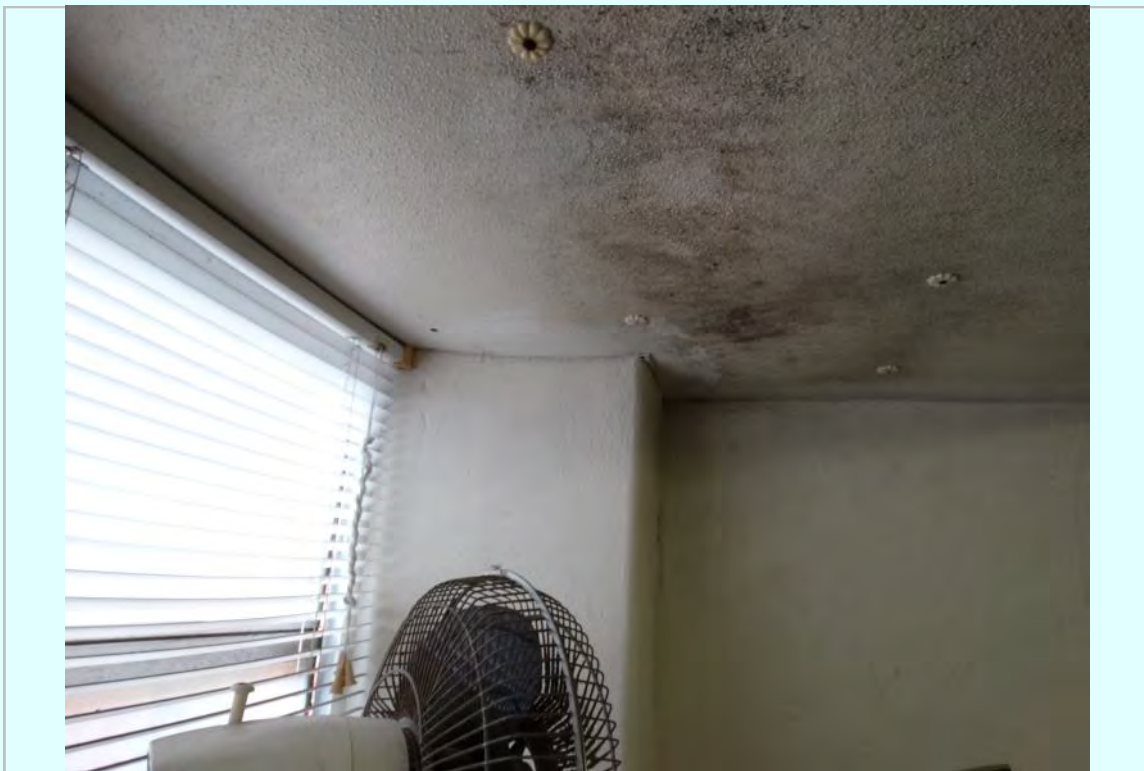
Photo: First floor ceiling moisture damage and biological growth

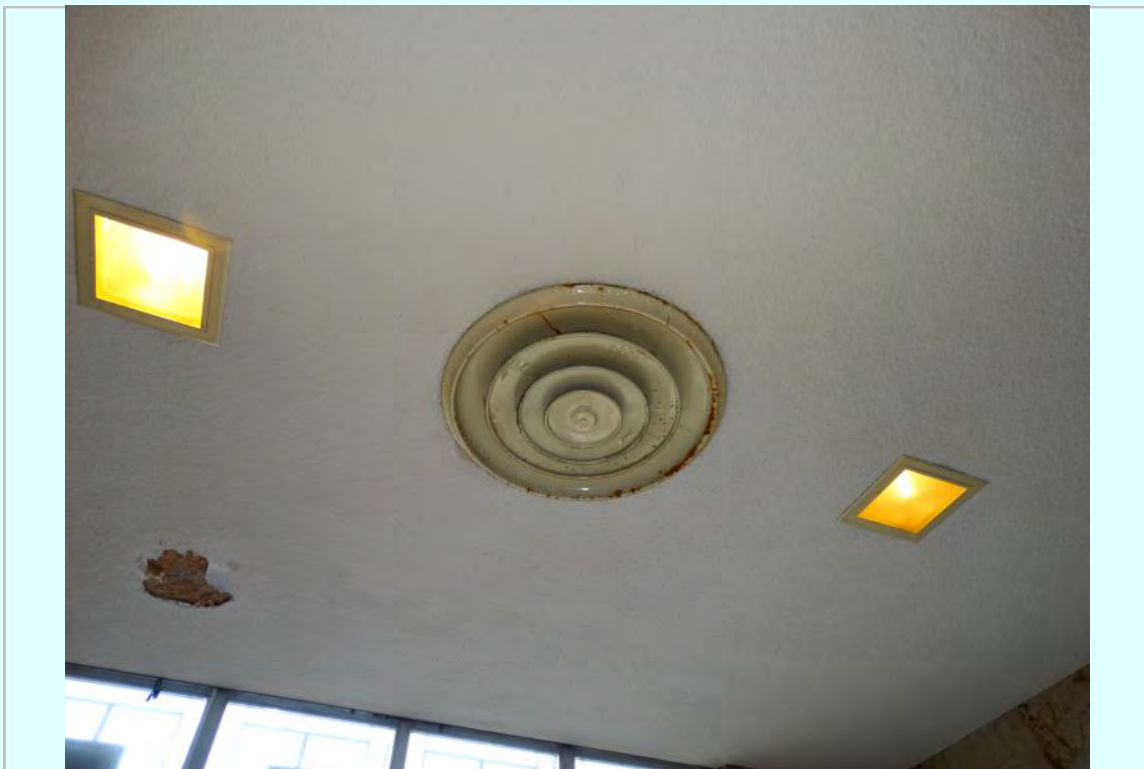
Photo: Mezzanine lobby ceiling, damage and supply vent rusting

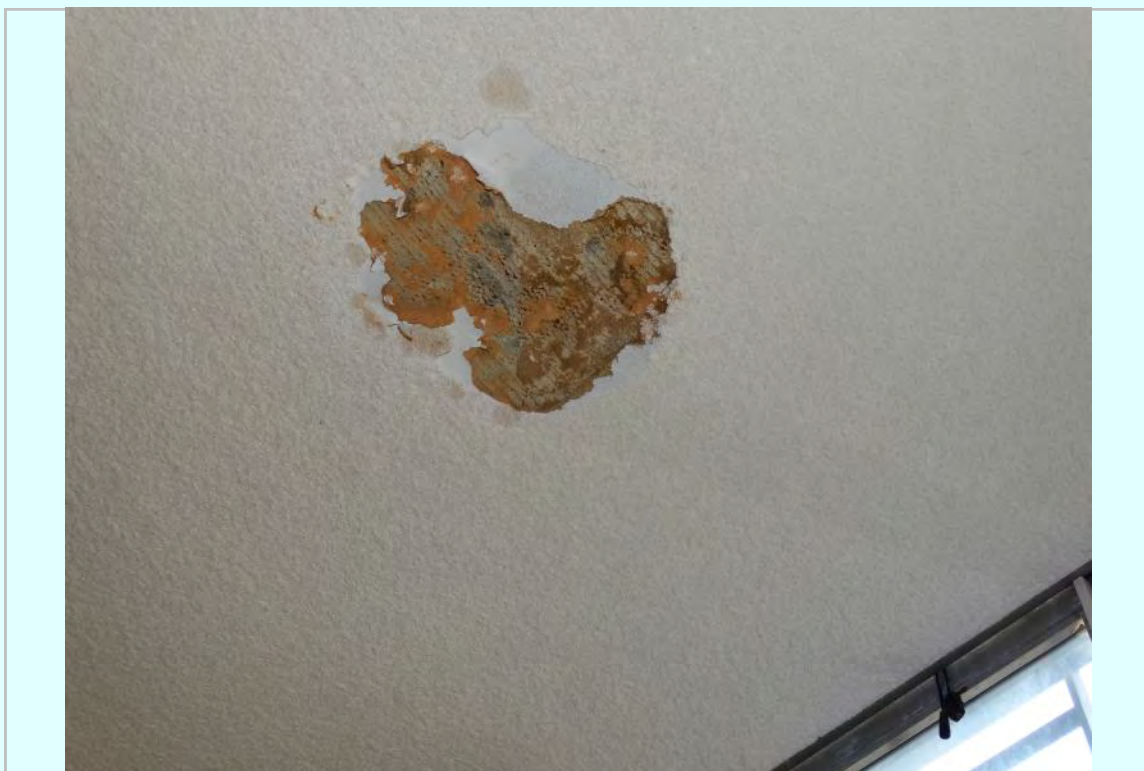
Photo: Mezzanine lobby ceiling damage

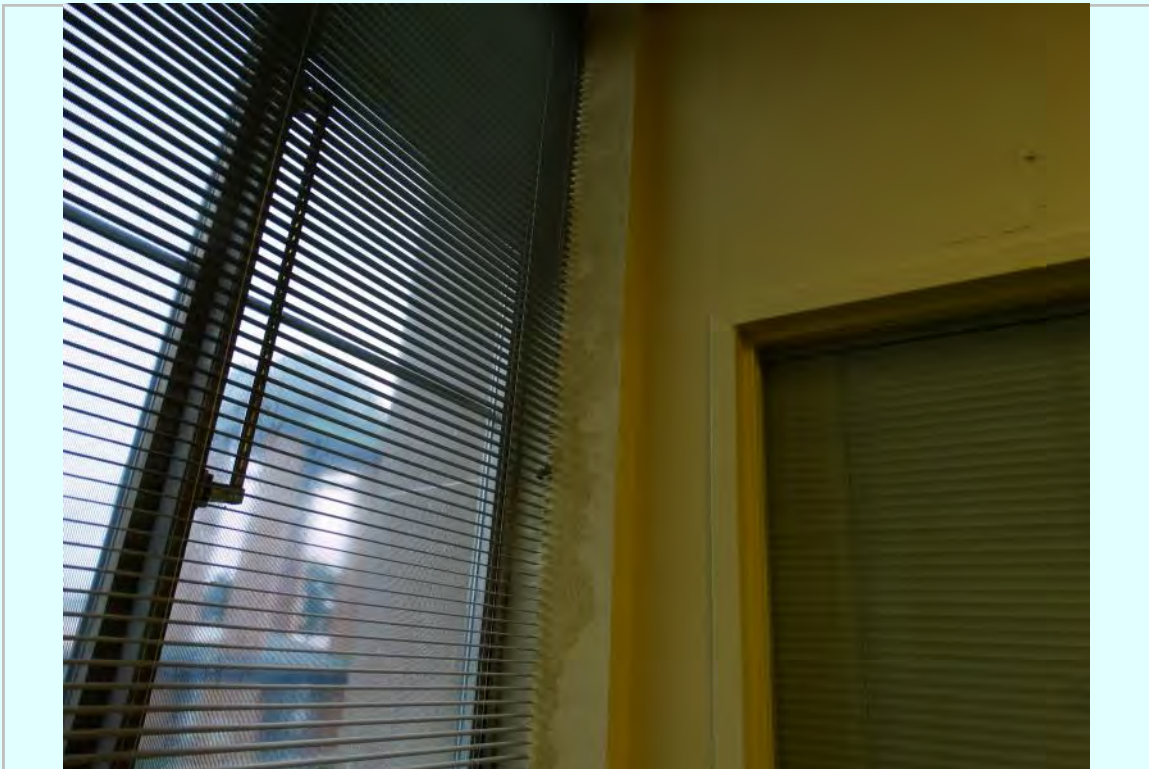
Photo: Mezzanine office, damage at window jamb

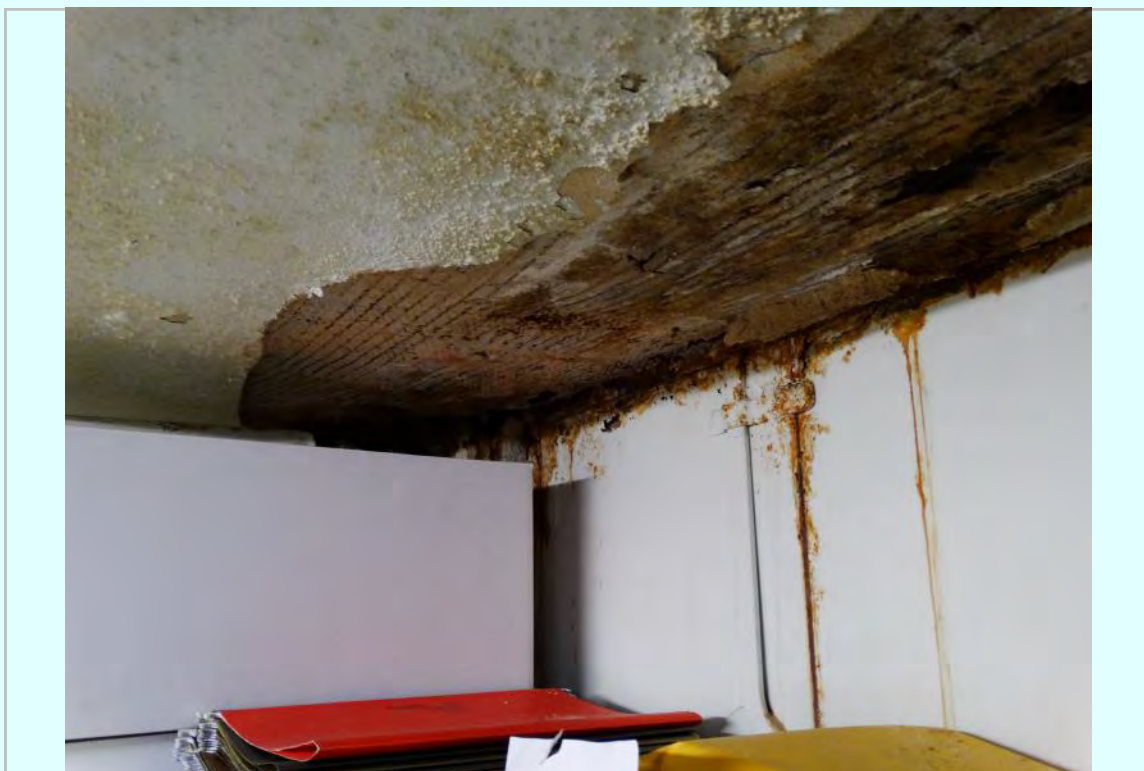
Photo: Extreme moisture damage at ceiling in storage space below County Auditor

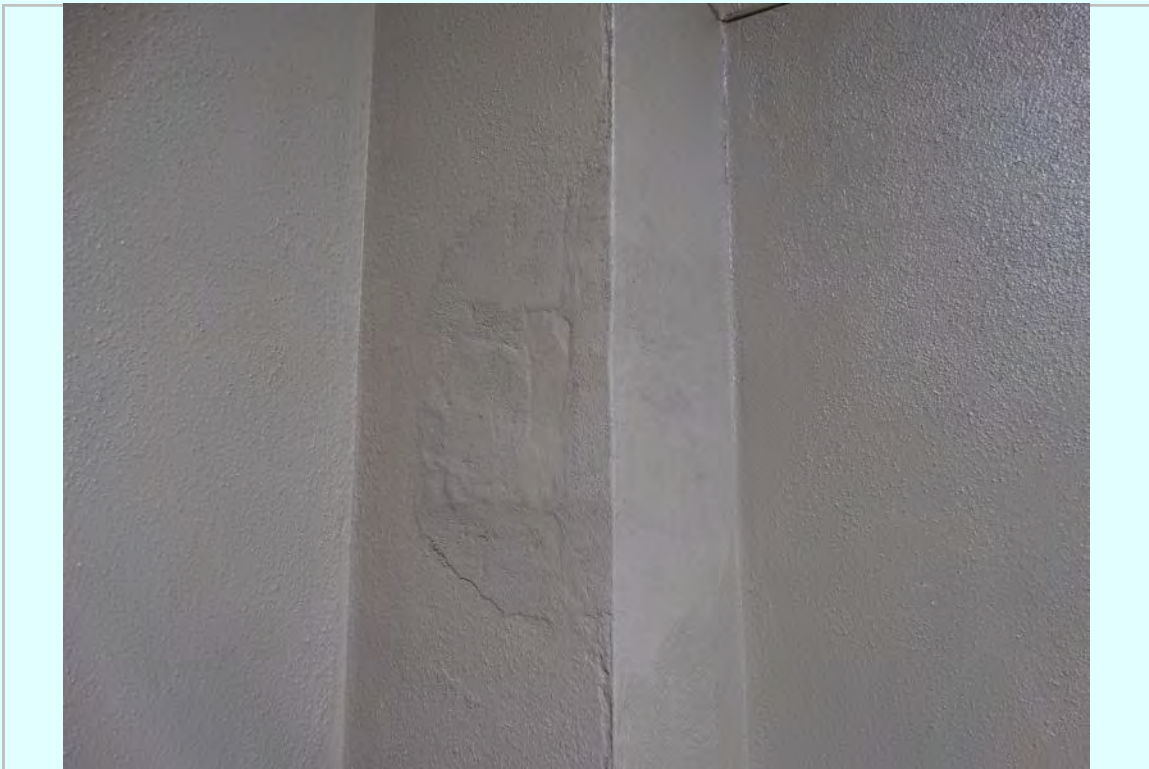
Photo: County Clerk office wall damage and poor repairs

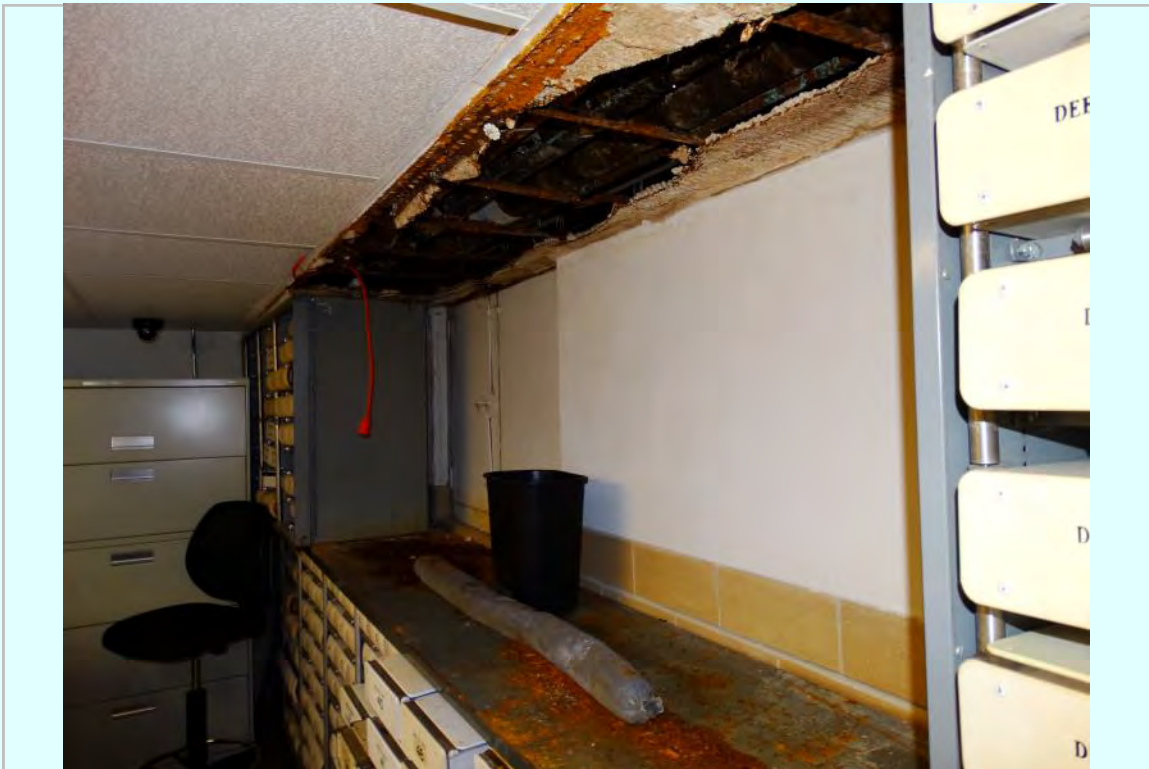
Photo: Storage space below County Clerk , ceiling damage, from moisture

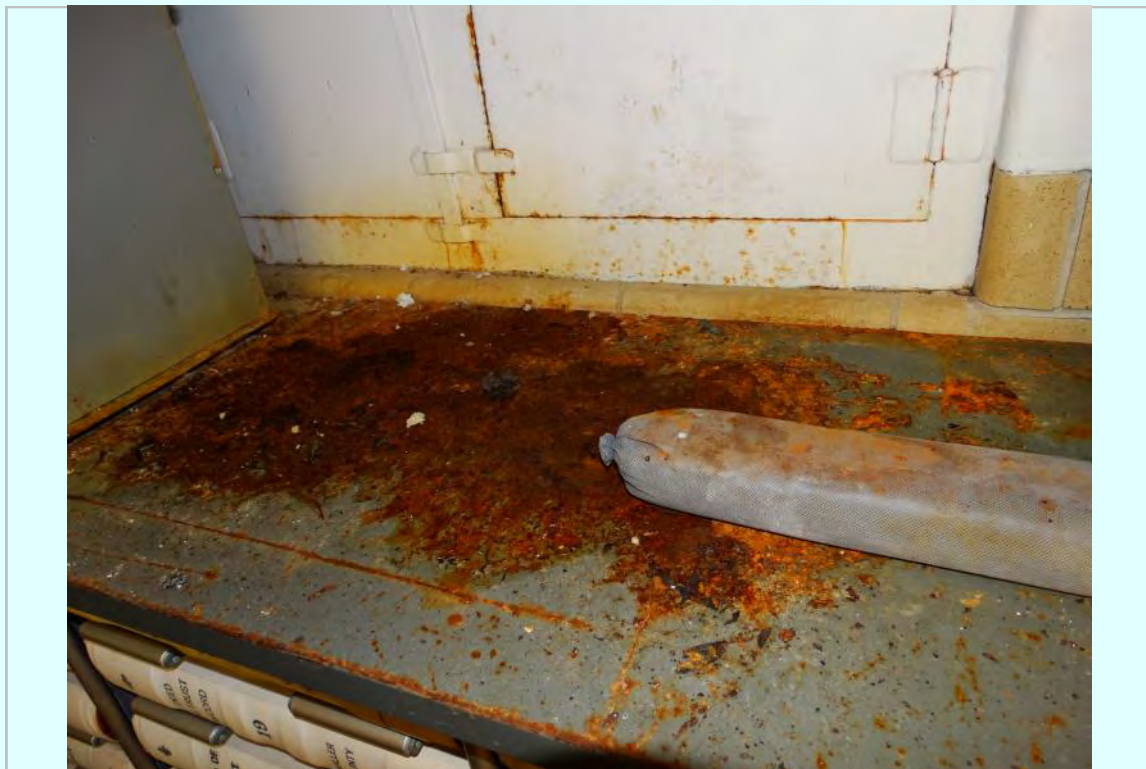
Photo: Storage space below County Clerk, rust from moisture damage

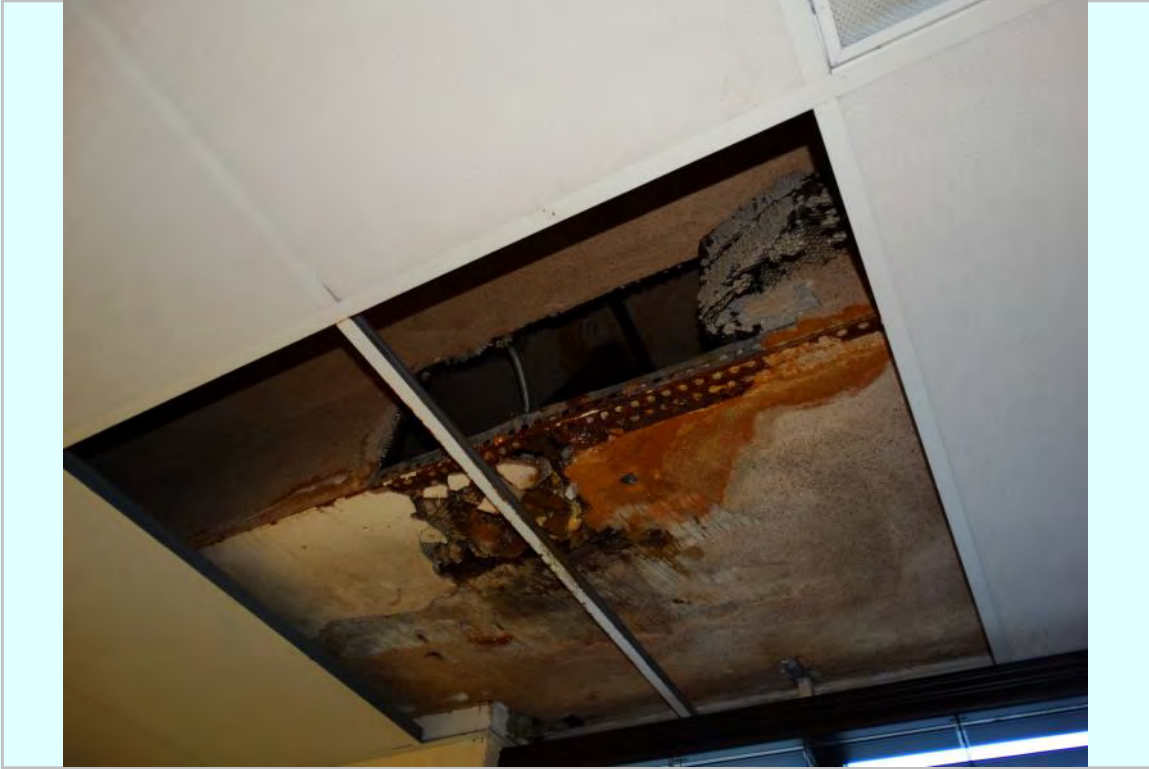
Photo: Storage space above County Clerk , moisture damage from HVAC

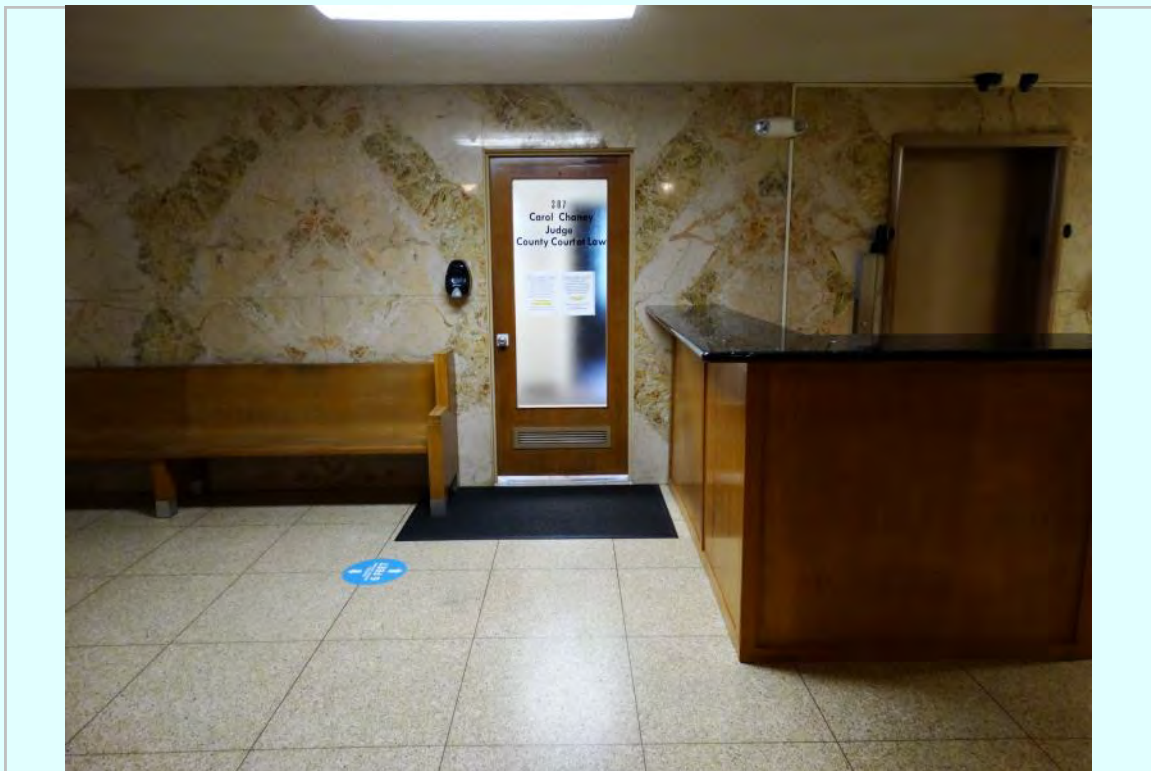
Photo: Third floor corridor

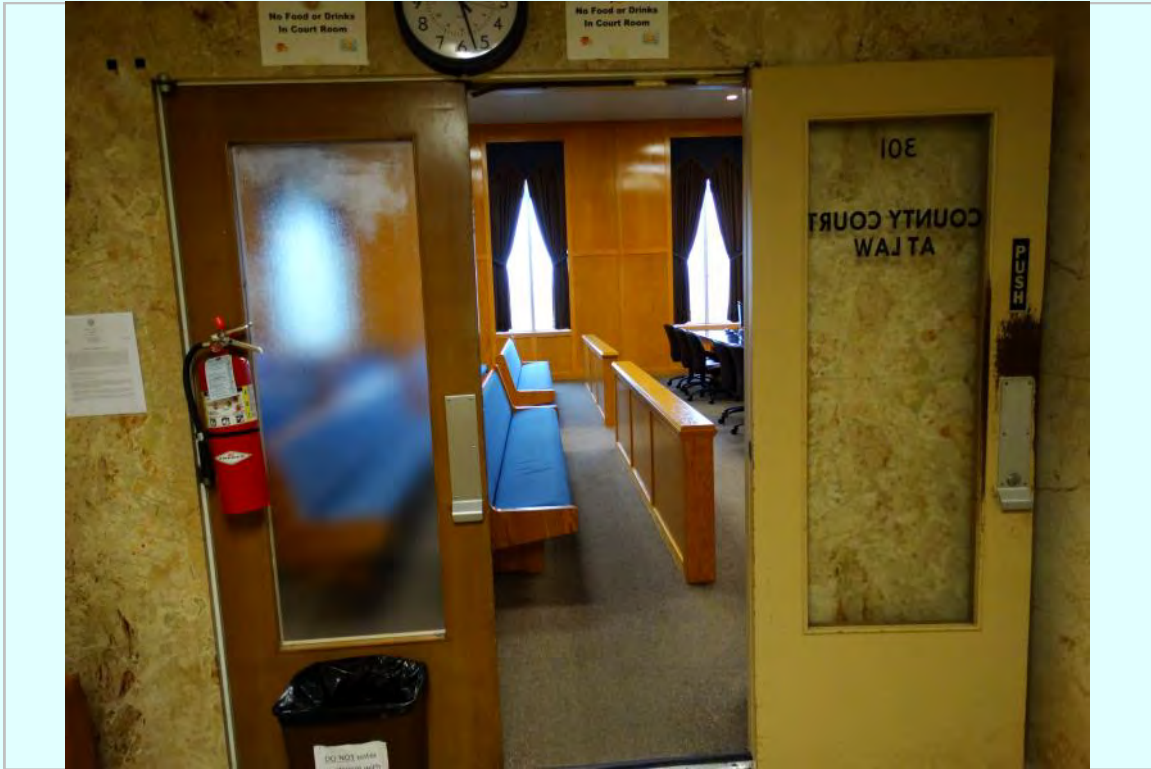
Photo: Third floor corridor

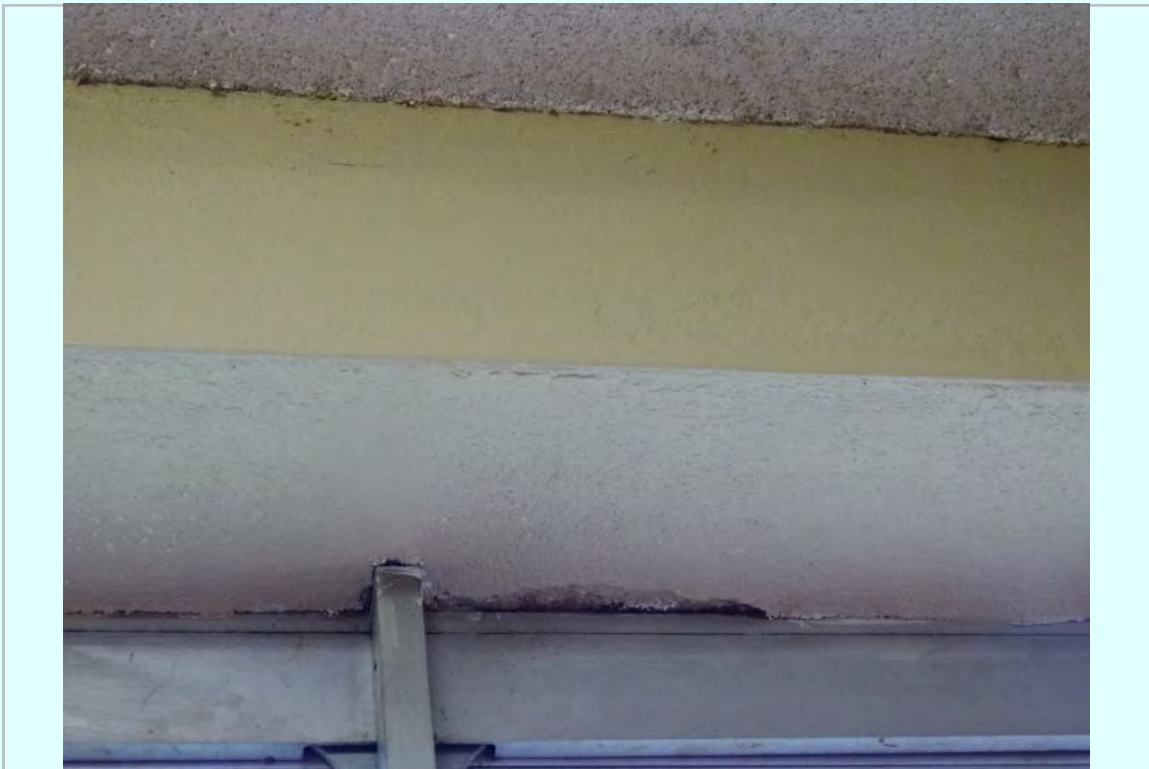
Photo: County Courtroom jury deliberation room

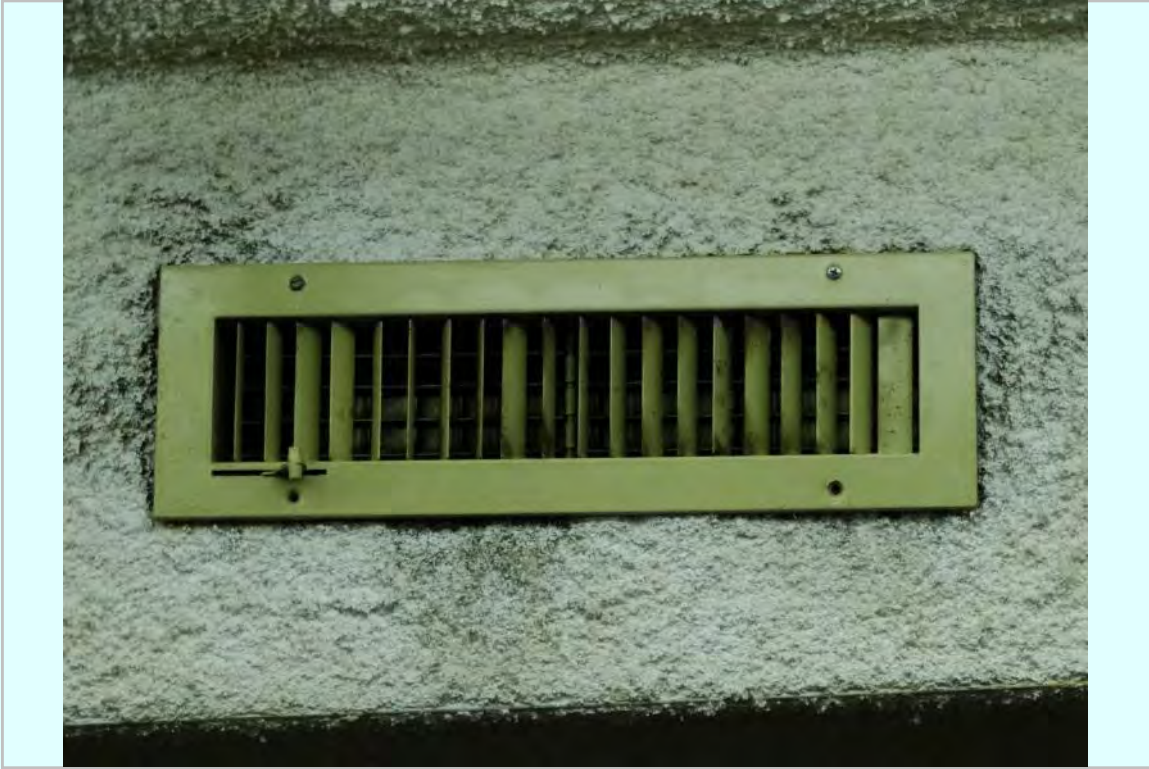
Photo: County Courtroom jury deliberation room damage at windows and soffit

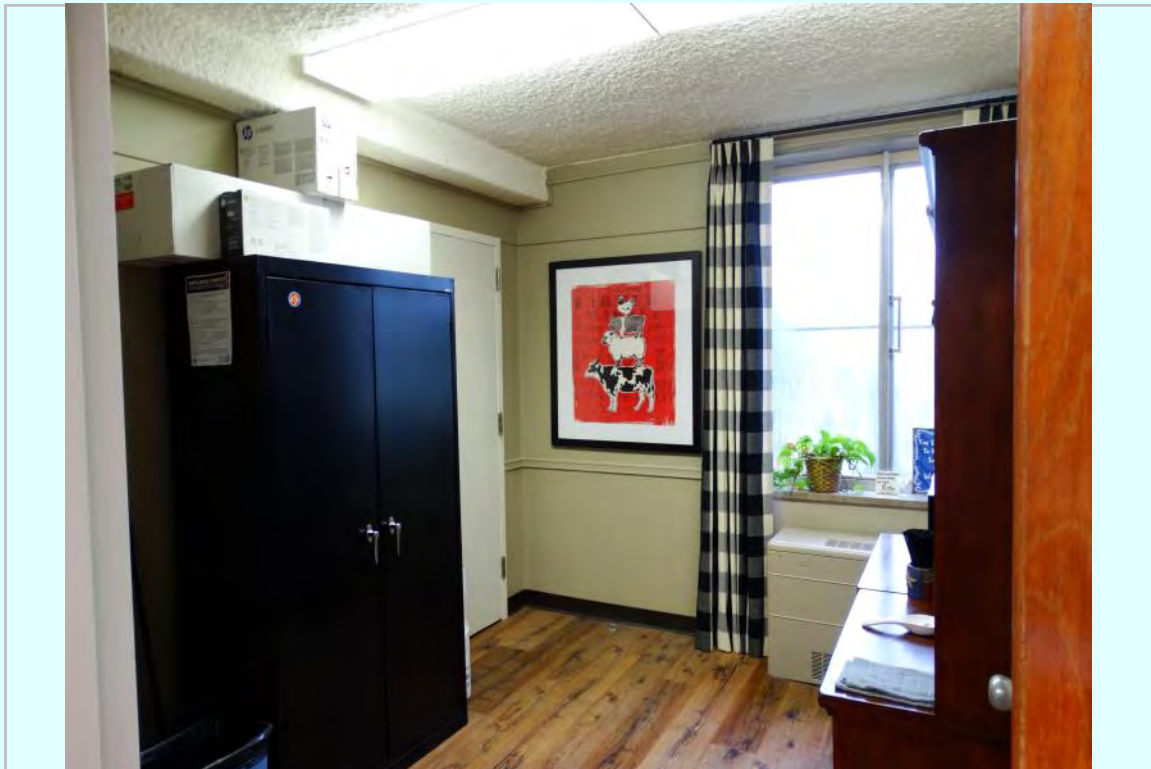
Photo: Third floor office space

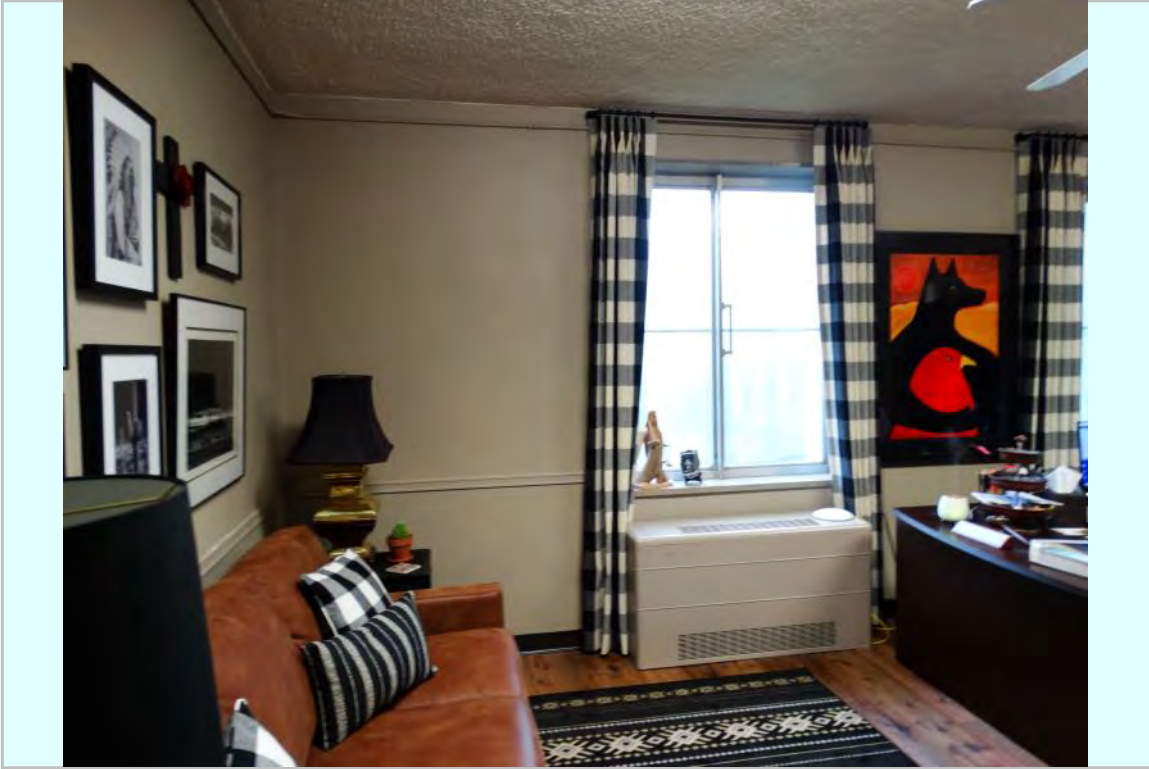
Photo: Third floor recently renovated office space

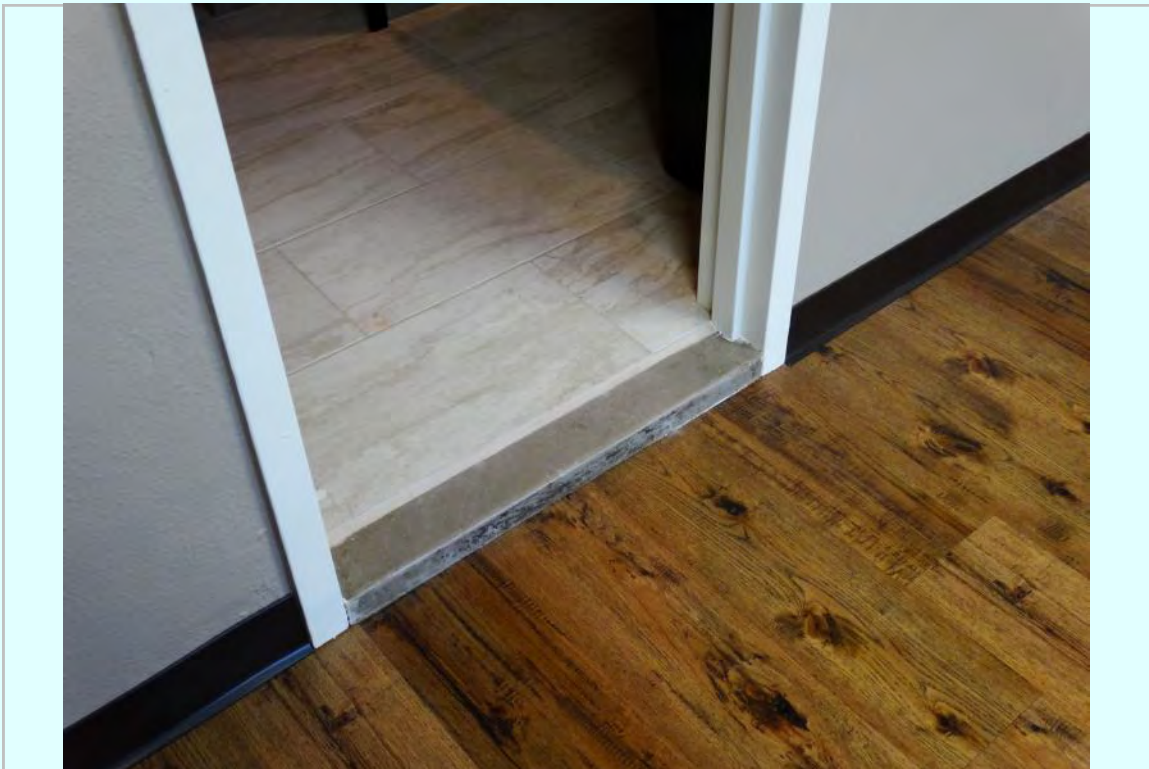
Photo: Third floor recently renovated office space

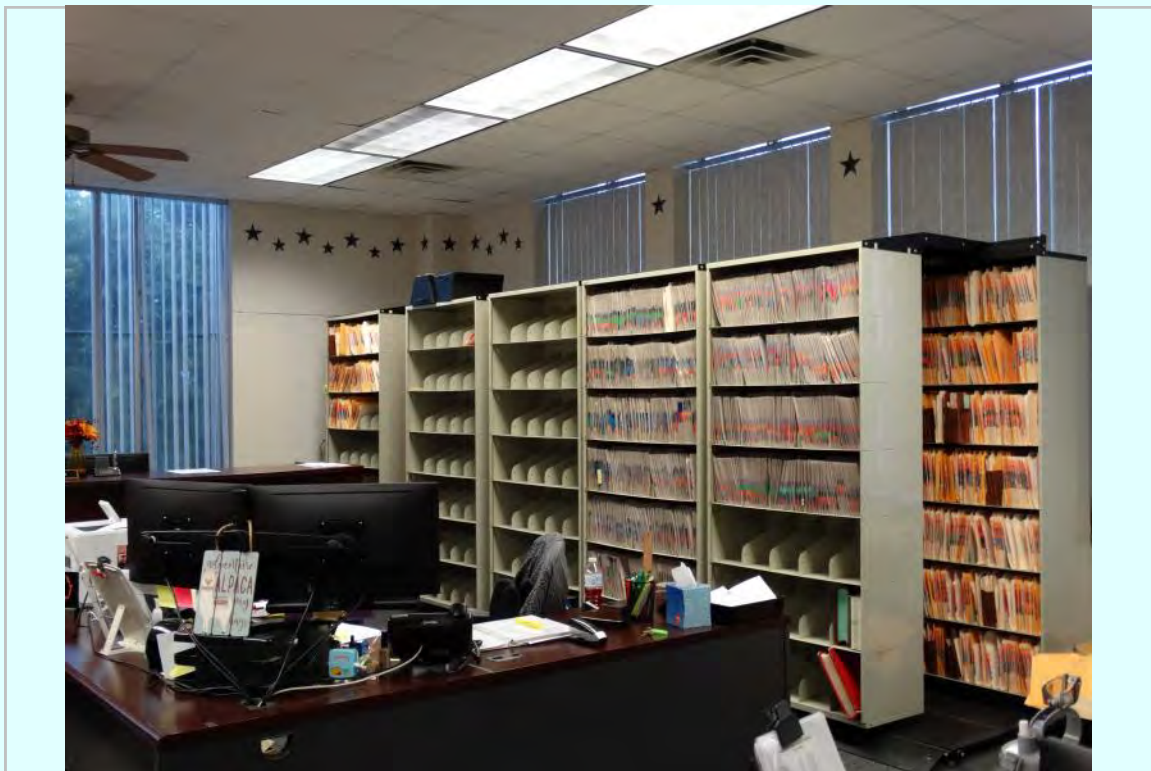
Photo: Third floor District Clerk space

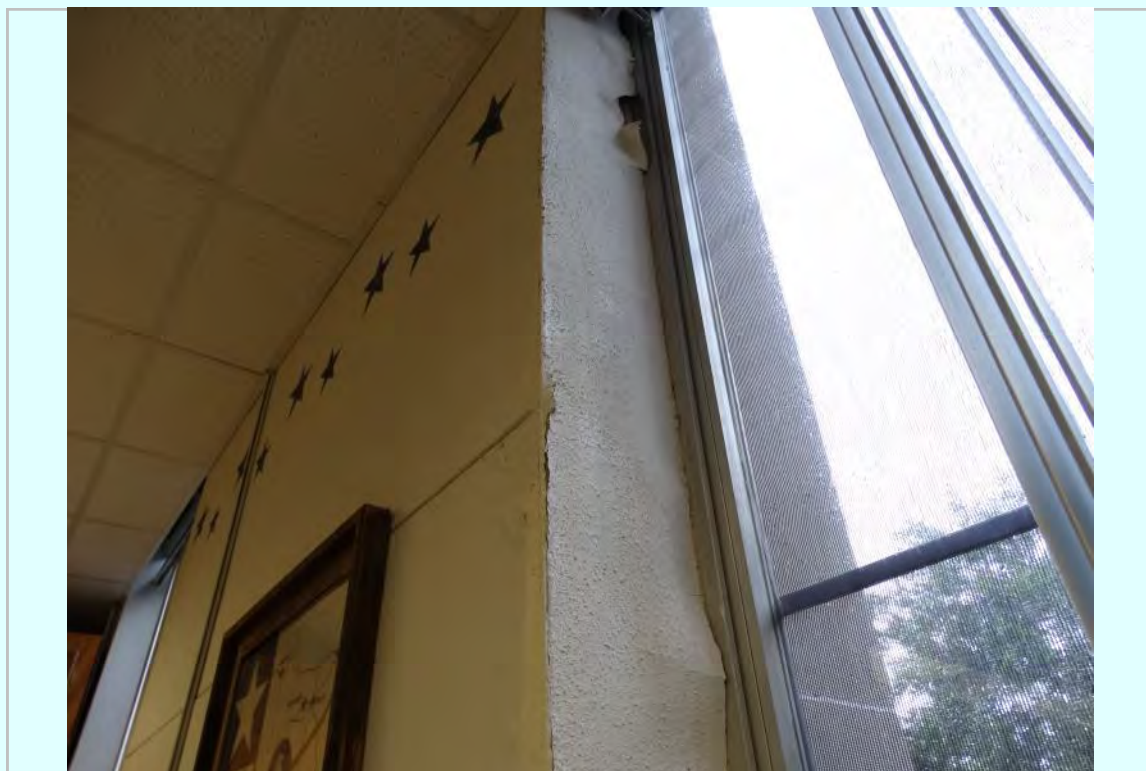
Photo: Third floor District Clerk space

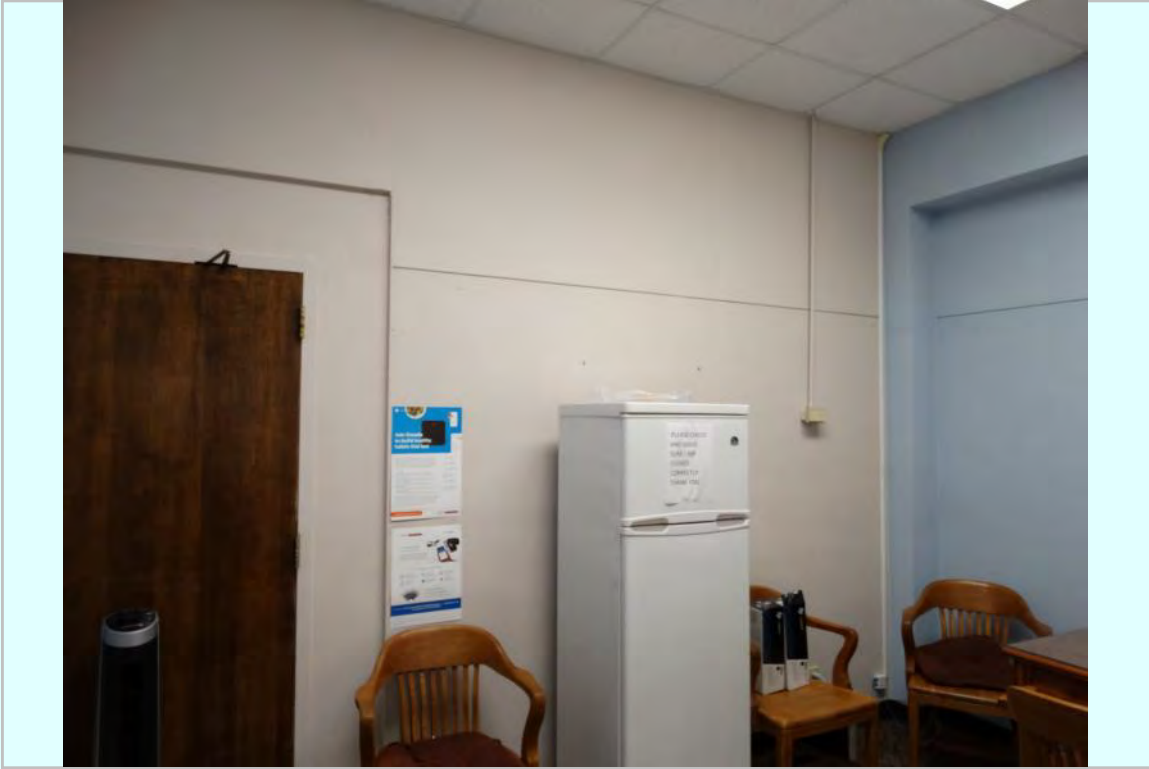
Photo: Third floor office space, double volume

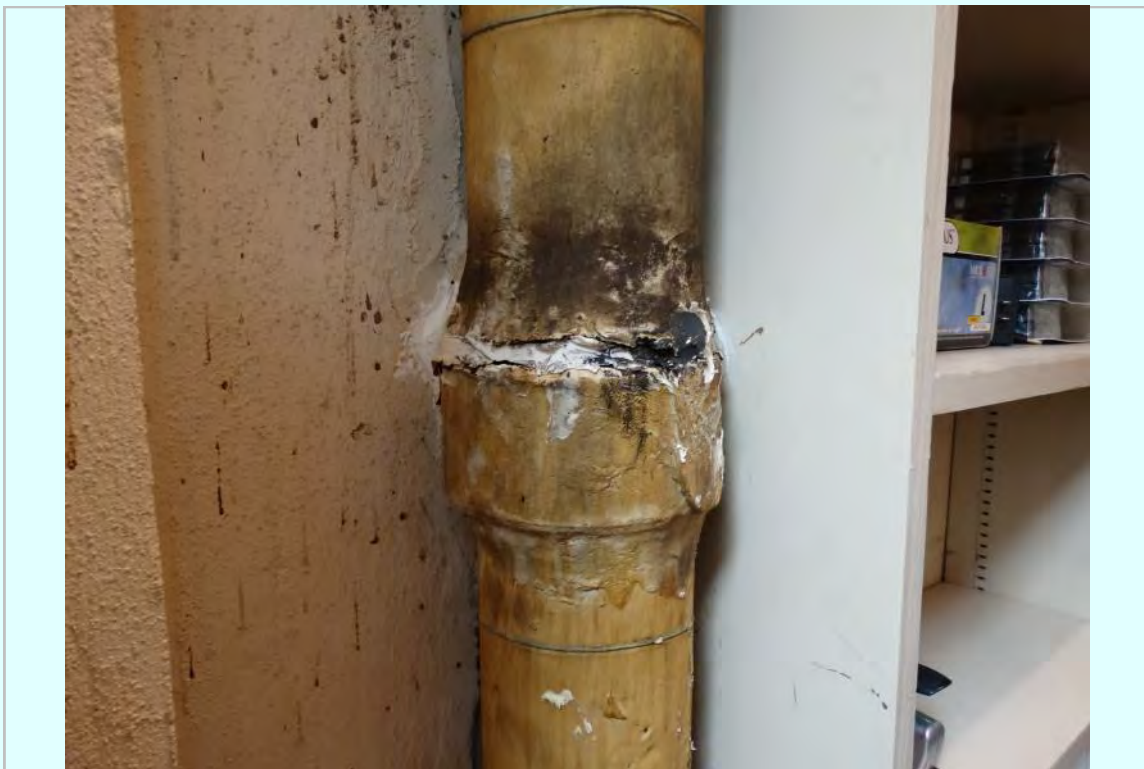
Photo: Third floor office space, internal roof drain damaged

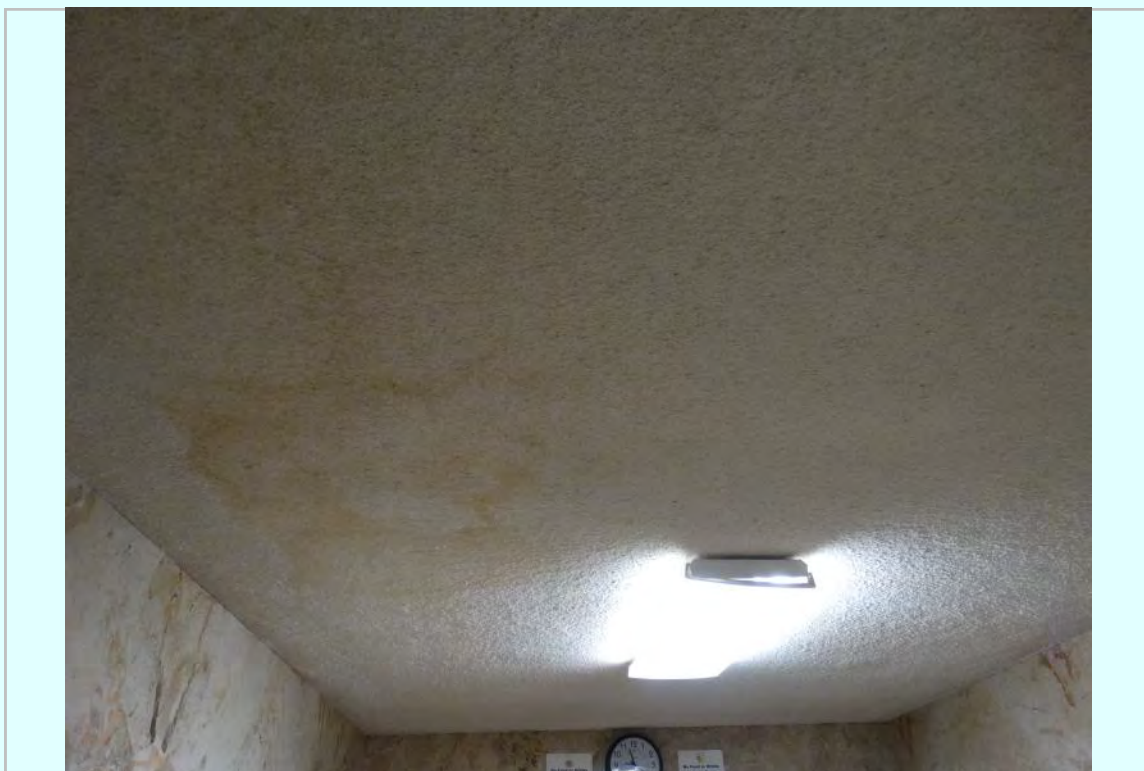
Photo: Third floor corridor ceiling damage and staining

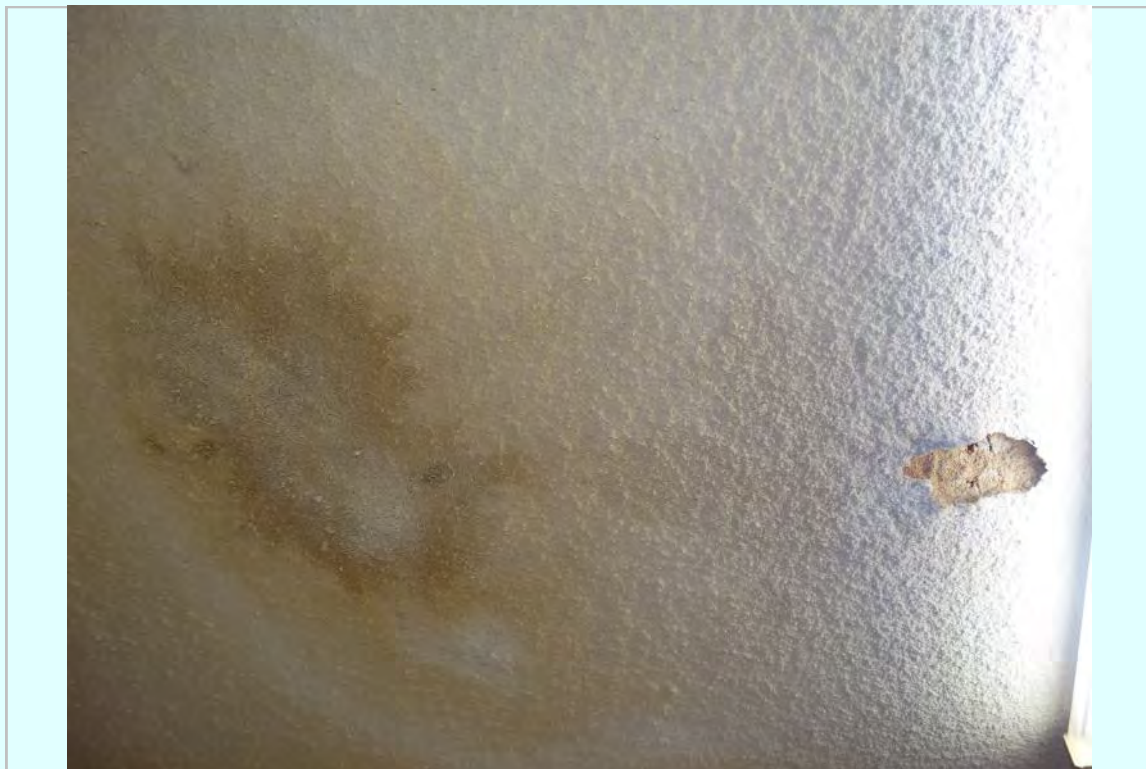
Photo: Third floor corridor ceiling damage, biological growth and spalling
