# EXISTING CONDITION ASSESSMENT

**WALLER COUNTY COURTHOUSE**  
Hempstead, Texas

**836 Austin Street**  
Hempstead, Texas 77445

October 27, 2021

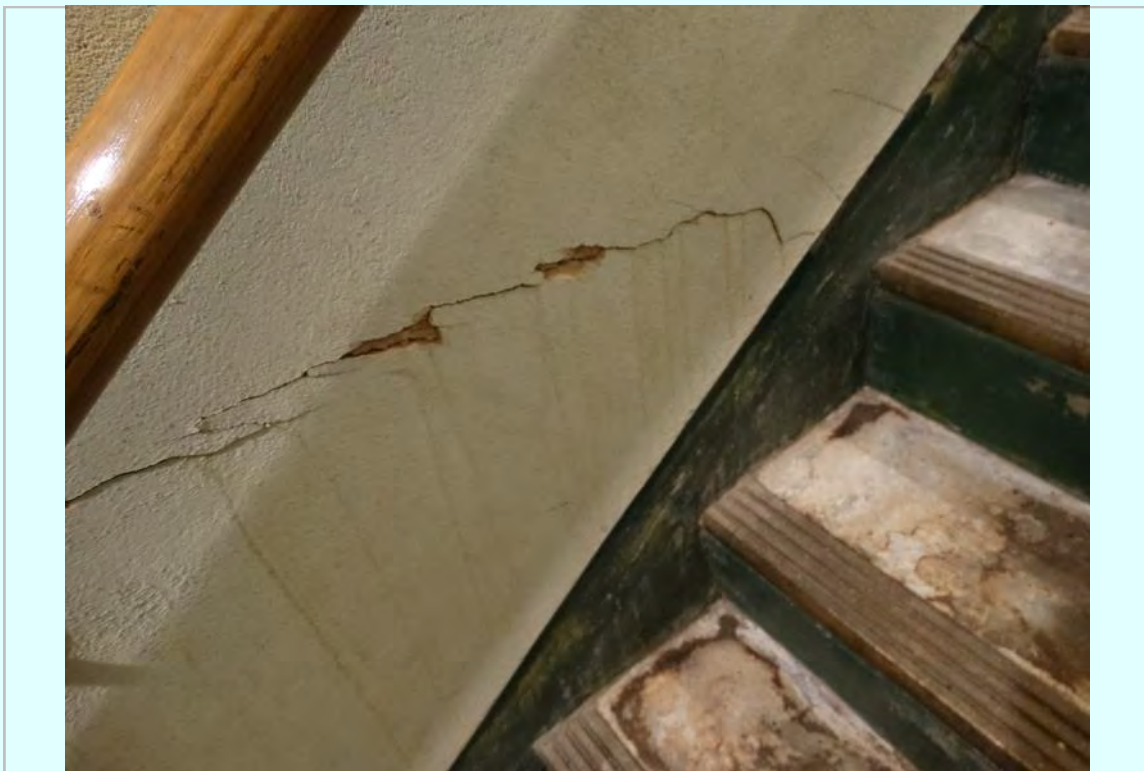
Photo: Fourth floor private stairs, plaster cracking

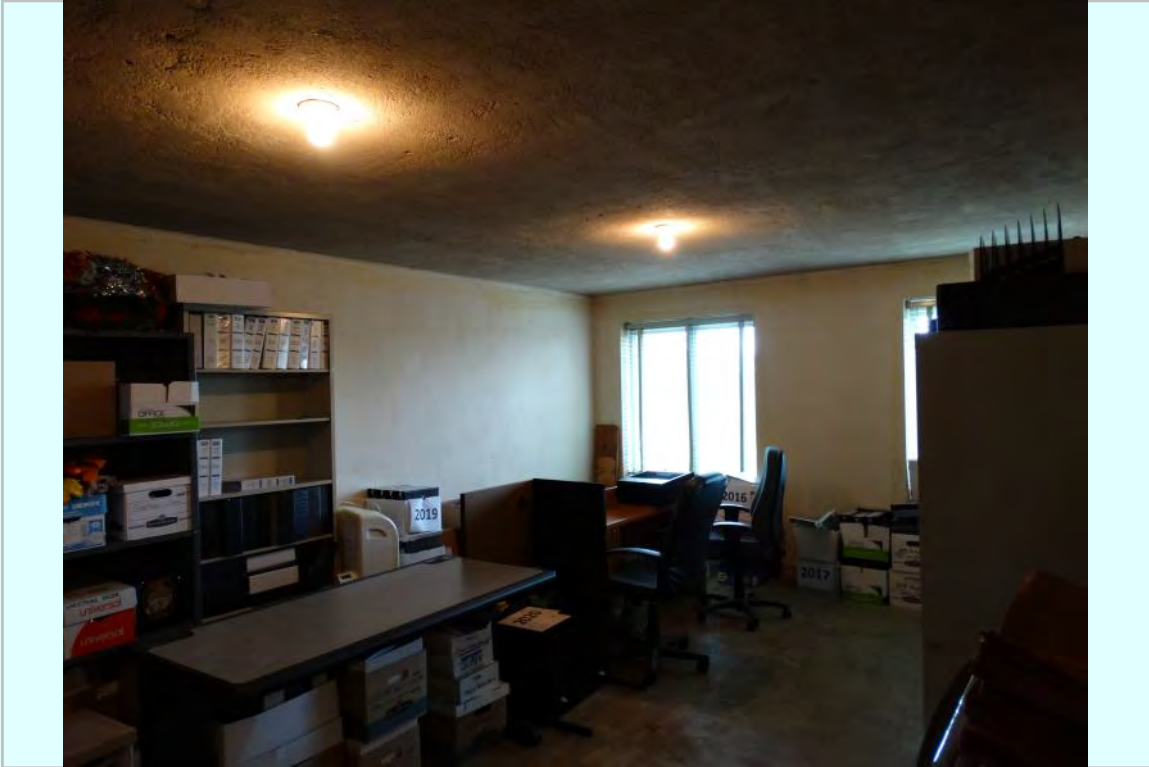
Photo: Fourth floor storage space

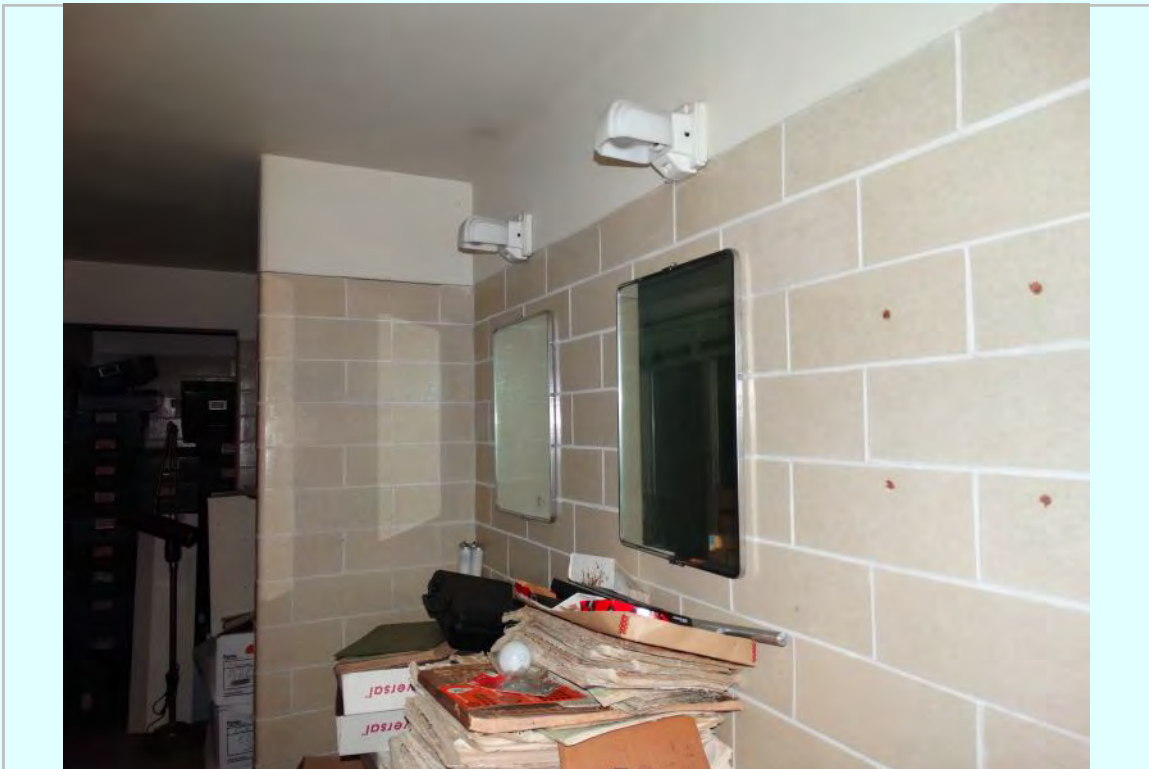
Photo: Fourth floor restrooms being used as storage space

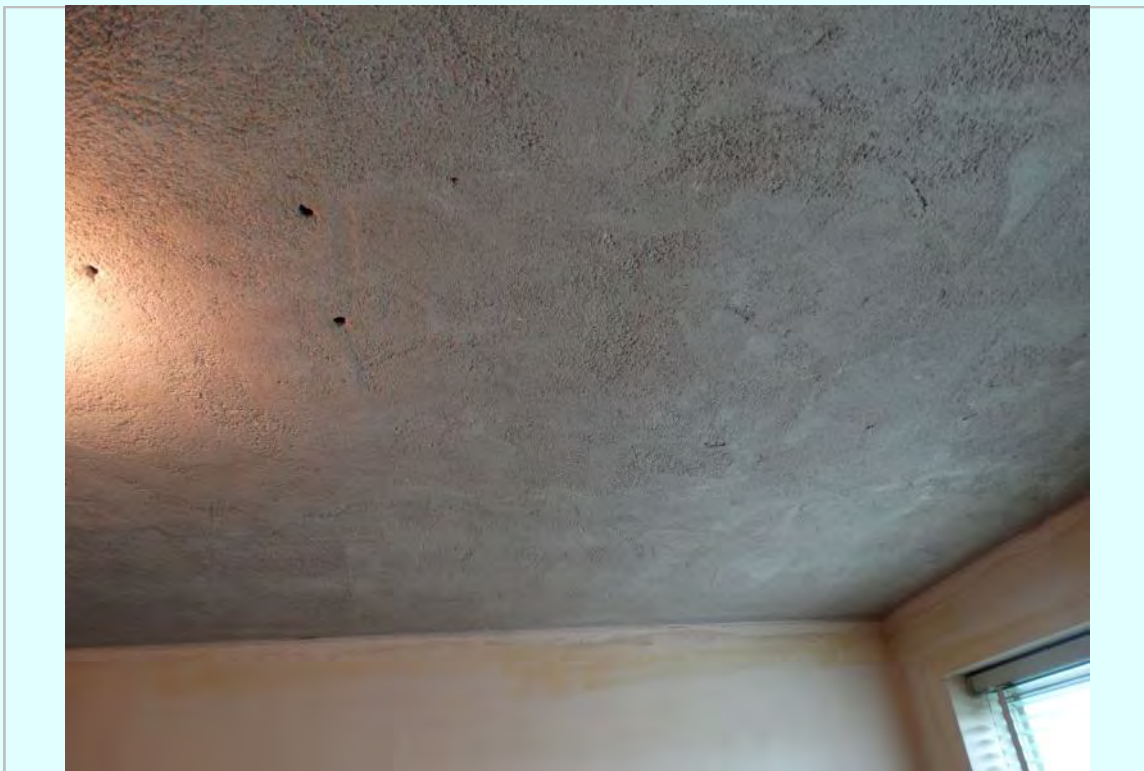
Photo: Fourth floor typical ceiling condition

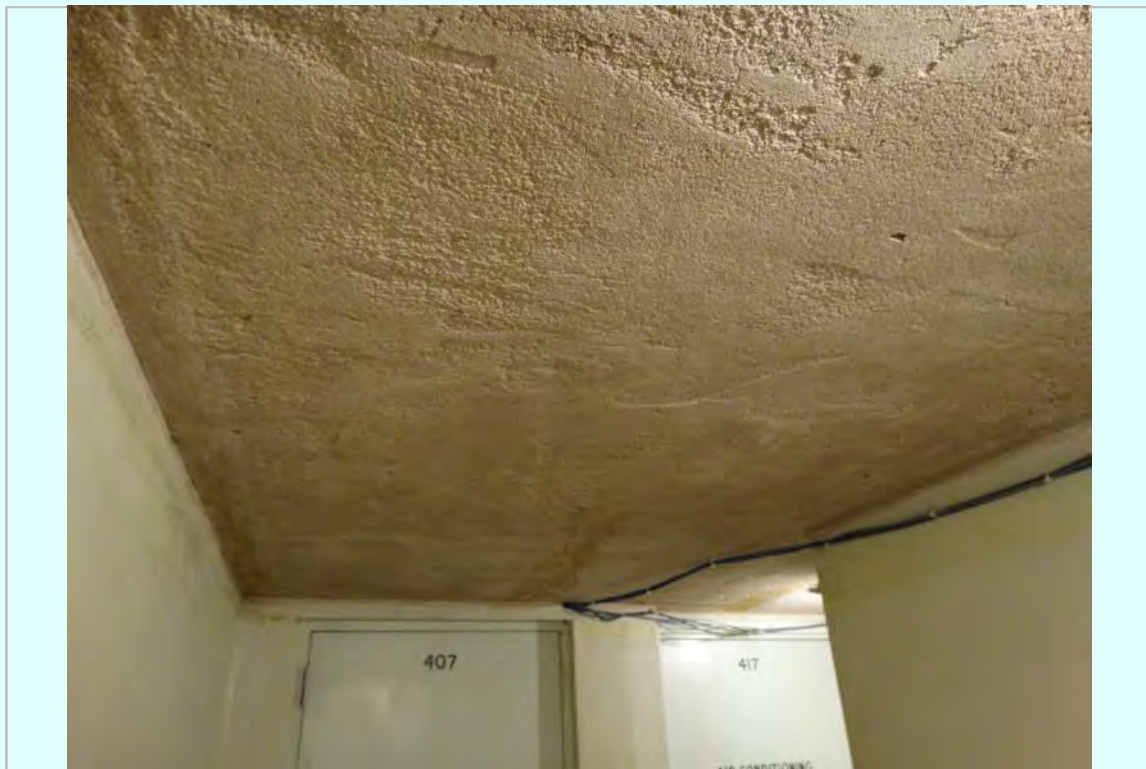
Photo: Fourth floor corridor typical ceiling condition

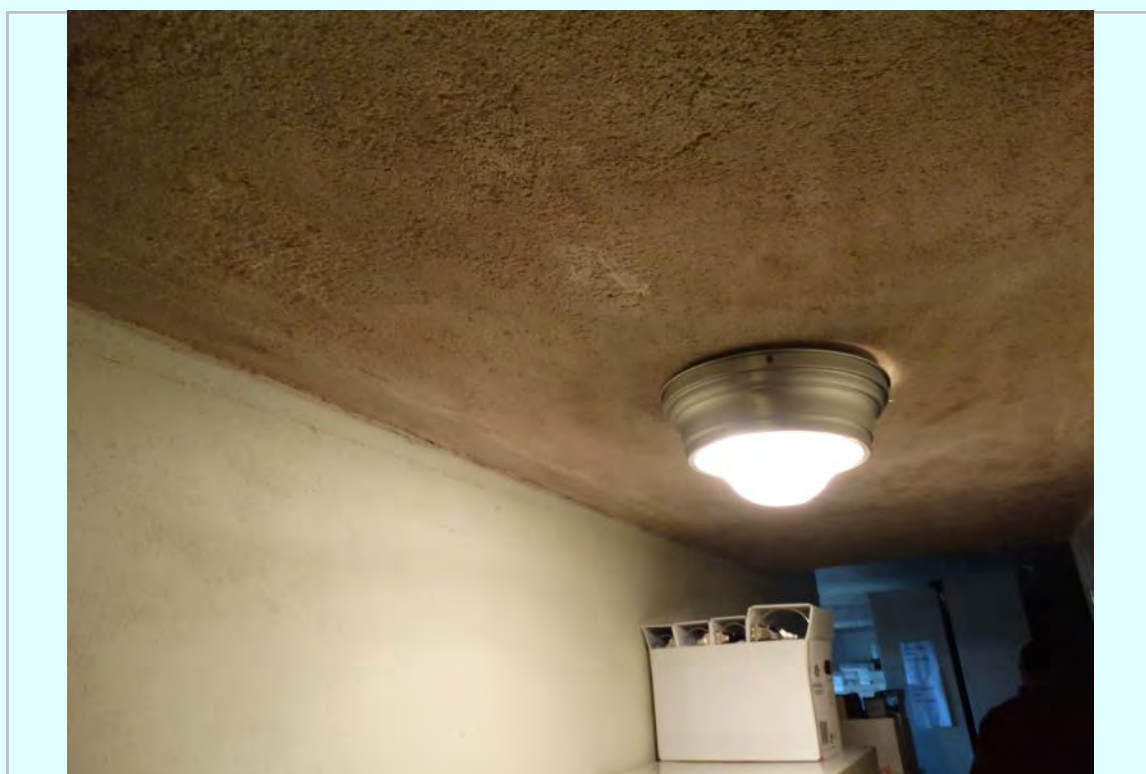
Photo: Fourth floor corridor typical light fixture

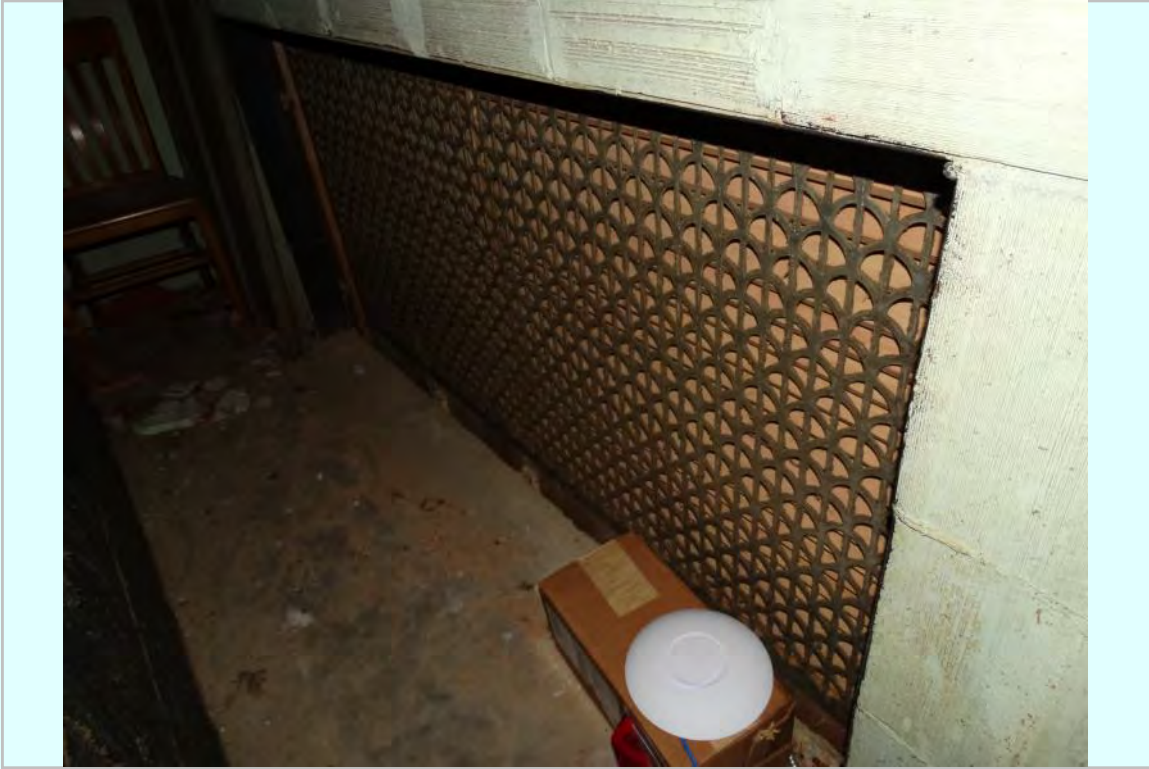
Photo: Fourth floor, mechanical space ventilation into district courtroom

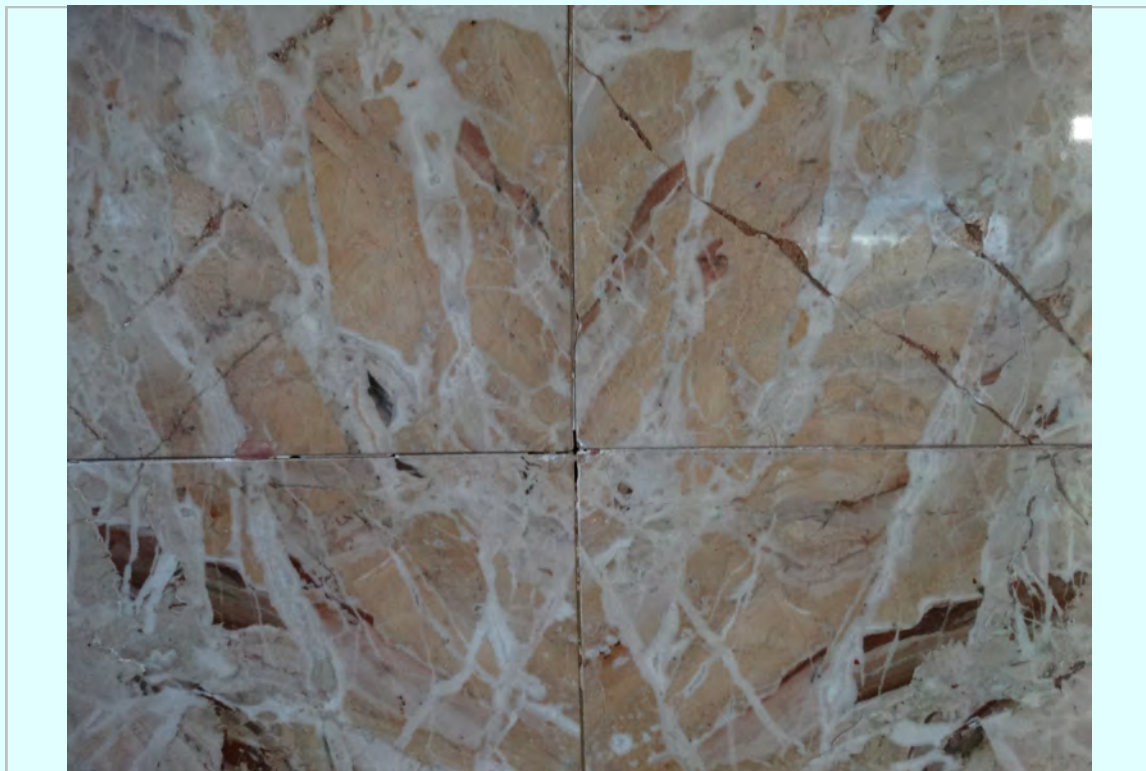
Photo: Typical marble stone condition at central stair

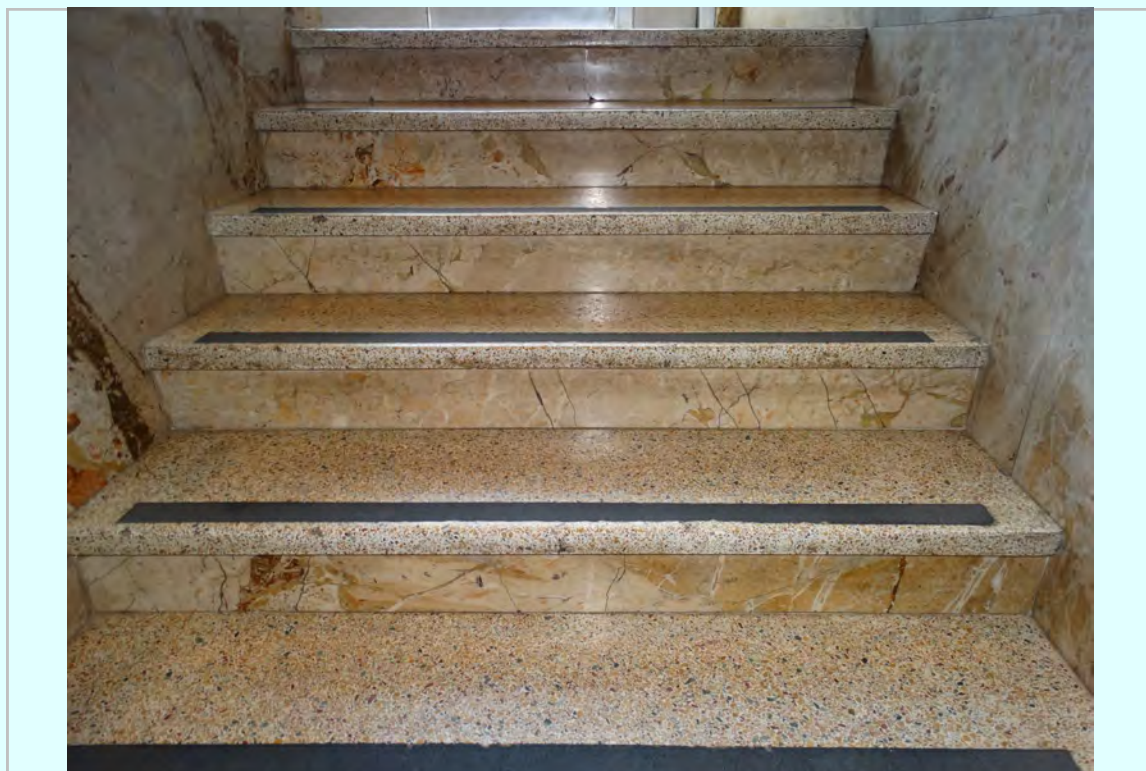
Photo: Typical riser and tread condition at central stair

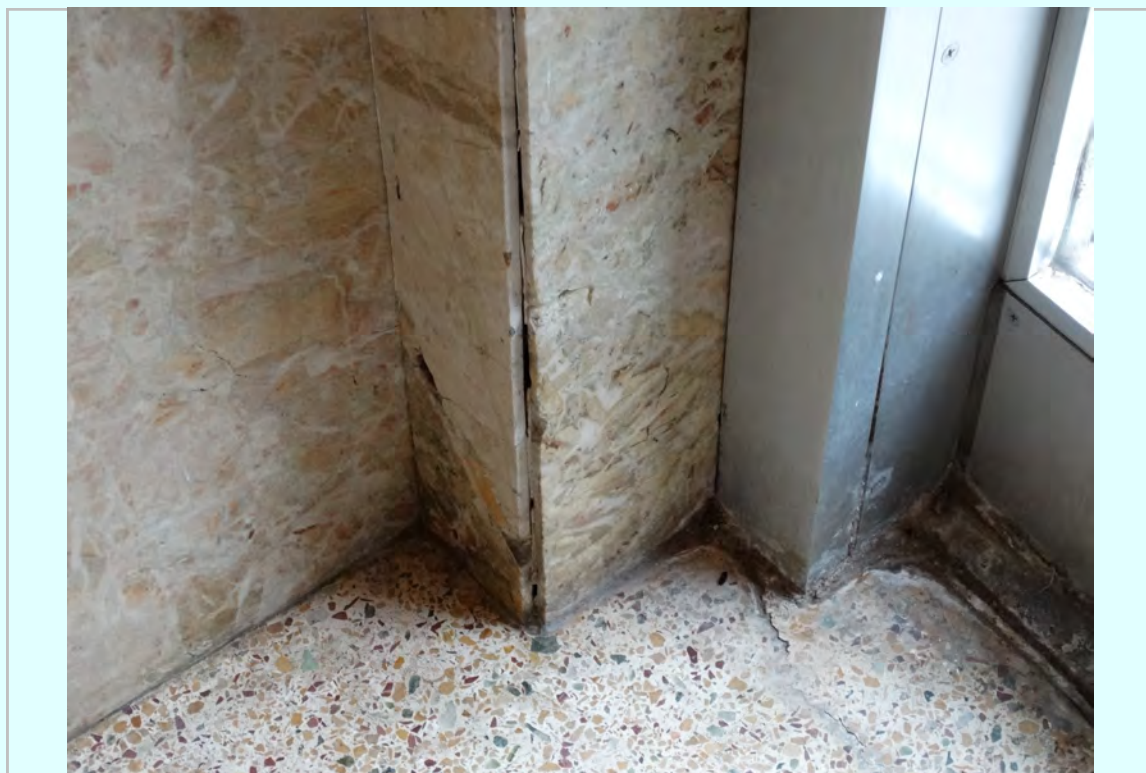
Photo: Typical stone condition at outside corner at north curtain wall

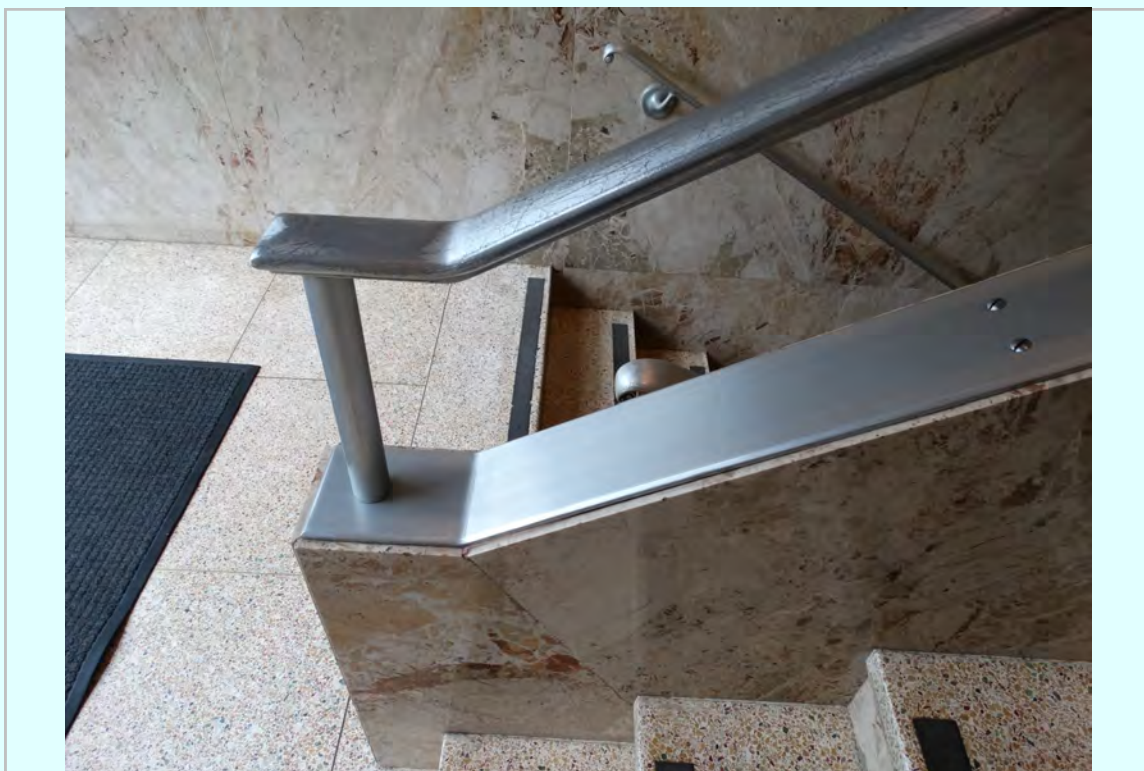
Photo: Central stair typical condition and non compliant handrail

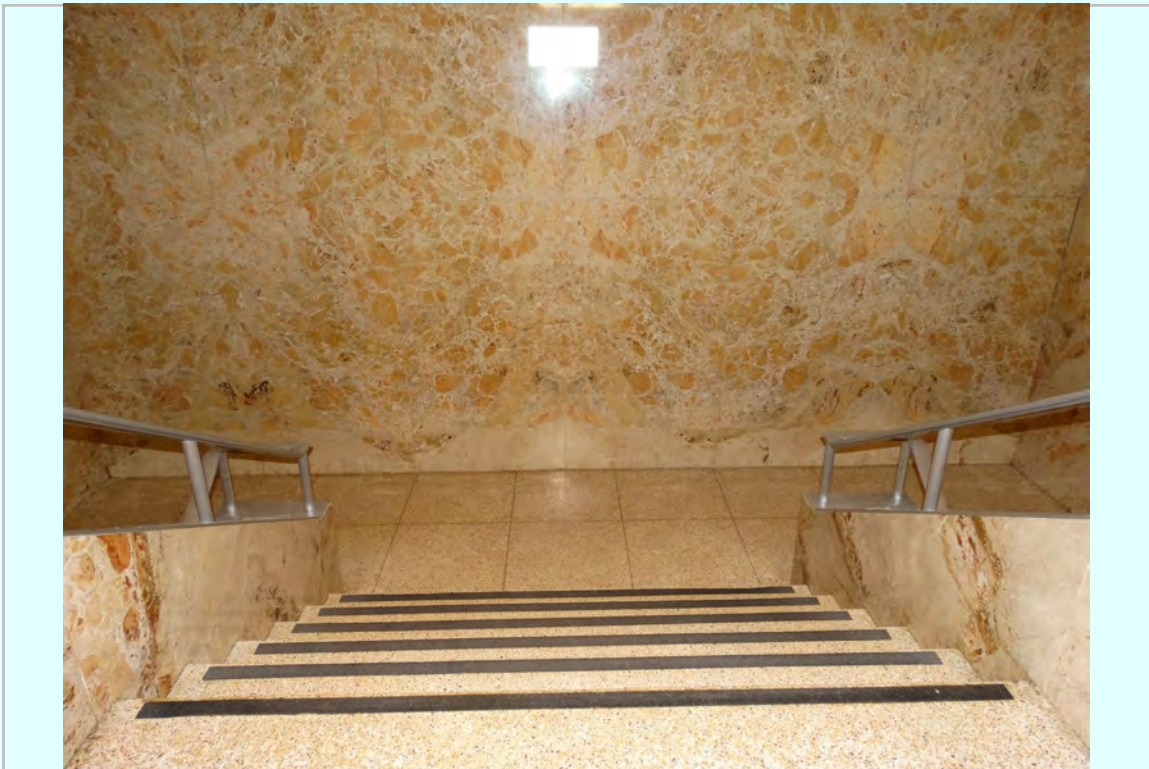
Photo: Typical inside corner at handrail detail

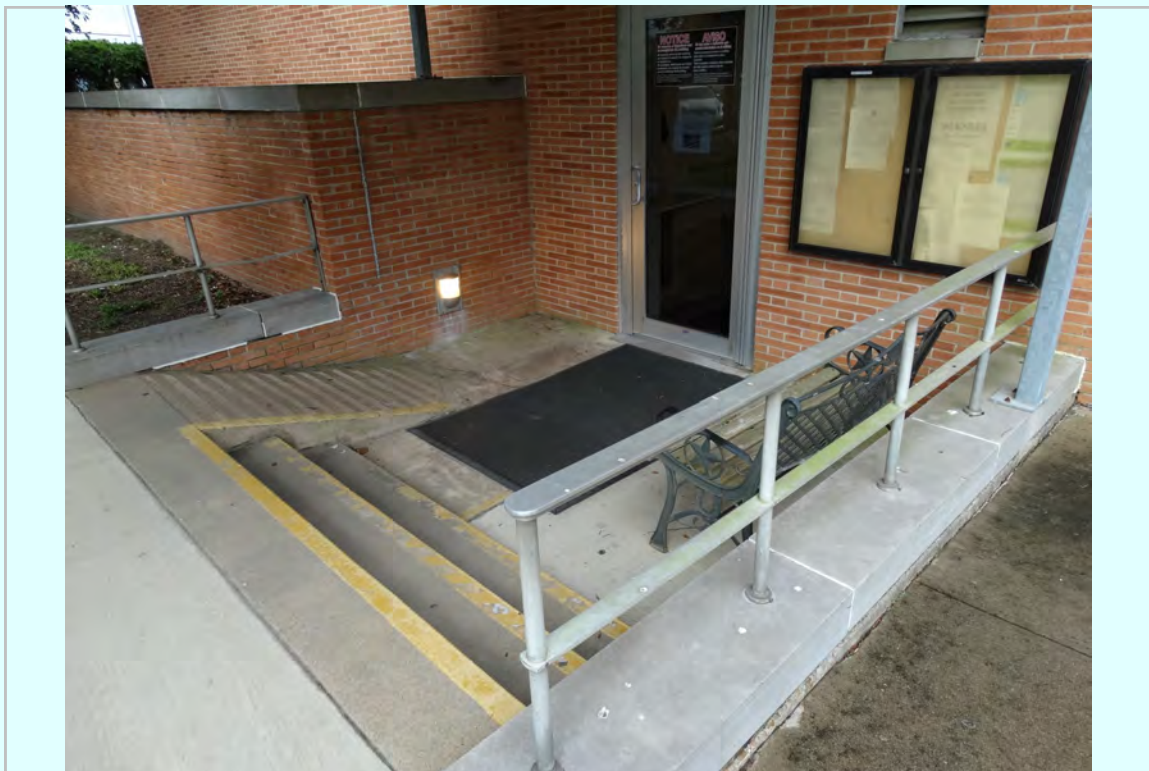
Photo: Non-compliant entry ramp, no handrails, non-compliant door, only existing ramp entry

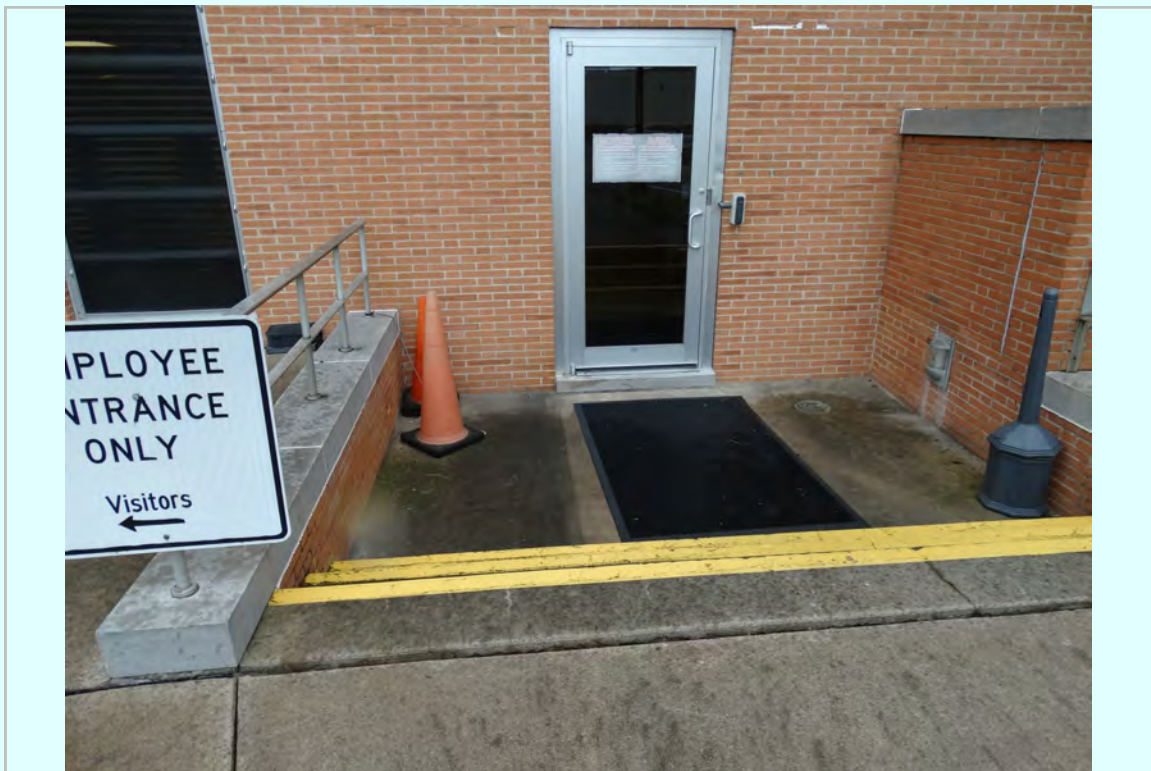
Photo: Non-accessible west entry, no handrails, non-compliant door

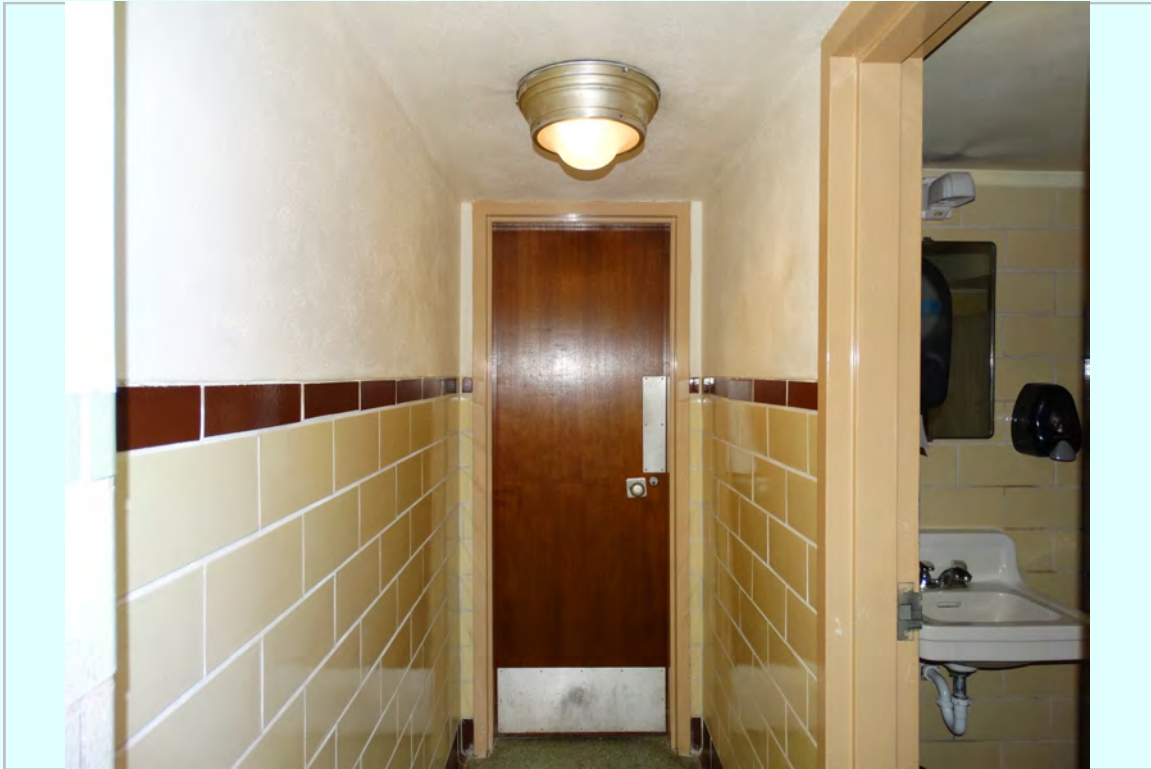
Photo: Non-compliant entry into public restrooms on ground floor

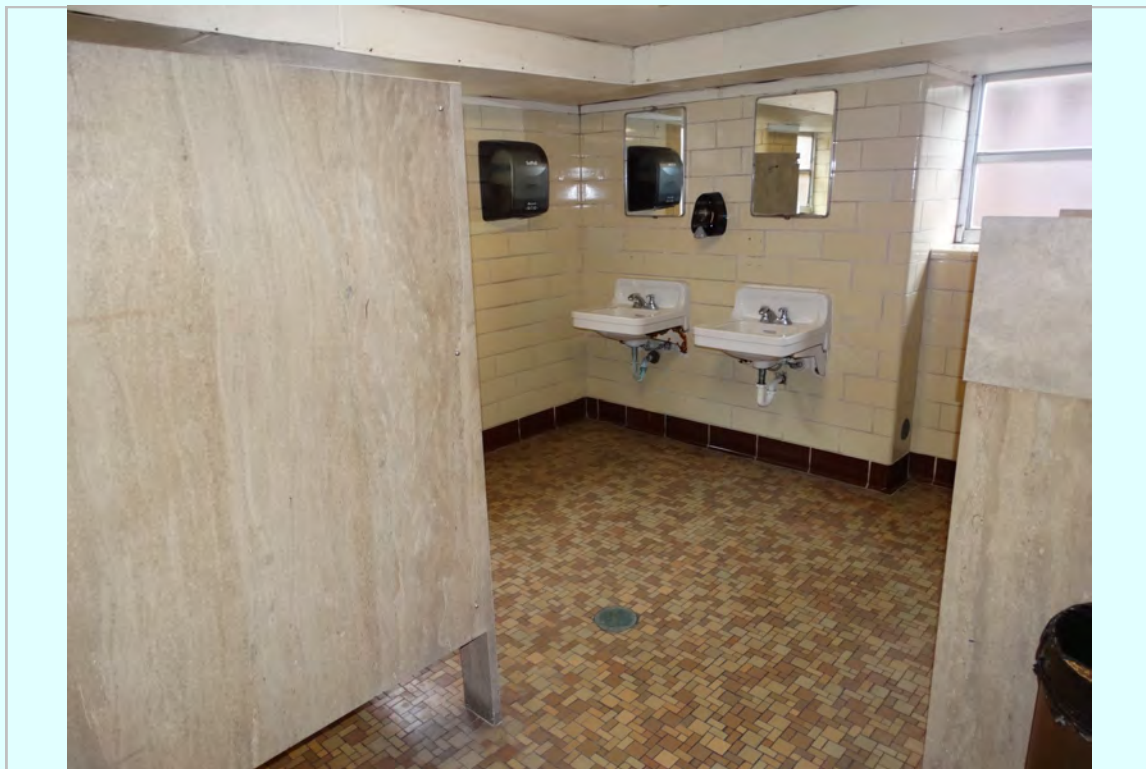
Photo: Non-compliant public restrooms at ground floor

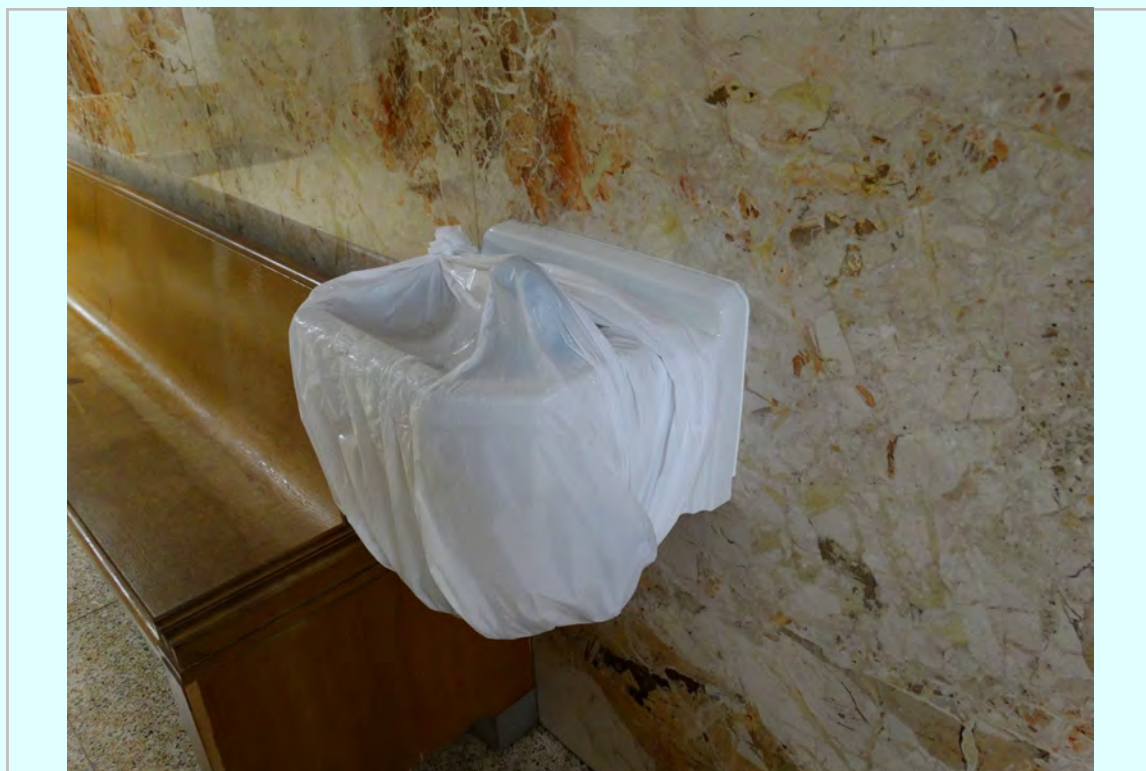
Photo: Non-compliant water fountain in public corridors.

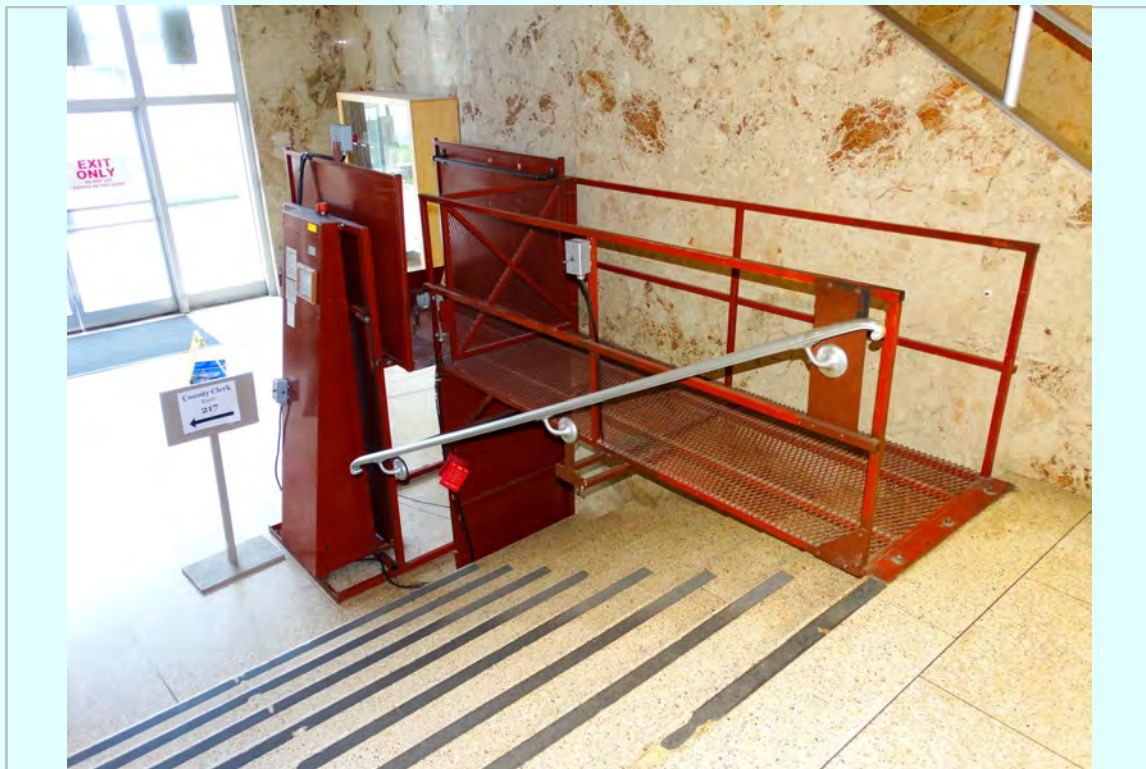
Photo: Wheel chair lift installed at grand stair from half floor to ground floor

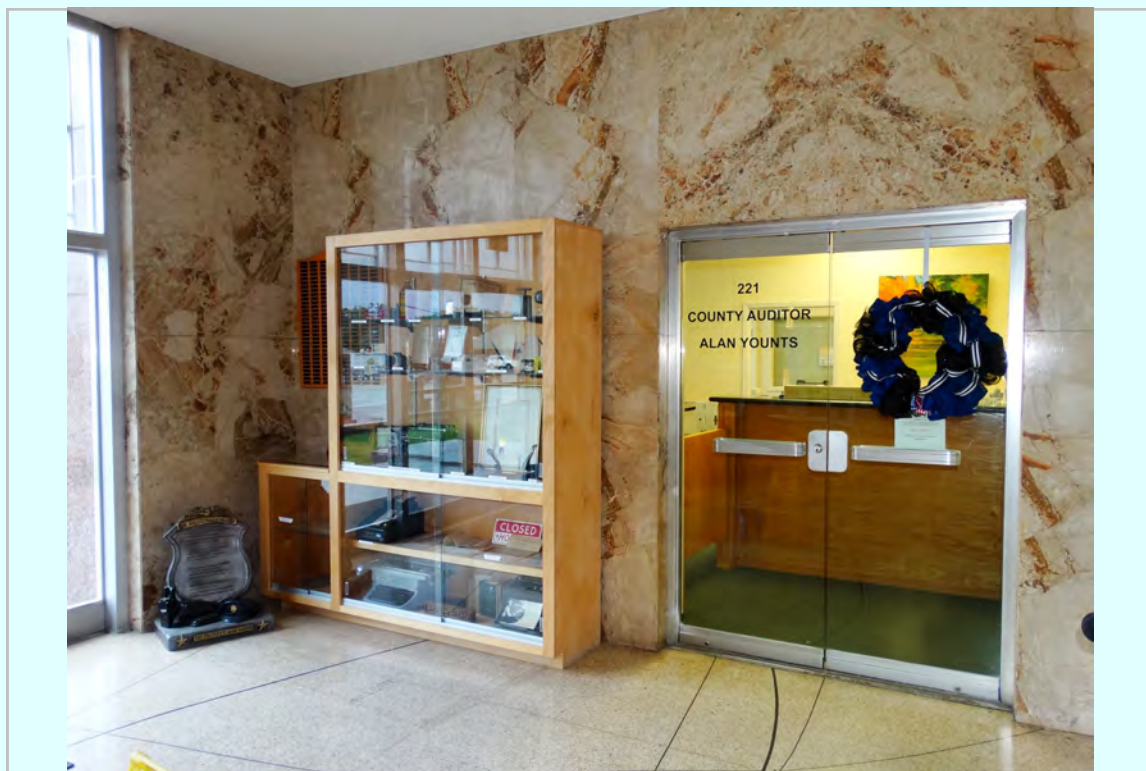
Photo: Non-compliant doors

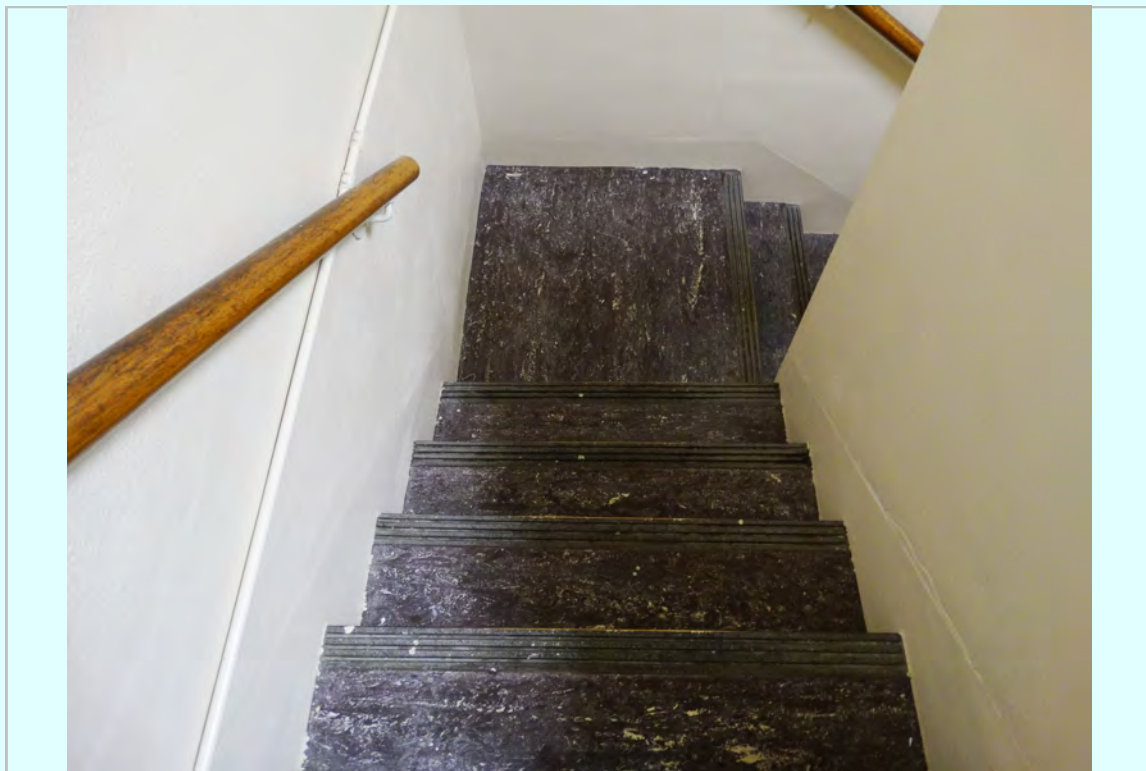
Photo: Non-compliant stair and railing

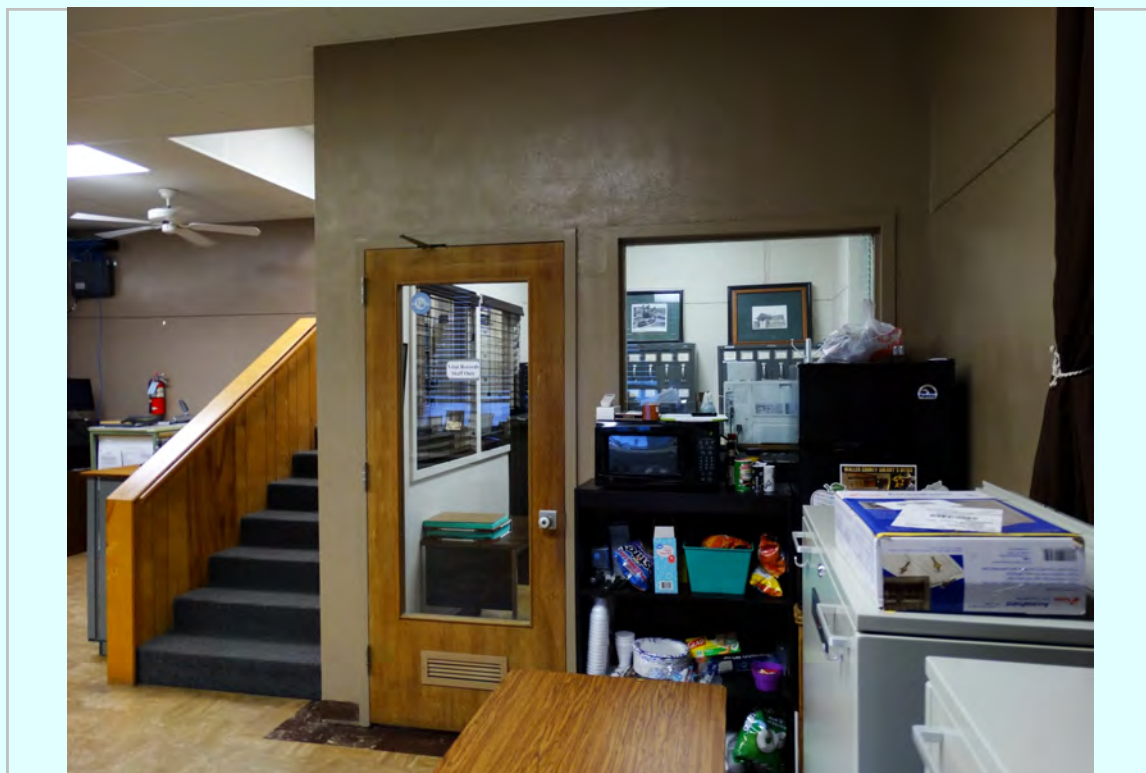
Photo: Non-compliant stair and railing

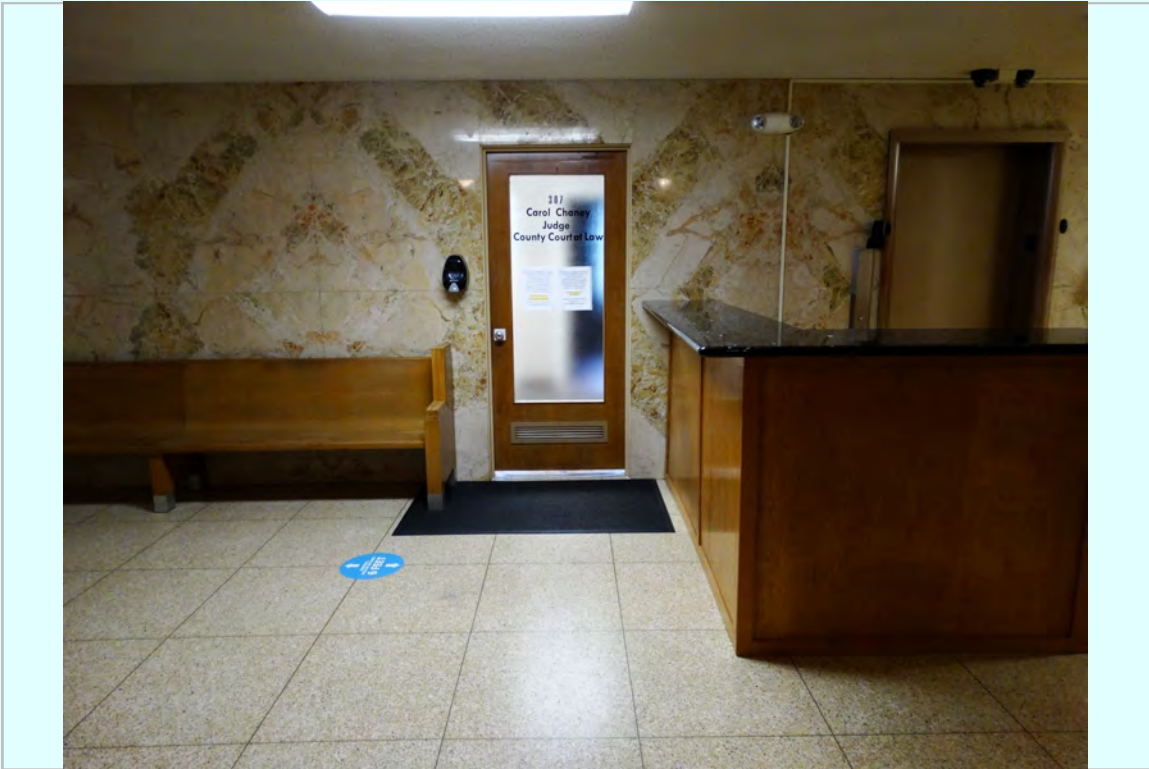
Photo: Non-compliant door hardware and help desk counter missing wheelchair access
