# EXISTING CONDITION ASSESSMENT

**WALLER COUNTY COURTHOUSE**  
Hempstead, Texas

**836 Austin Street**  
Hempstead, Texas 77445

October 27, 2021

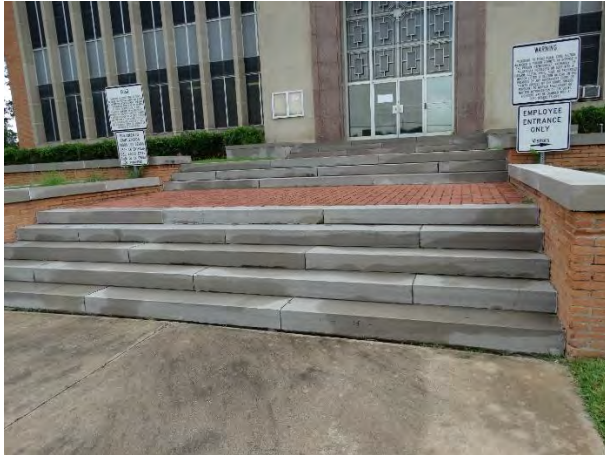
**Figure 4. (Left) South walkway entrance with limestone steps and clay pavers. Figure 5. (Right) South walkway entrance masonry cheek wall with planter**

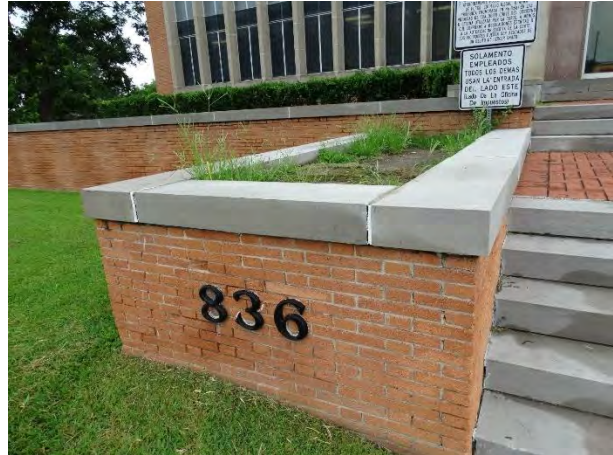
planter. There is only soil and no evidence of appropriate plantings currently in the planters, which is evidence that the maintenance are likely poor soil conditions and maintenance is too great for the County staff to maintain.

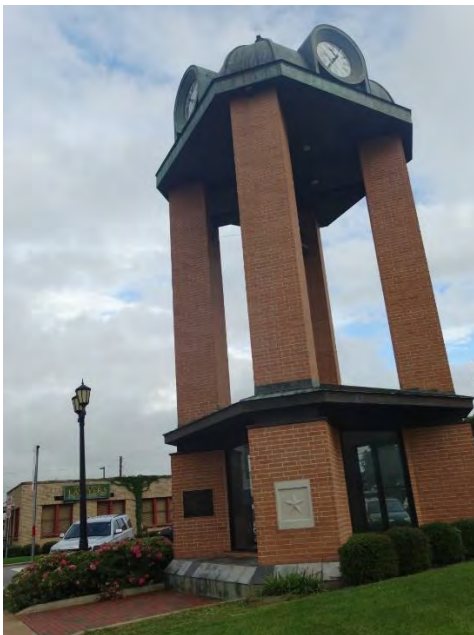
On the southwest corner of the site stands a monument dedicated to the previous demolished courthouse dating from 1894. The monument is a contemporary structure with four large columns matching the 1955 courthouse masonry and infilled with a storefront system at the base. There is a copper roof enclosing the space at the base and a copper roof at the upper clock tower and bell level. This clock tower was salvaged from the 1894 courthouse and restored by Lloyd Larish out of Fairbault, Minnesota. Construction for this monument began in 2004, but it was not capped with the bell, clock, and top roof until 2010. The bell and clock were restored and installed into this tower monument in 2010. This project was spearheaded by the local Waller County Historical Society and supported by hundreds of citizens that donated to the project funds by purchasing brick pavers. The copper and masonry on this monument are in good condition and the landscape grounds directly around it are all well-kept.

**Figure 8. (Left) Monument dedicated to the historic 1894 courthouse. Figure 9. (Right) Veteran’s monument**

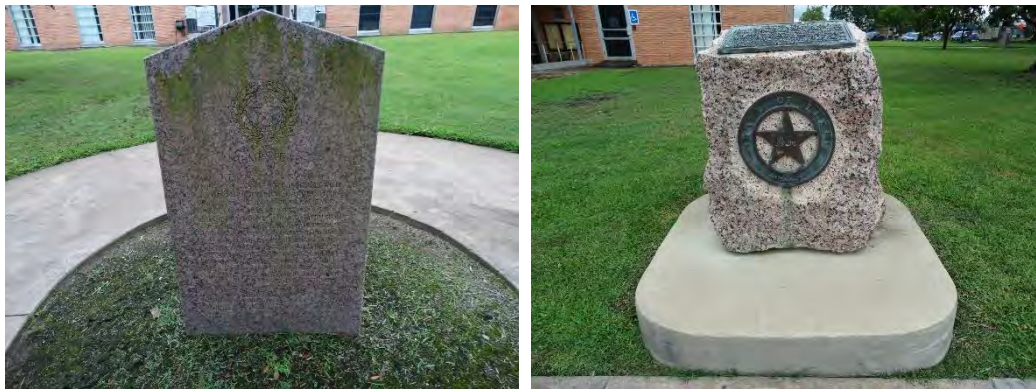
On the north side of the Courthouse Square, there are only four smaller individual monuments peppered around the grounds. Centered on the main walkway going into the buildings north entry is a large pink granite slab as a memorial to the state of Texas for serving the Confederacy. The monument is in good condition though an installation date has not been determined. The lettering is difficult to read and the stone is starting to contain a large amount of biological growth on the top and all down the face of the monument.

**Figure 10. (Left) Monument dedicated to Texas service in the Confederacy. Figure 11. (Right) Monument dedicated to Waller County formation.**

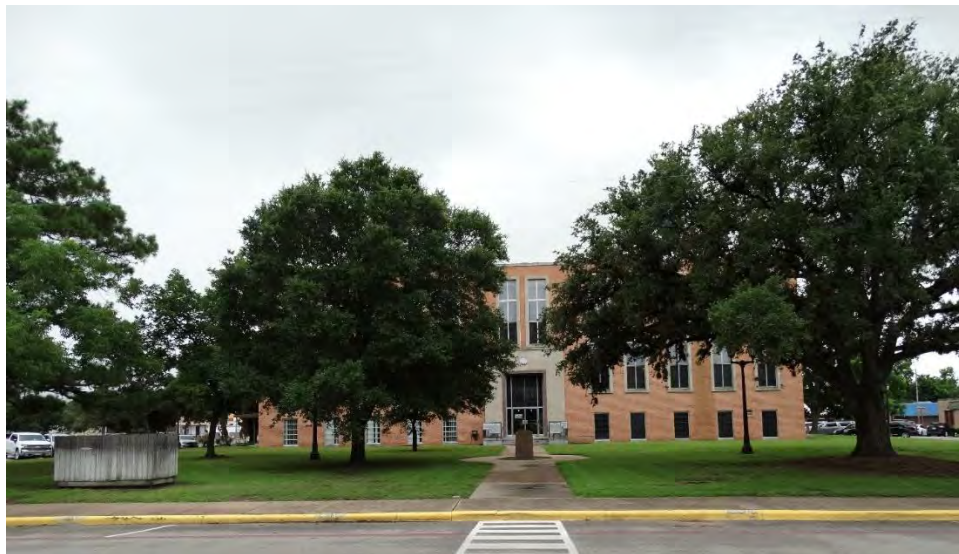
The north side of the courthouse contains a large number of mature trees. There are approximately seven to nine mature trees ranging from a few large oaks, pecans, and tall pine trees. These trees all appear to be in good condition. If possible, the mature trees should be saved for any future modifications to the site.

**Figure 15. North lawn with mature Oak and Pecan trees to be protected**

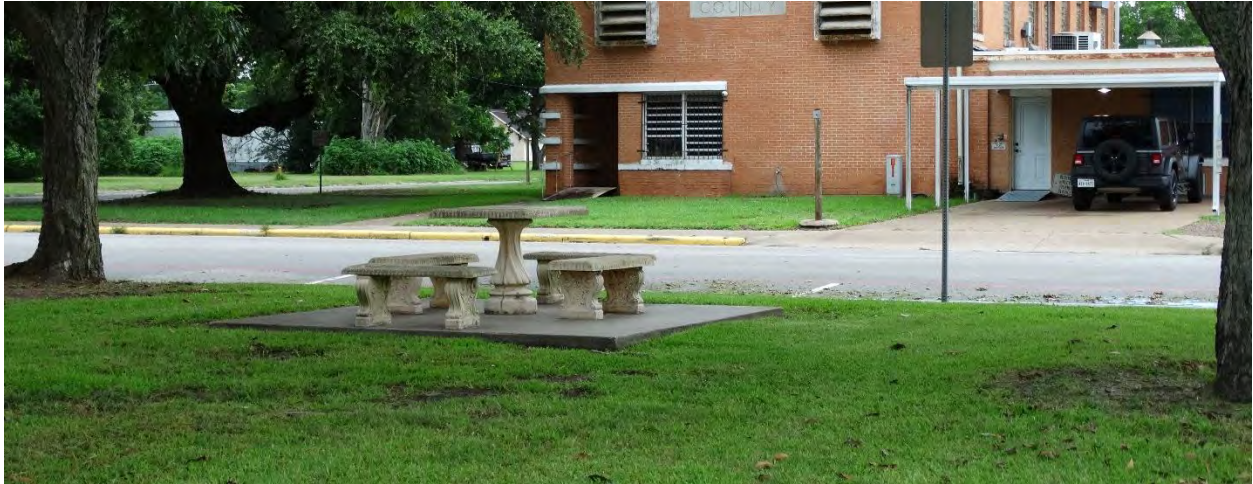
Along the north border to the west and east of the Square sits two concrete slabs with cast concrete picnic table and benches. Both are intelligently placed beneath large shade trees and out of site mostly. They appear to be in good condition; however, they are not of any significance or architecturally fitting to the site. There are not paths to them and no signs of dirt trails in the grass, which would lead to the conclusion that they do not get used often.

*Figure 17. Edge of North lawn with concrete picnic table and benches on a concrete slab*

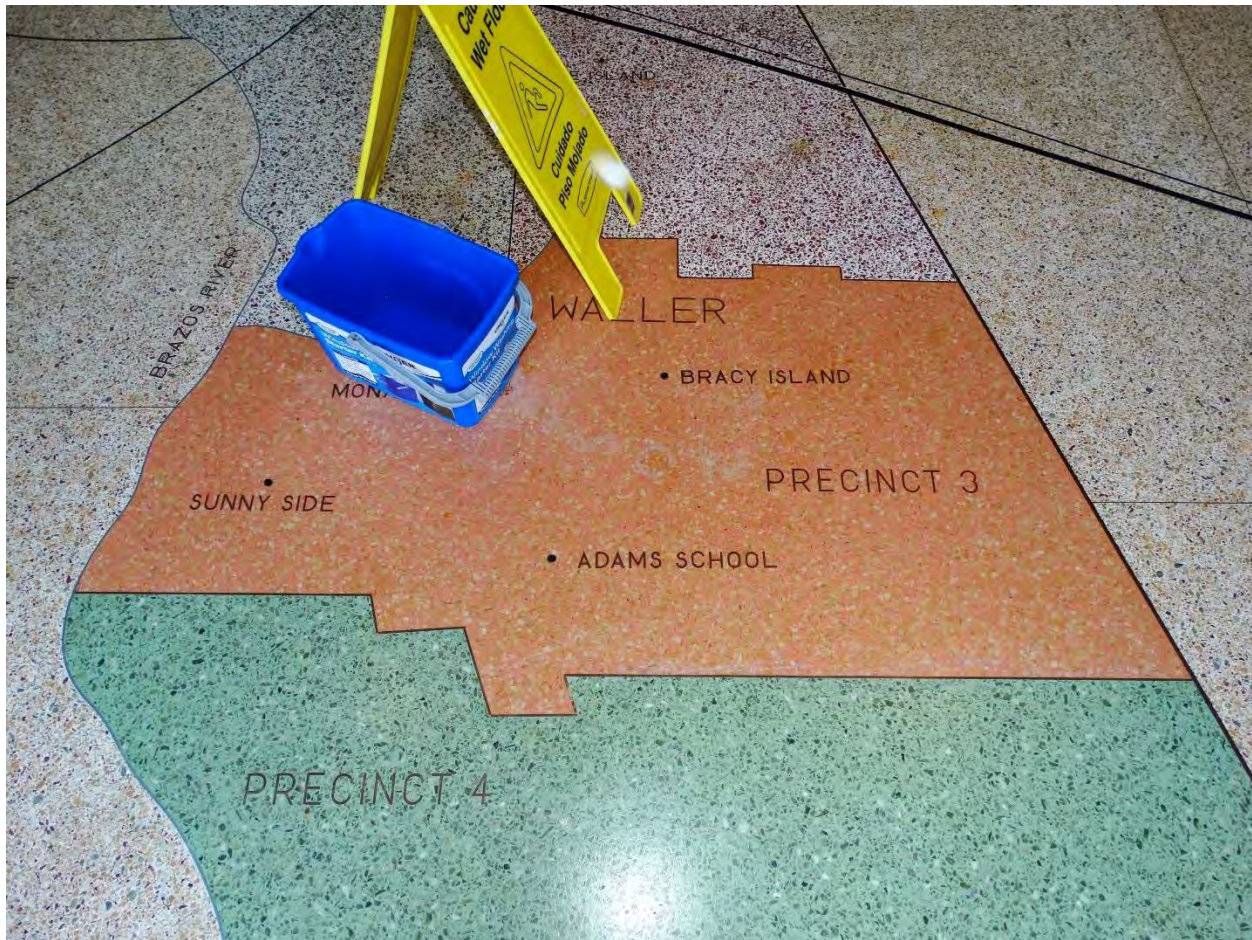
The south entry lobby space between the County Clerk and Auditor, has a high level of integrity and contain a custom detailed map of Waller County, designed into the terrazzo flooring. This is also the same space that has regular leaks from the ceiling and contains plaster failure. Please refer to the photo index.

**Figure 44. Existing mezzanine lobby/south entrance lobby terrazzo floor map**

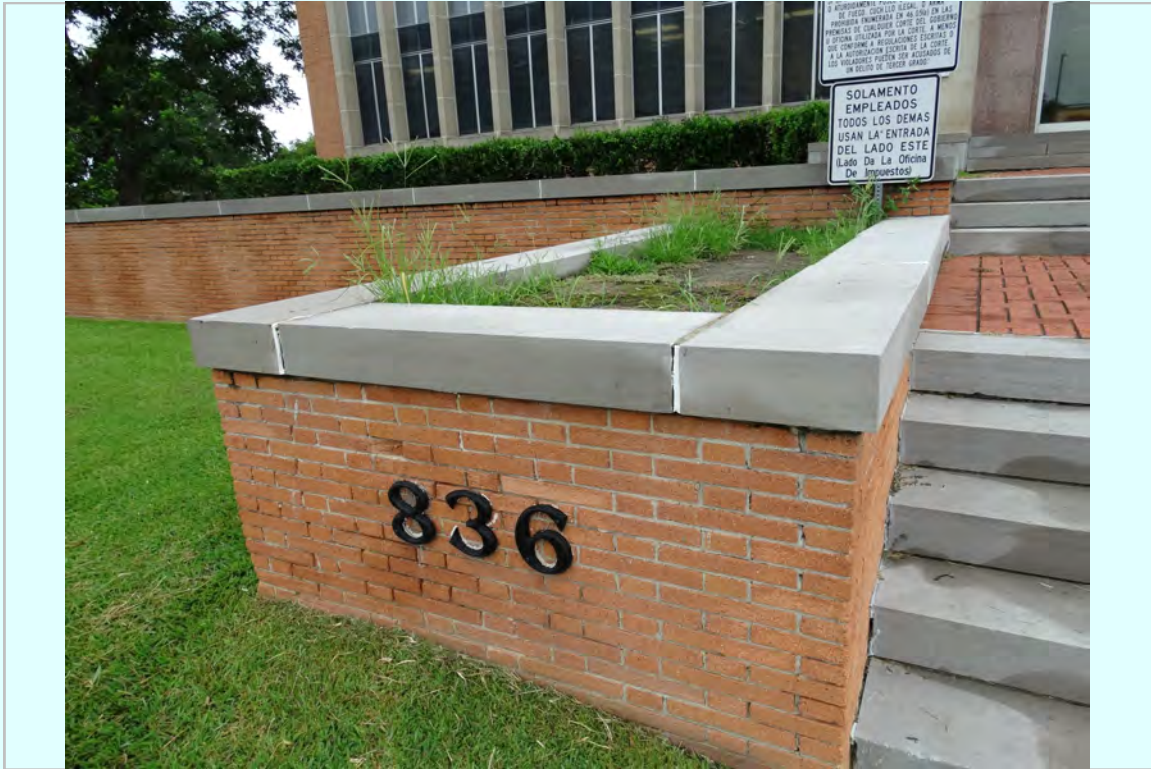
Photo: South entry address marker

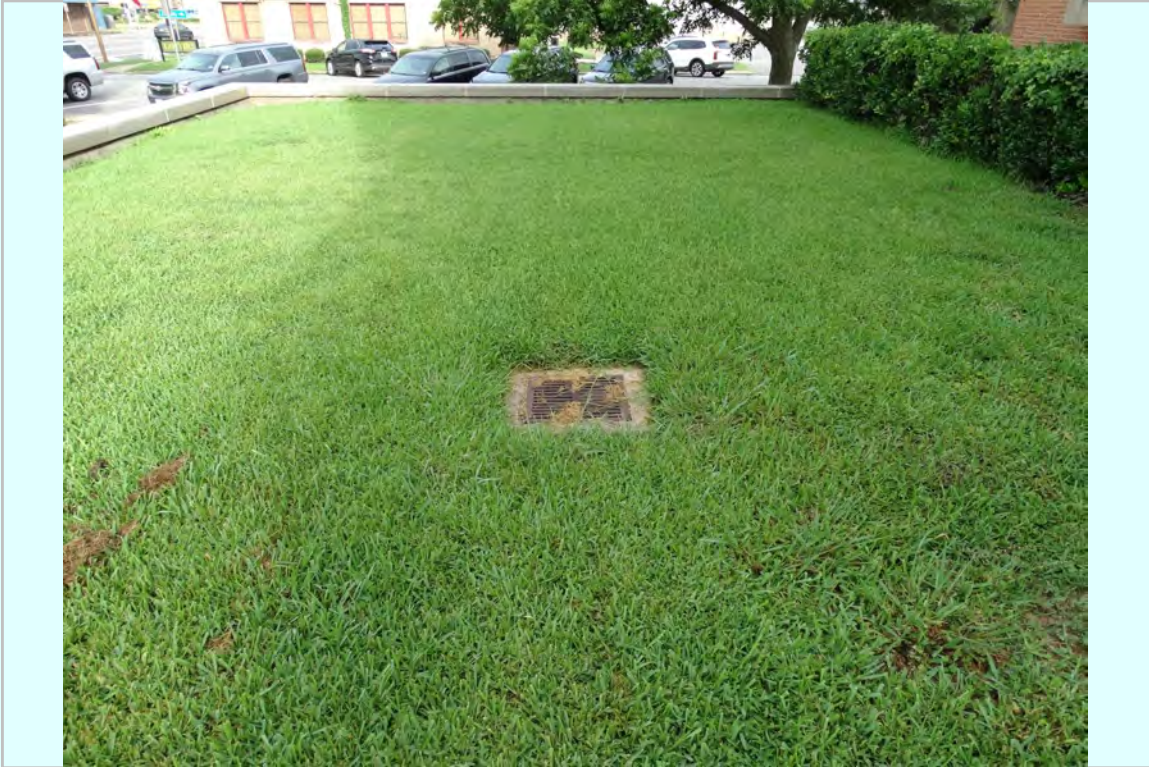
Photo: South west lawn area drain

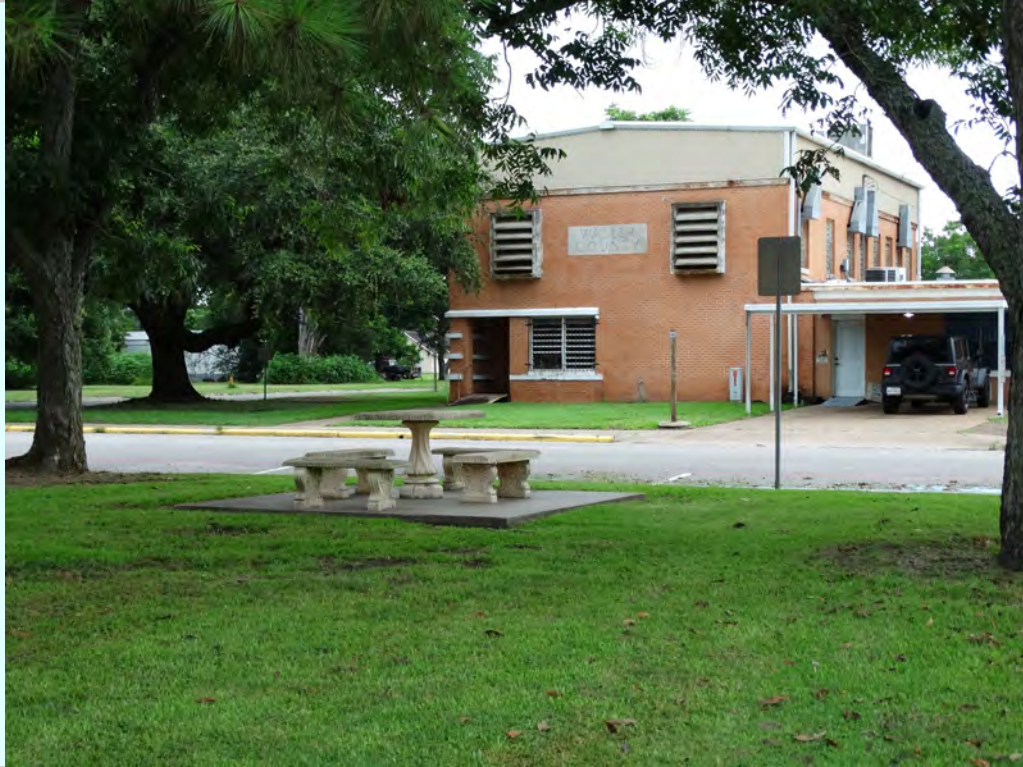
Photo: Similar era structure at property north of the square

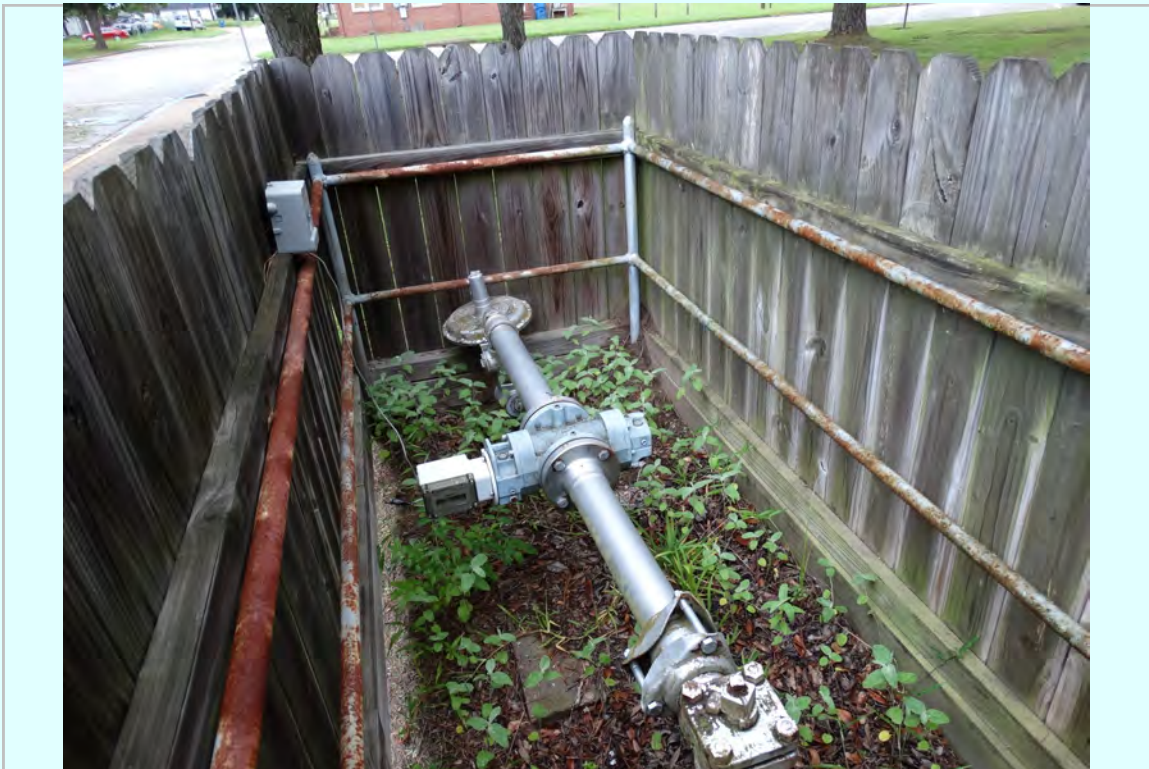
Photo: Utility Yard

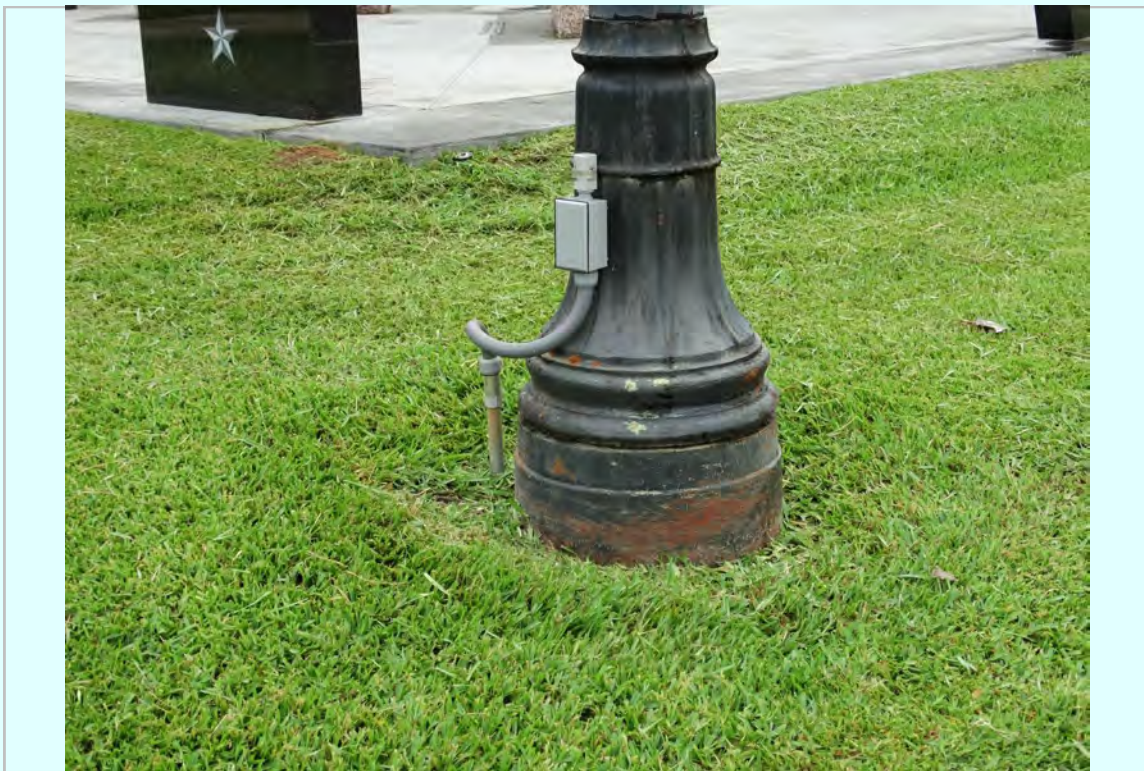
Photo: Modifications to light standards

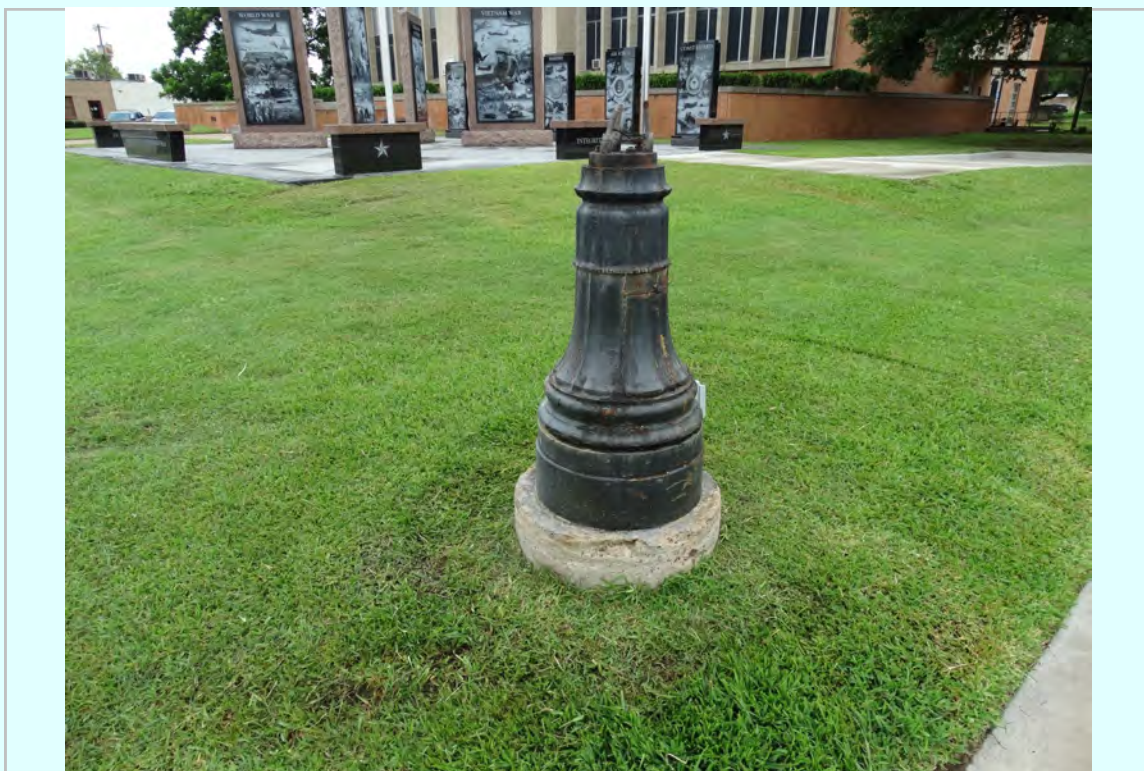
Photo: Remains of a light standard, circa 1955

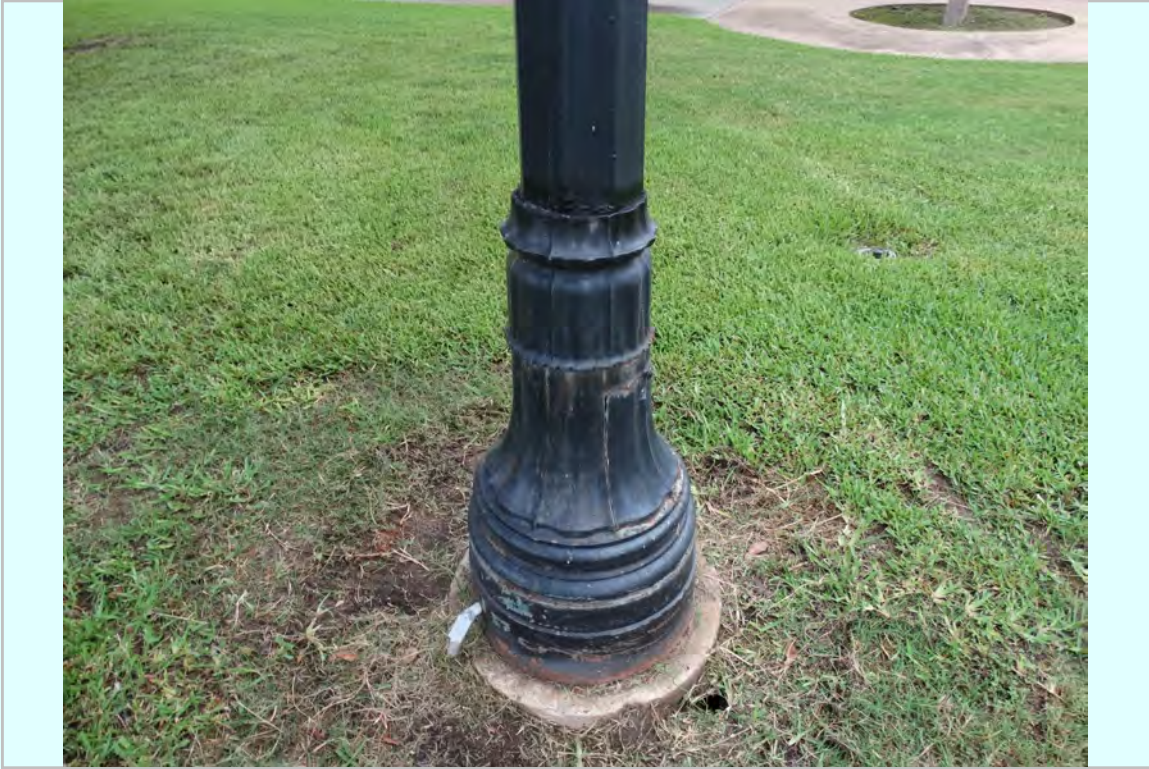
Photo: Modifications to light poles,

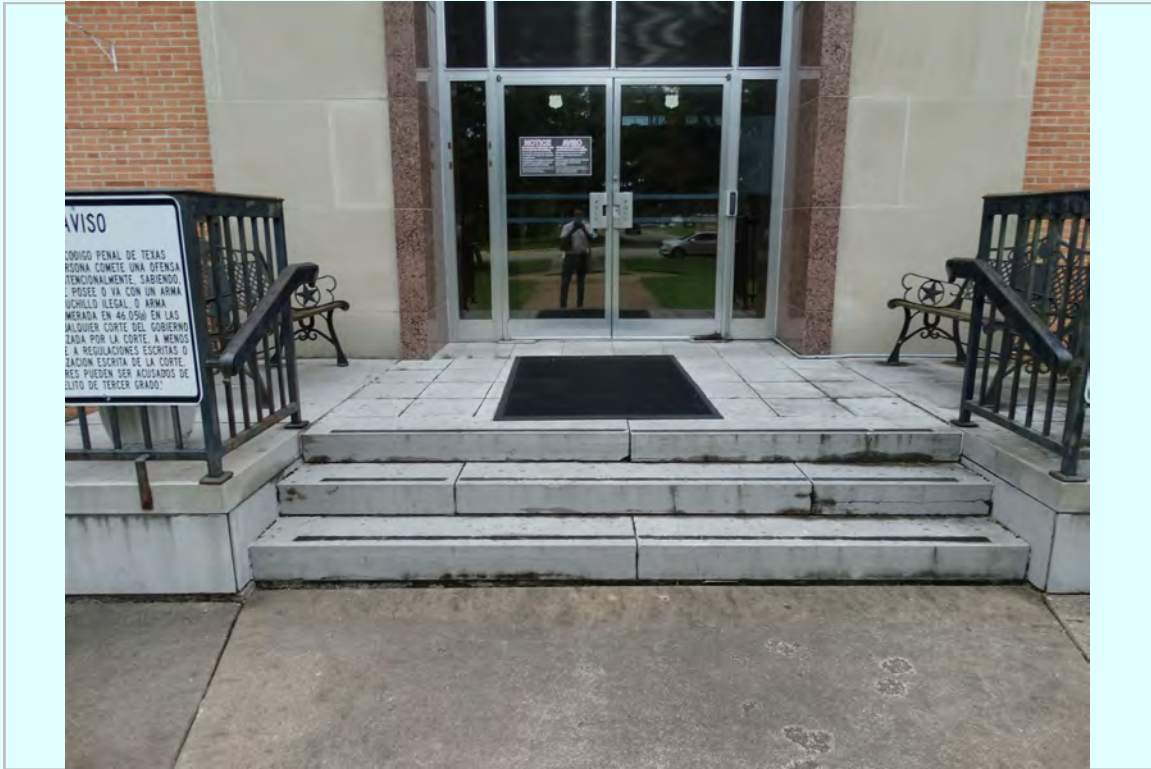
Photo: North entry patio

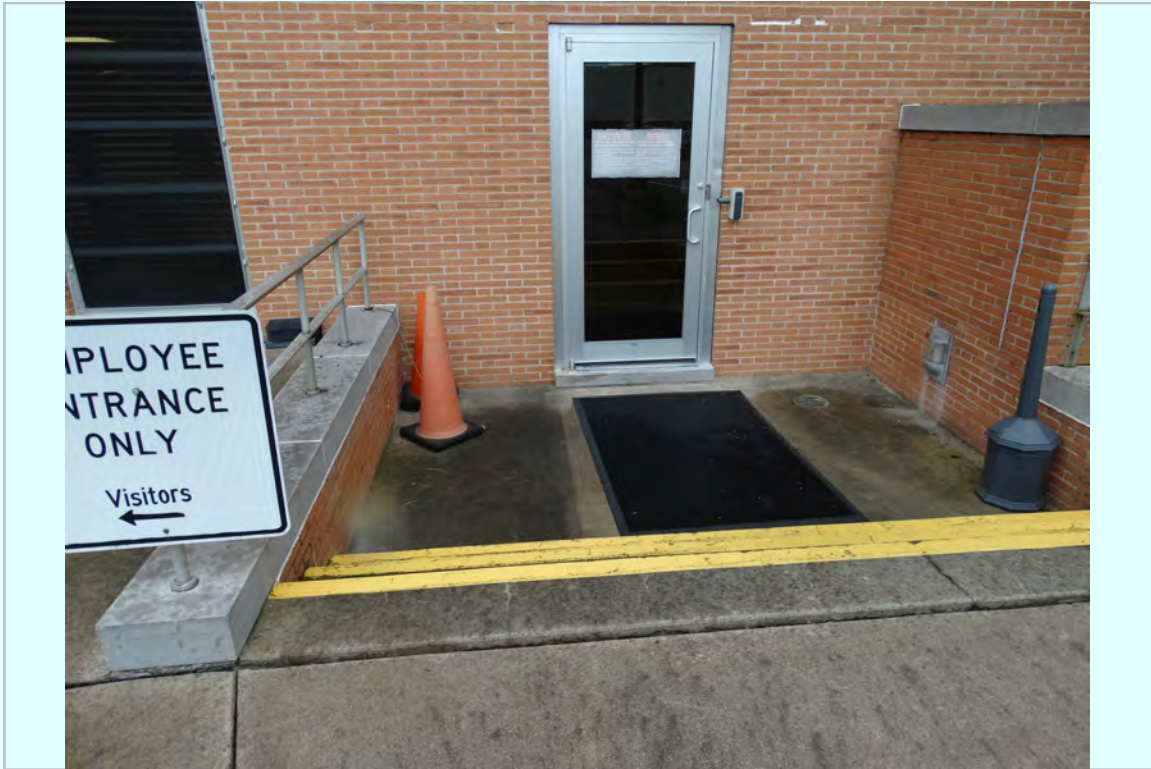
Photo: West Elevation, entry, non accessible

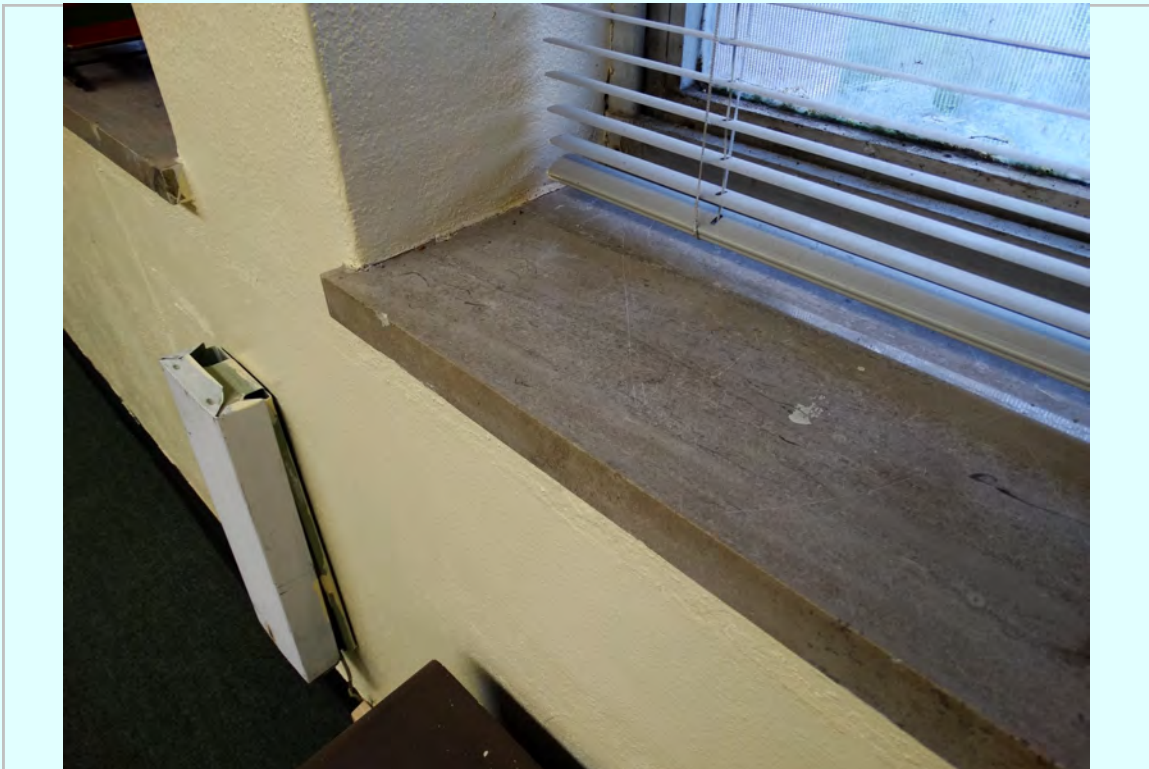
Photo: 2nd floor window existing condition, stone stool

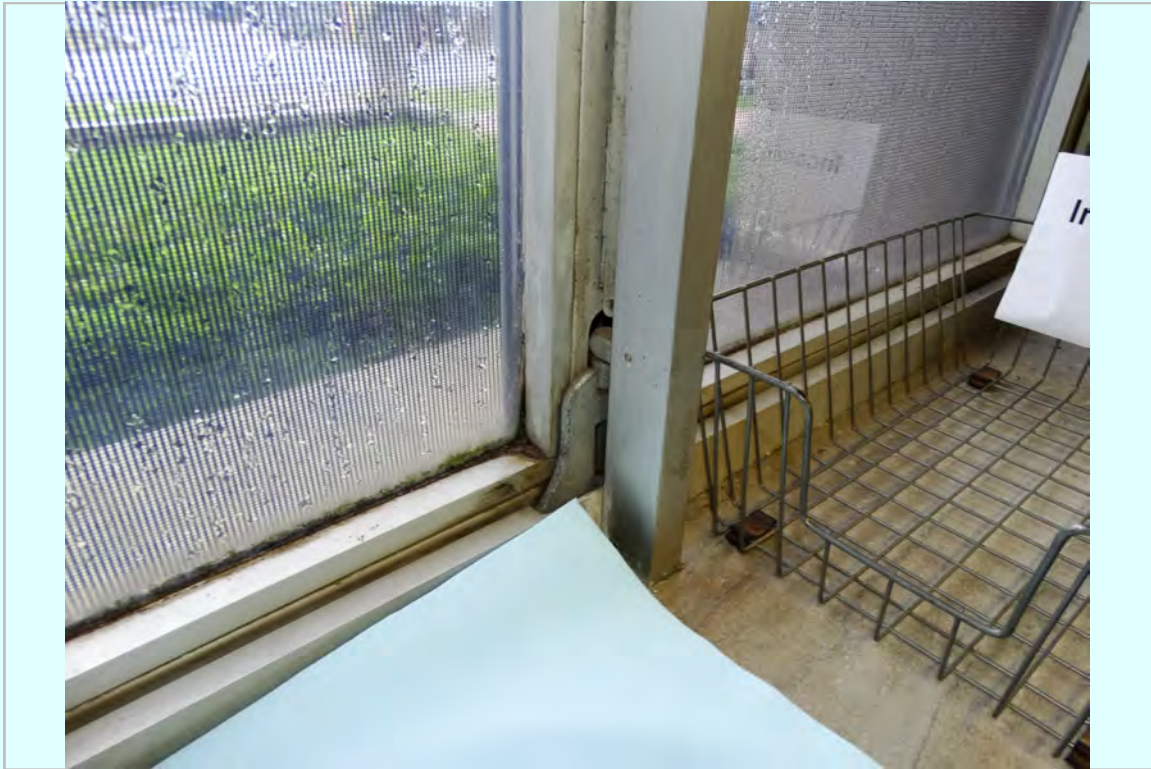
Photo: 2nd floor existing window operator

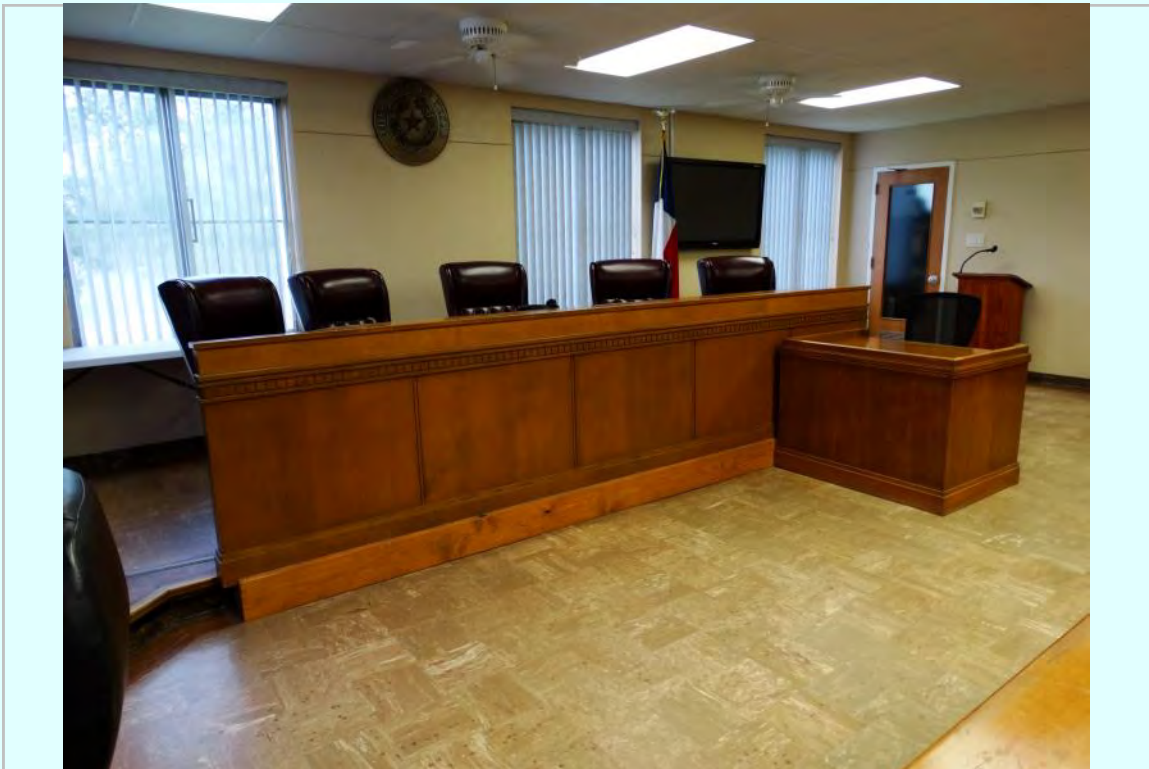
Photo: Second floor courtroom Commissioners Bench platform

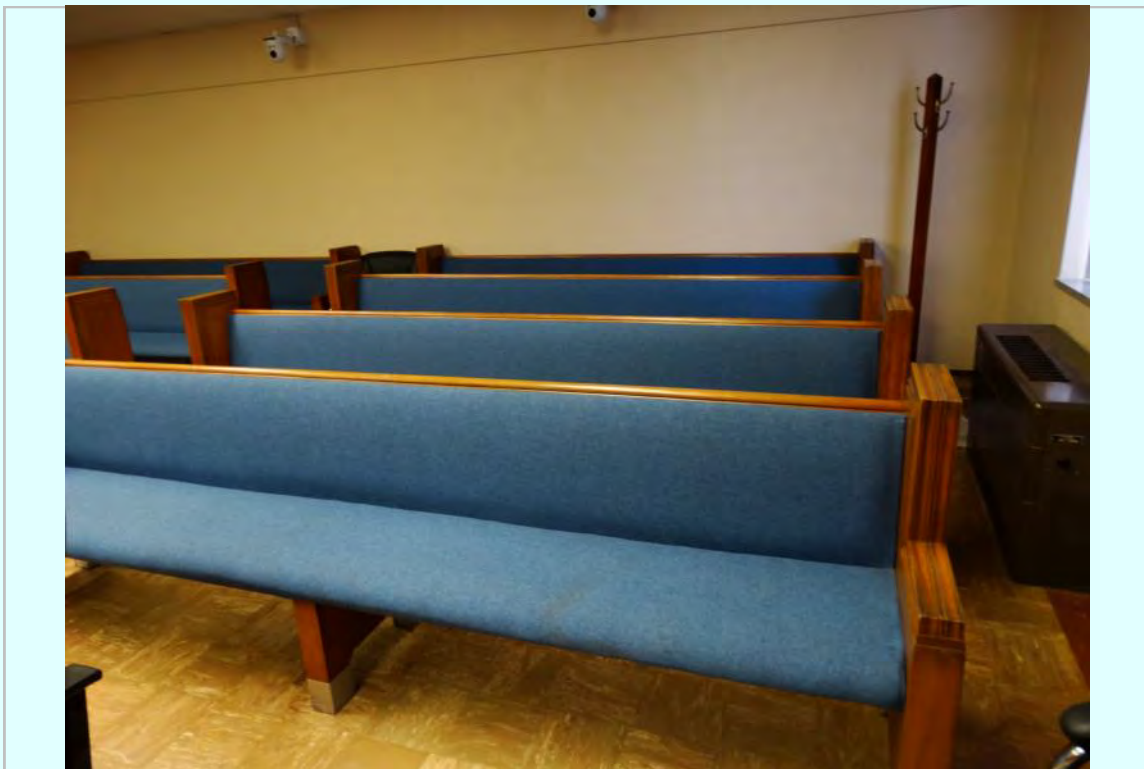
Photo: Second floor Commissioners courtroom

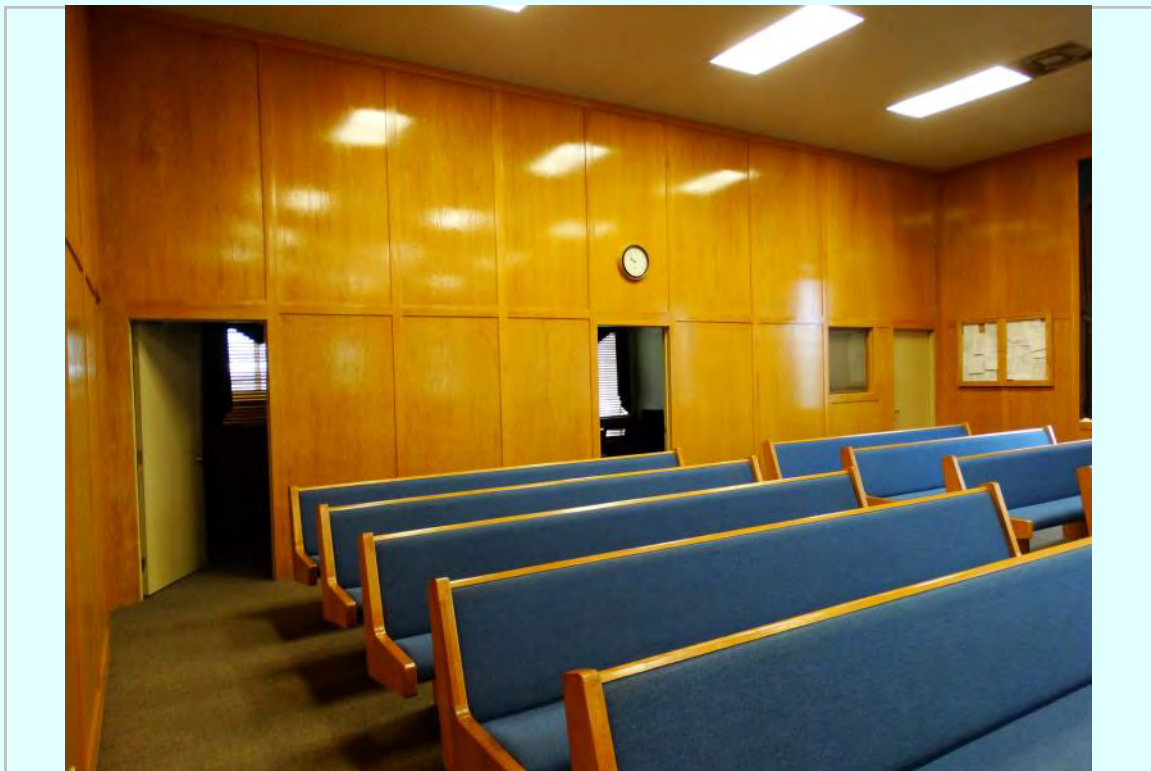
Photo: Third floor door into County Courtroom

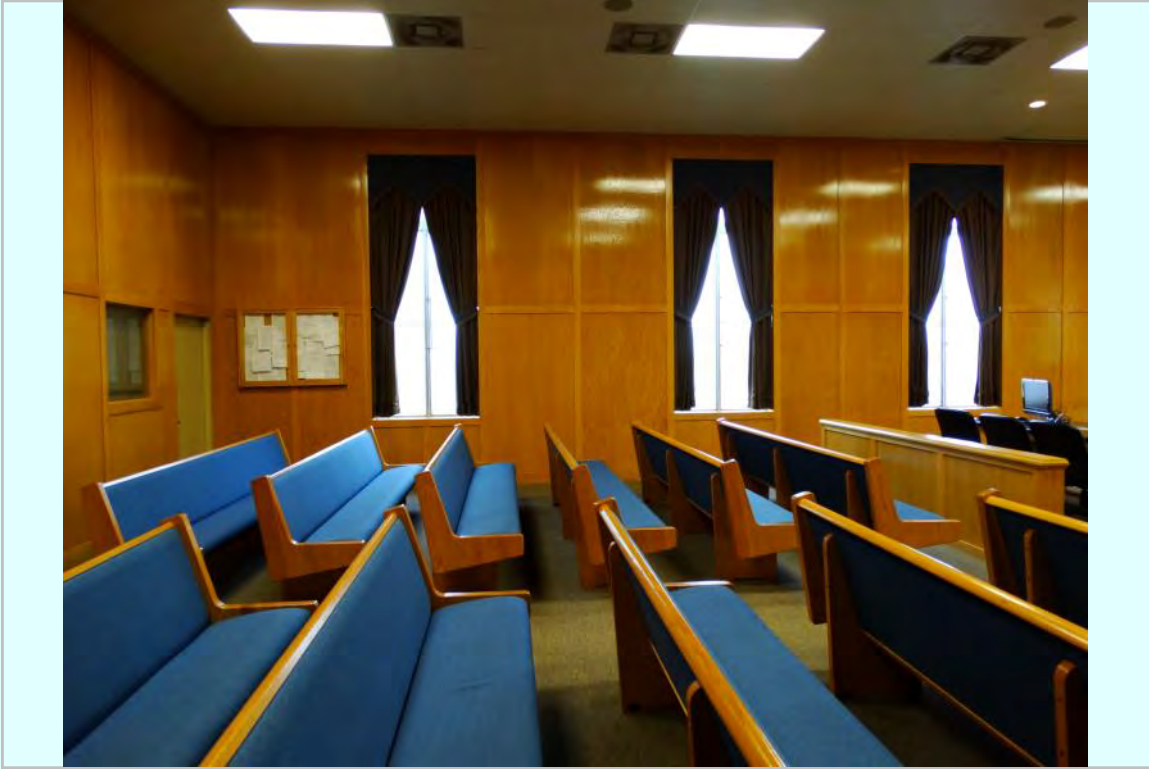
Photo: County Courtroom

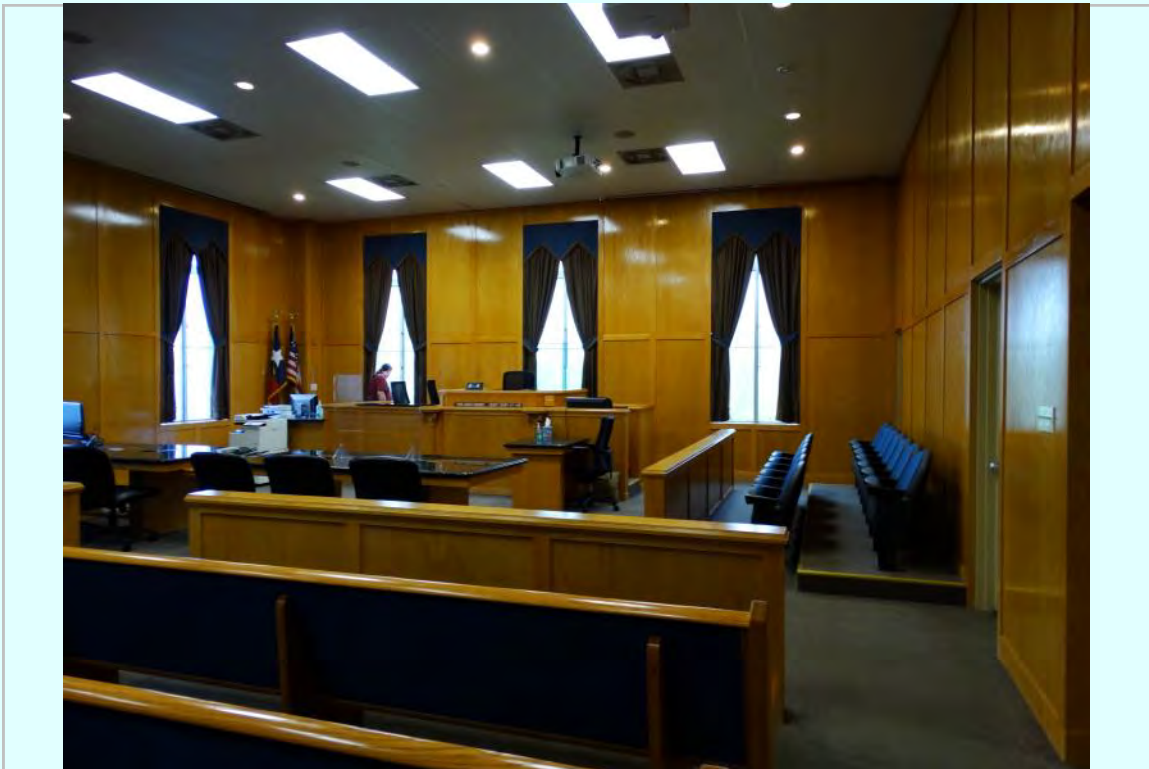
Photo: County Courtroom

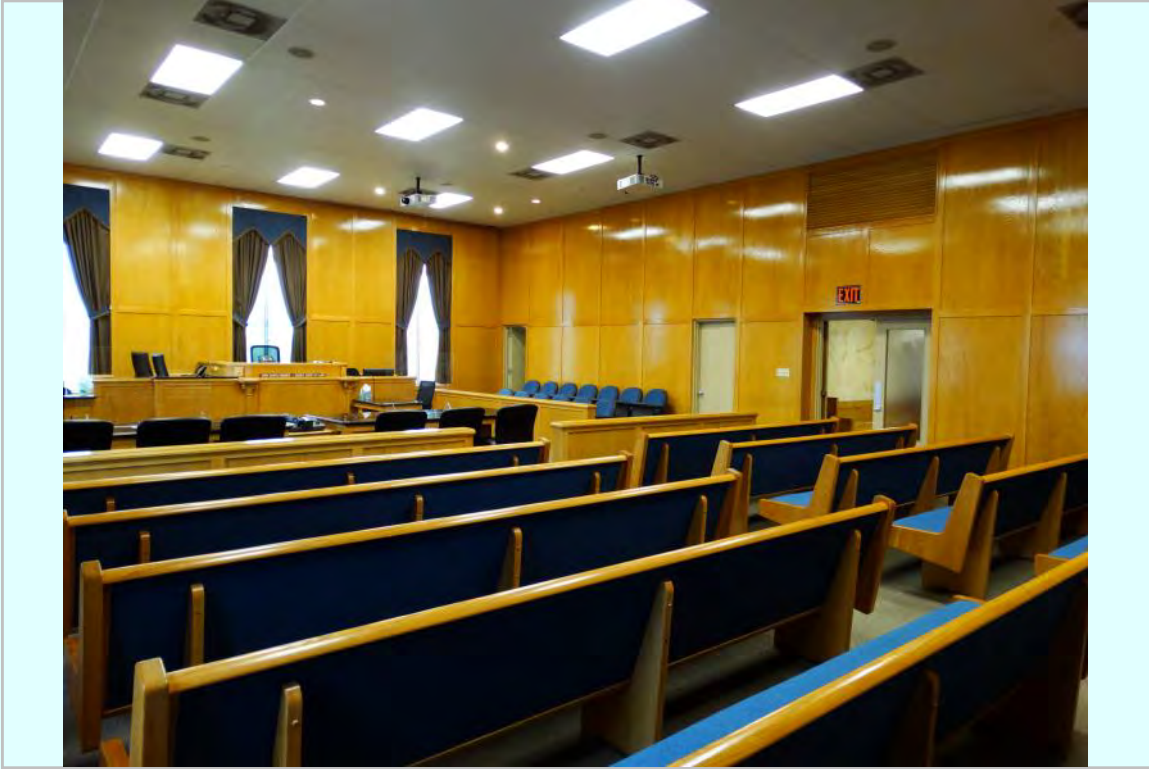
Photo: County Courtroom

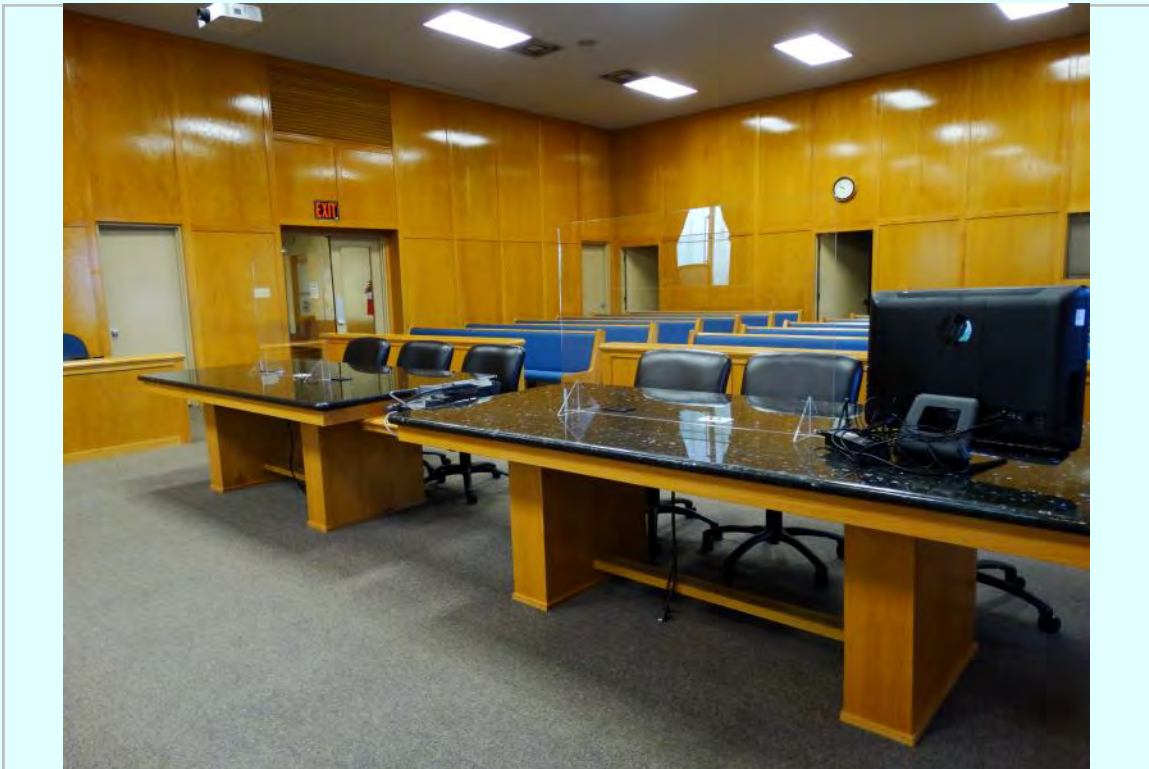
Photo: County Courtroom

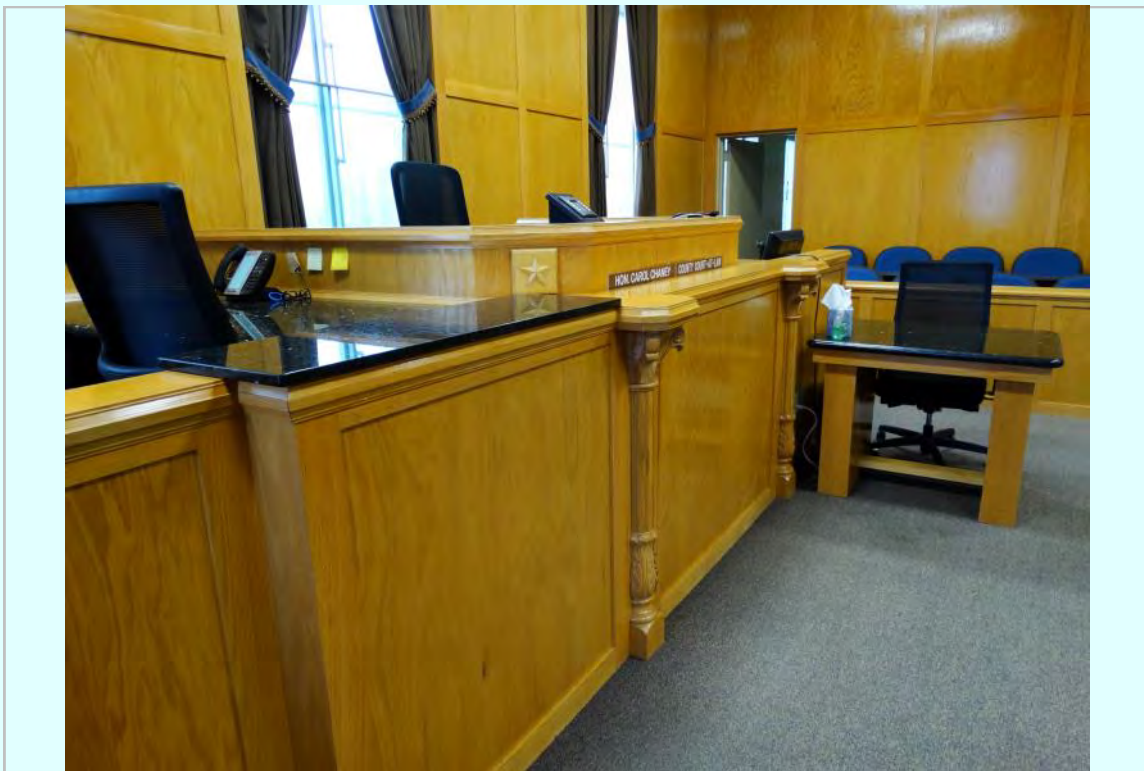
Photo: County Courtroom

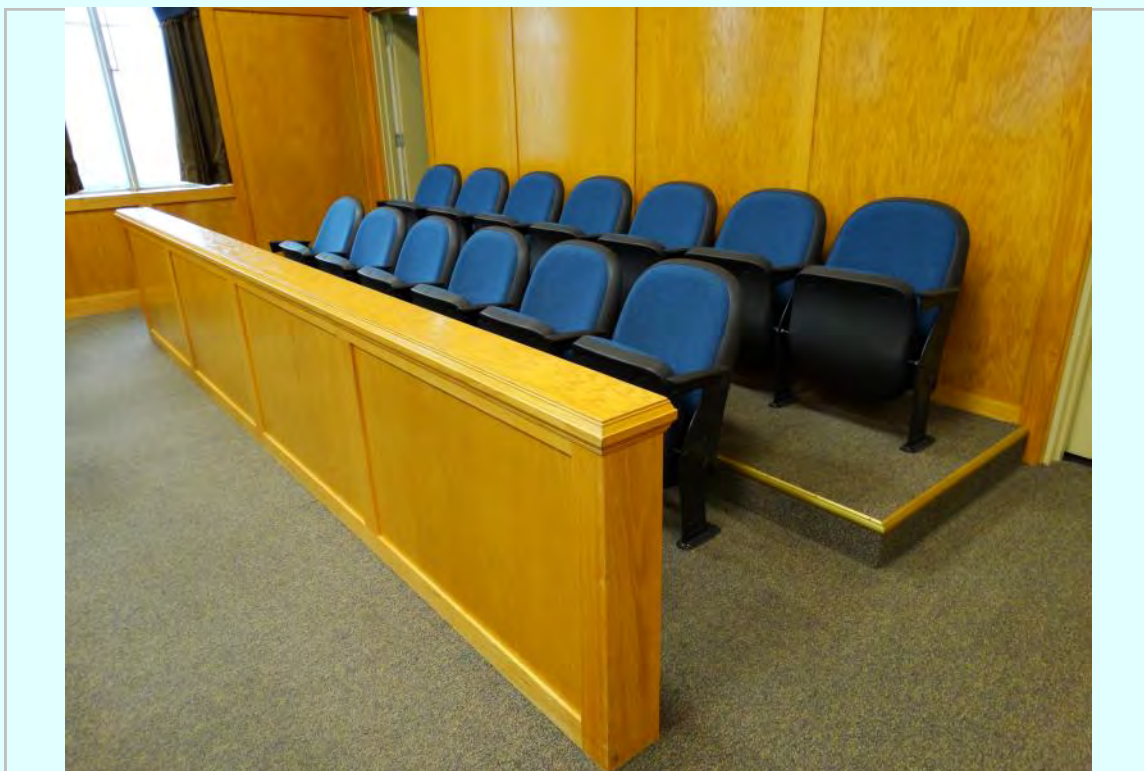
Photo: County Courtroom

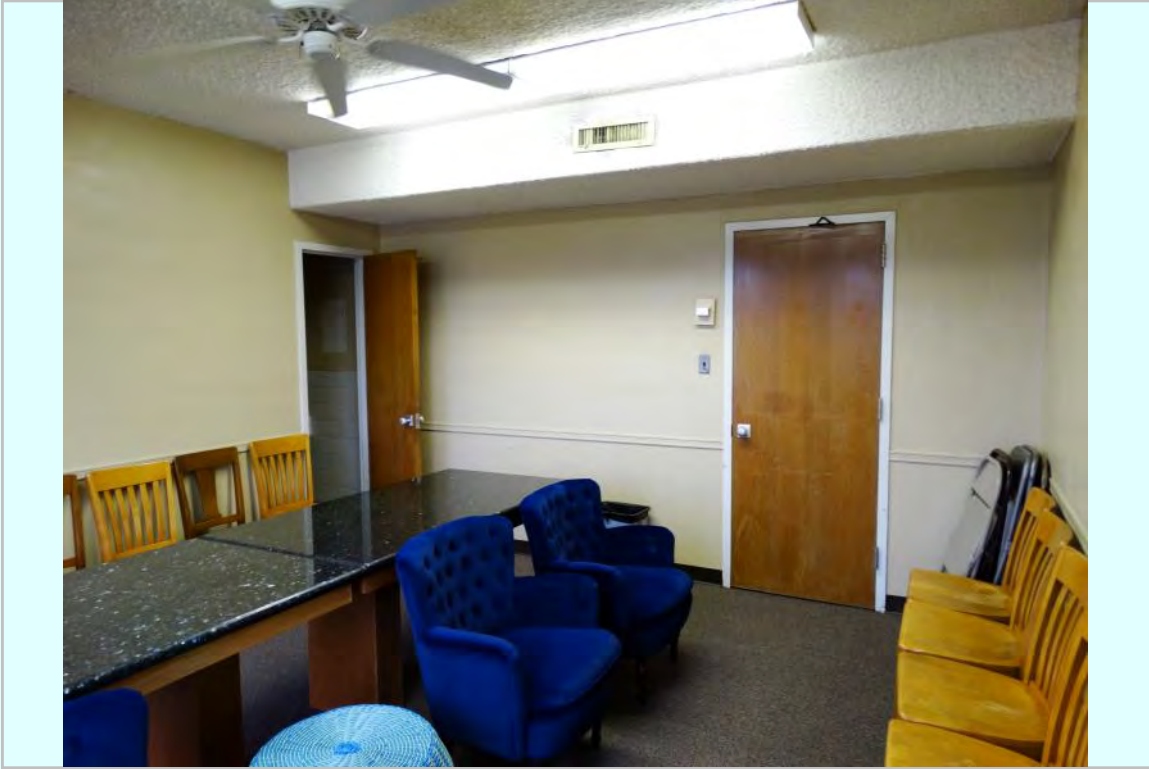
Photo: County Courtroom jury box
