# EXISTING CONDITION ASSESSMENT

**WALLER COUNTY COURTHOUSE**  
Hempstead, Texas

**836 Austin Street**  
Hempstead, Texas 77445

October 27, 2021

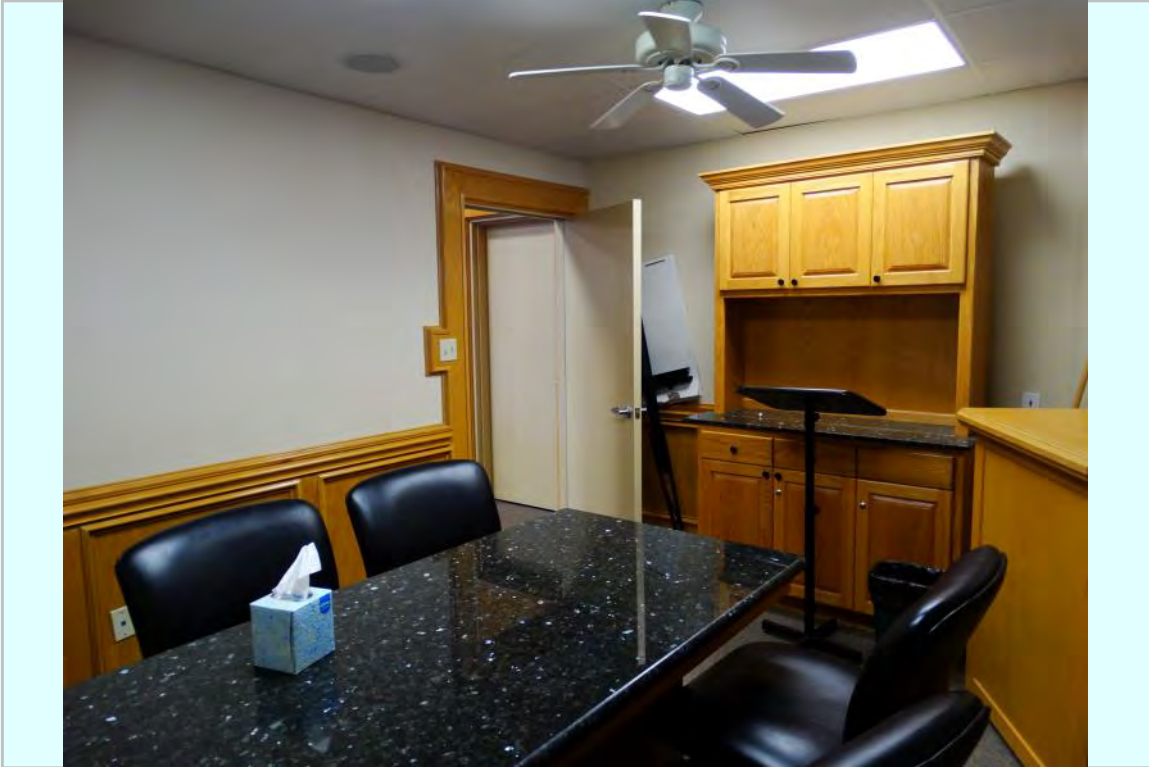
Photo: Third floor office space, non original millwork

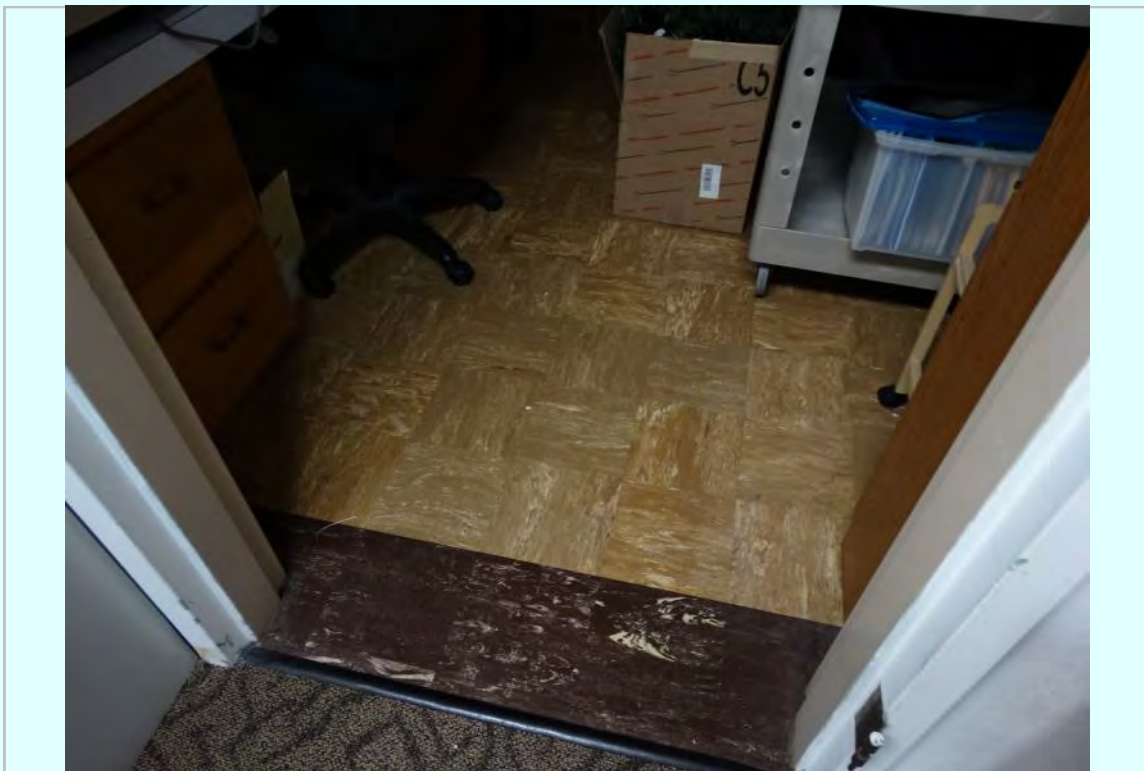
Photo: Third floor office space/storage

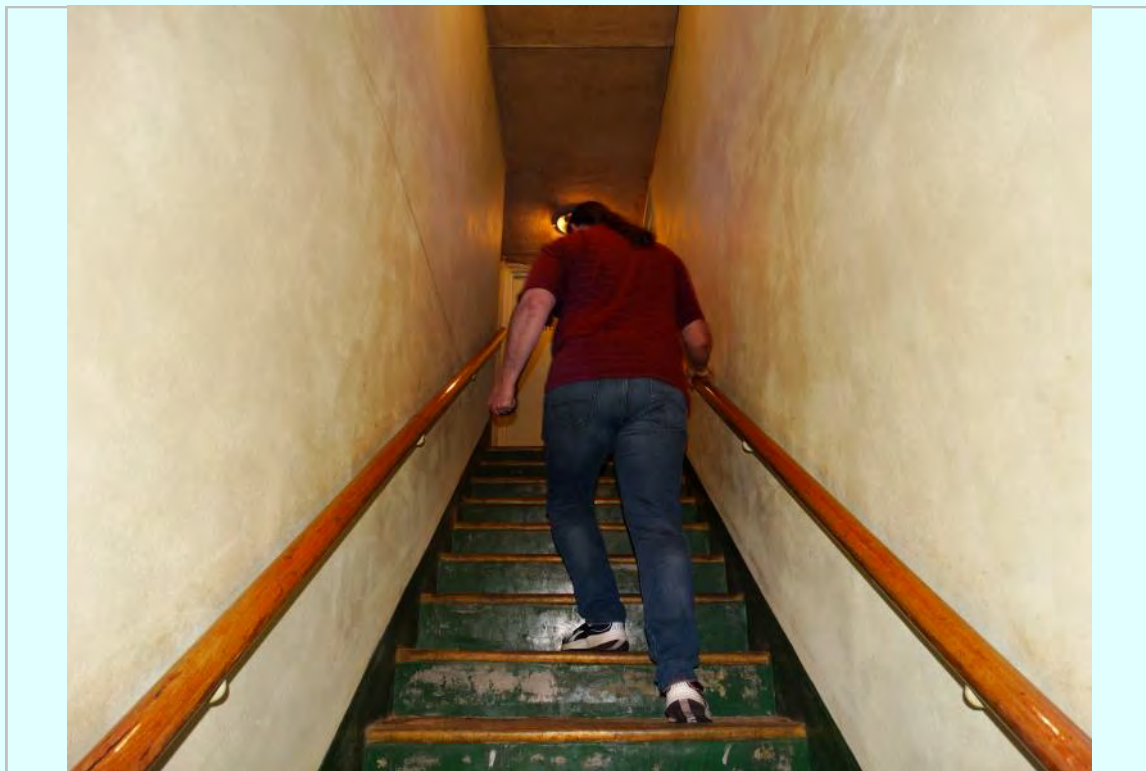
Photo: Fourth floor private stairs, possible prisoner stair

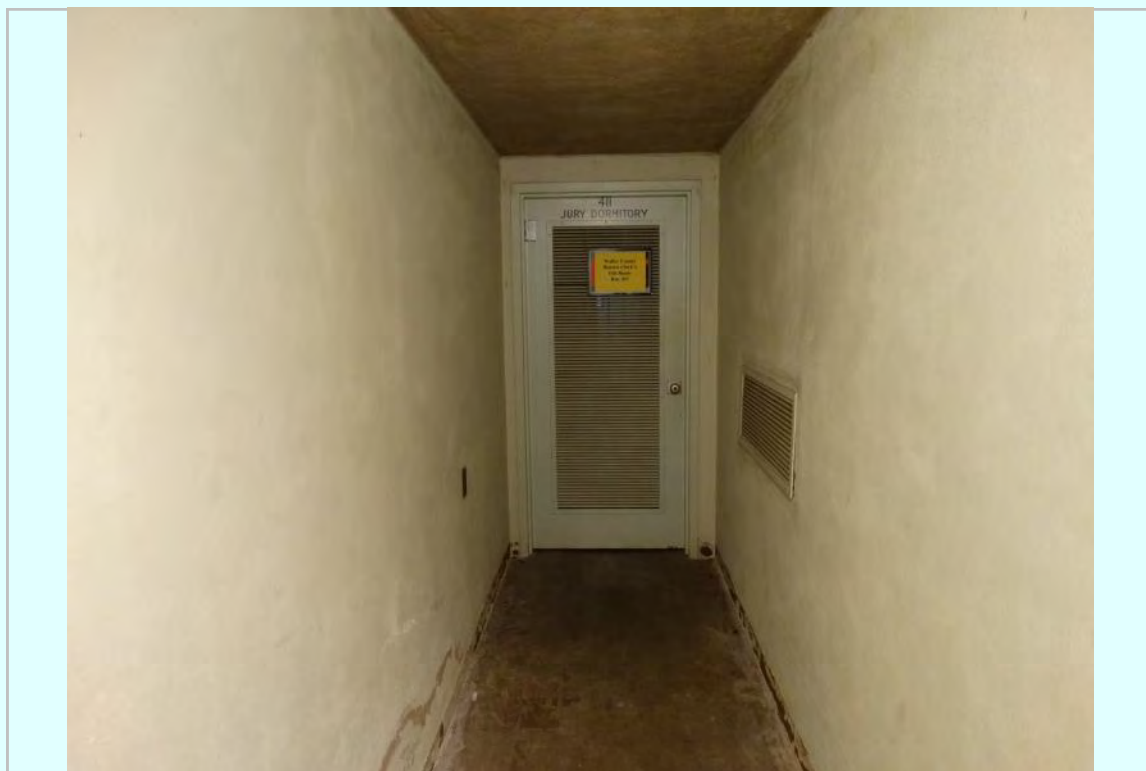
Photo: Fourth floor corridor

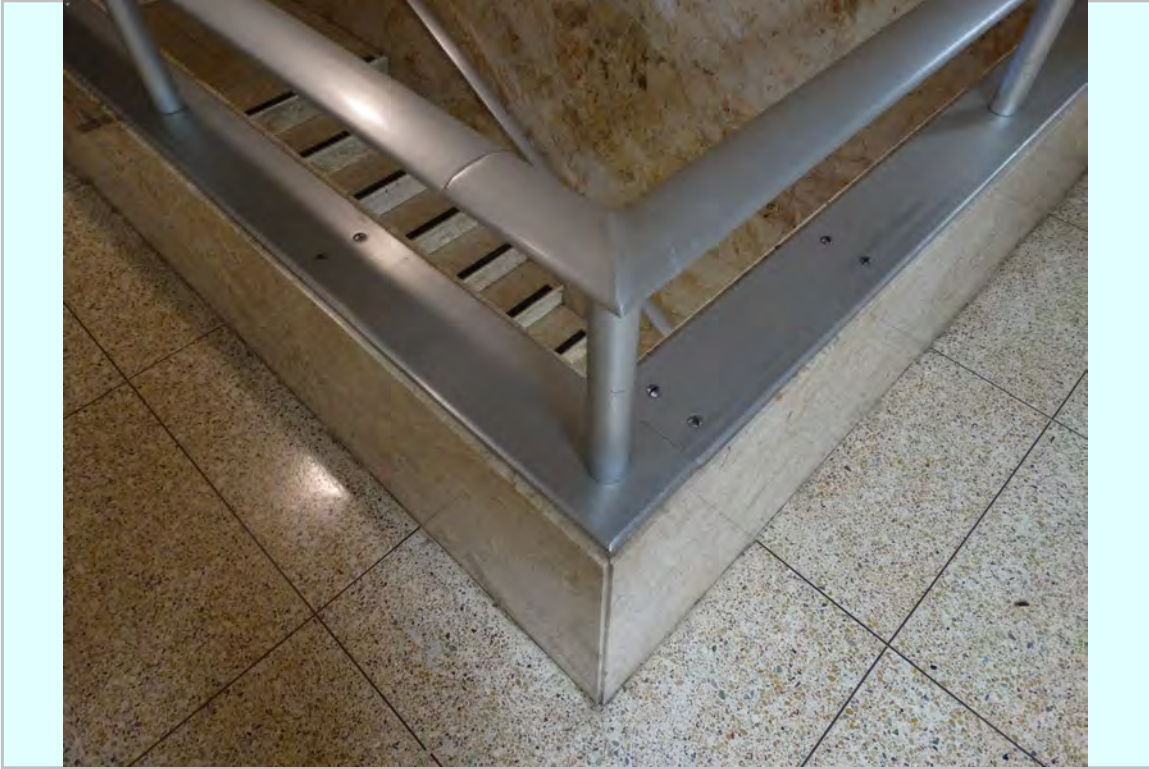
Photo: Top of central stair
